Australian Government
Department of Agriculture
and Water Resources

Machinery Cleaning Guide - Articulated Dump Trucks

April 2016

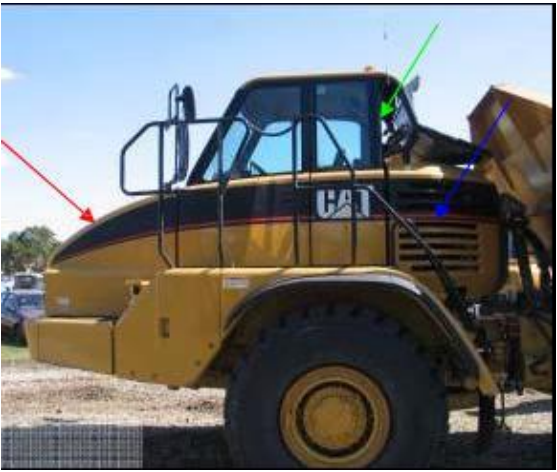
Description	Images
<p>The new style of articulated dump truck Cabin. Cabin door rubbers can be contaminated and are therefore an area of concern to the department (green arrow). The engine cover is to be lifted, (red arrow), the rear radiator covers removed (blue arrow) and all handrails checked for open ends or drainage holes. On some models of articulated dump trucks, the cabin can be hydraulically tilted, allowing access to the top of the engine block.</p>

<p>A photograph of a yellow articulated dump truck from the side. A red arrow points to the front engine cover, a blue arrow points to the rear radiator covers, and a green arrow points to the cabin door rubber seal.</p>
<p>The older style of articulated dump truck cabin. Again, all cabin door rubbers (red arrow) may be of concern, the air-filter pre-cleaner (blue arrow) removed for cleaning and inspection as well as cabin vents covers (aqua arrow). The rear non-affixed panels have already been removed in this illustration (green arrow).</p>

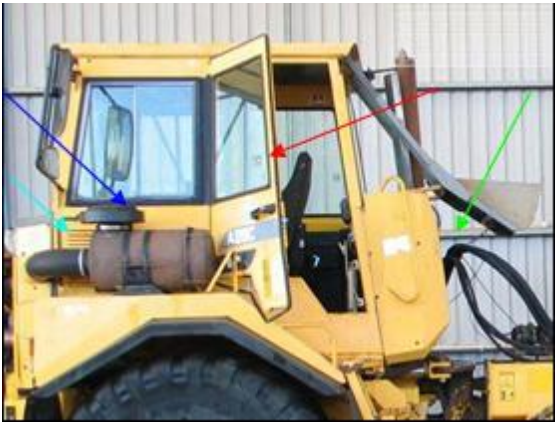
<p>A photograph of an older yellow articulated dump truck with its cabin door open. A red arrow points to the door rubber seal, a blue arrow points to the air filter pre-cleaner, an aqua arrow points to a cabin vent cover, and a green arrow points to a rear non-affixed panel.</p>

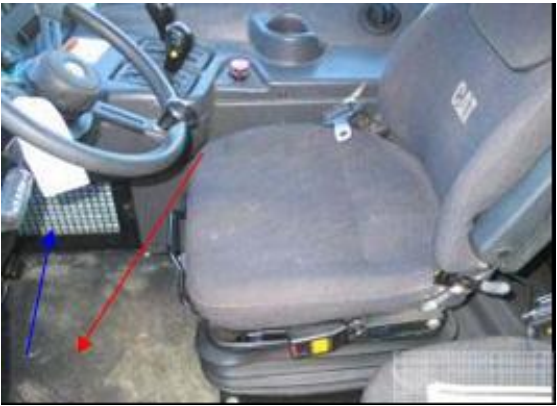
<p>The inside of the articulated dump cabin. The rubber floor matting is to be removed (red arrow) as well as the non-affixed floor pan, allowing access to the engine (see later illustration). Remove air-filter cover (blue arrow) for cleaning and inspection.</p>

<p>An interior photograph of the truck's cabin. A red arrow points to the rubber floor matting, and a blue arrow points to the air filter cover.</p>

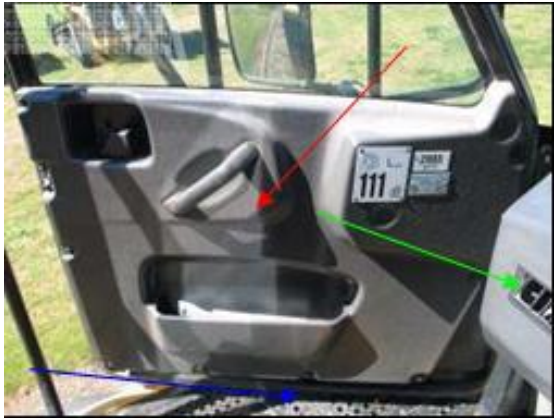
Description	Images
<p>Depending on the configuration, the internal door void (red arrow) may harbour biosecurity risk material and be of interest to the department. Likewise door rubbers (blue arrow) and air-conditioning vents (green arrow) have previously been found to be contaminated and therefore will need to be inspected.</p>

A photograph of the interior of an articulated dump truck cab. A red arrow points to a dark, recessed area in the door panel. A blue arrow points to a rubber seal at the bottom of the door. A green arrow points to a rectangular air-conditioning vent on the dashboard area.
<p>Biosecurity risk material has previously been found in some air-conditioning vents (red arrow) and therefore is an area of interest to the department.</p>

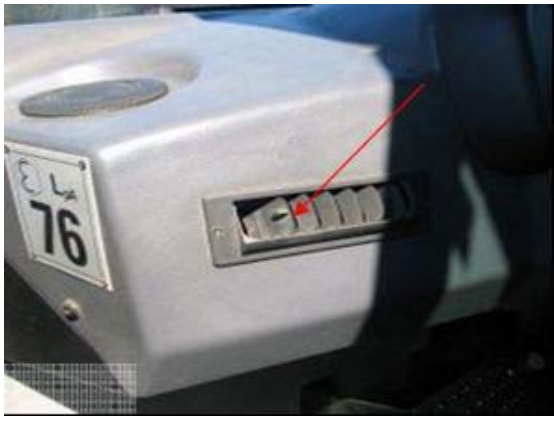
A close-up photograph of an air-conditioning vent on the dashboard. A red arrow points to the vent's grille.
<p>A close up of the air-vent cover. Remove the grill (red arrow) and check the cleanliness of the internal filter (pressurised air). The rubber cabin pedals (green arrow) have been removed for cleaning and inspection.</p>

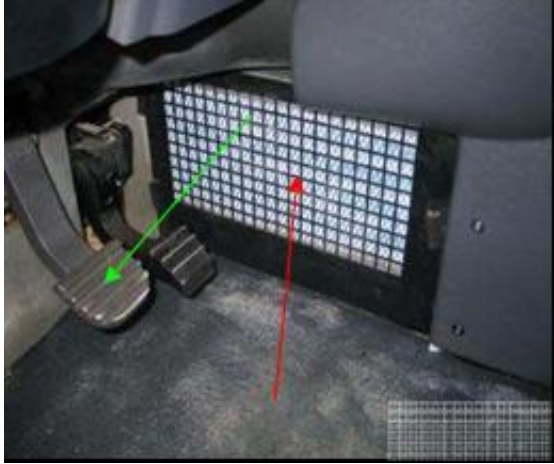
A close-up photograph of the air-vent cover and rubber cabin pedals. A red arrow points to the vent cover, and a green arrow points to the rubber cabin pedals.

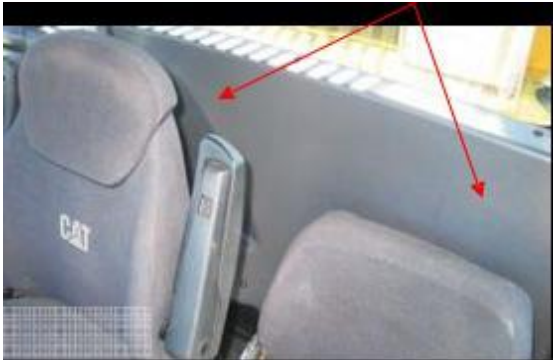
Description	Images
<p>Behind all internal wall linings (red arrows) is to be cleaned and accessible at the time of inspection.</p>

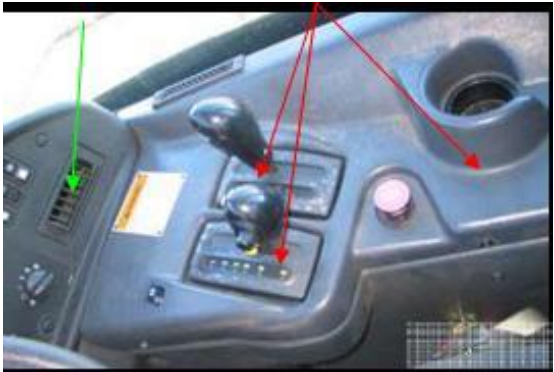
<p>The internal housing of all joystick control panels (red arrows) is to be cleaned and accessible at the time of inspection. Air-conditioning vents (green arrow) are to be internally cleaned and accessible for inspection.</p>

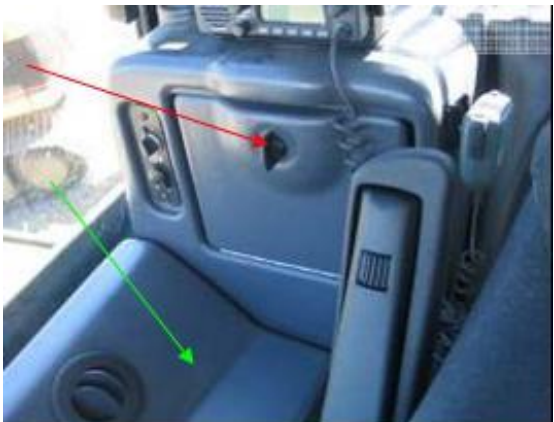
<p>All storage compartments (red arrow) are to be internally cleaned as well as behind any wall paneling (green arrow).</p>

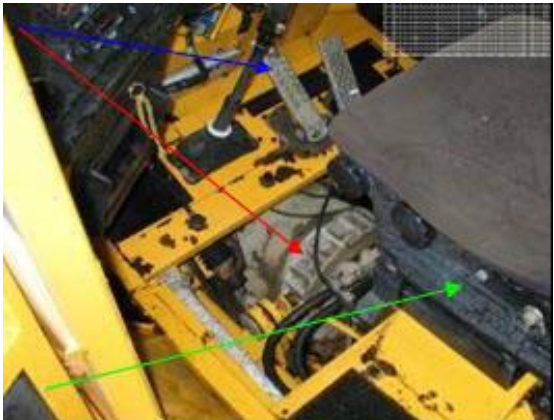
<p>Inside the cabin, the floor pan has been removed, allowing inspection access to the top of the engine block (red arrow). The blue arrow highlights where the rubber pedal covers have been removed for cleaning and inspection, while the green arrow highlights the rubber seat shroud, which must be cleaned both internally and externally. On some of the newer models the whole cabin can be hydraulically tilted sideways, allowing access to the topside of the engine block.</p>

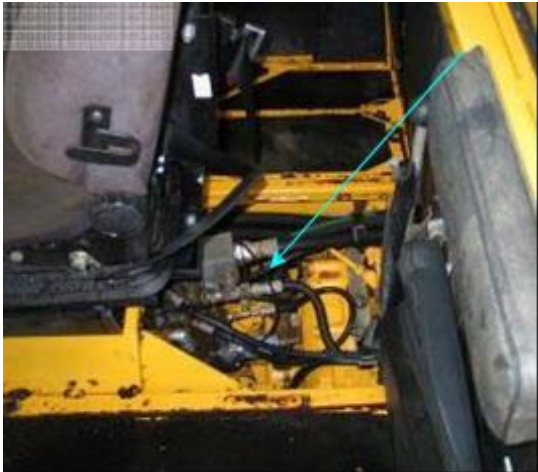
Description	Images
<p>The non-affixed floor pan behind the seat has been removed, allowing cleaning and inspection access (green arrow).</p>

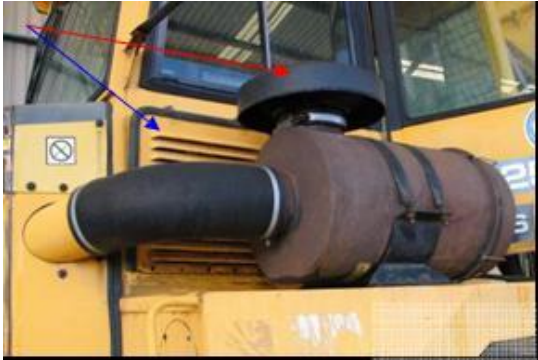
<p>The air-filter pre-cleaner (red arrow) and air-conditioning vent cover (blue arrow), require removal for cleaning and inspection.</p>

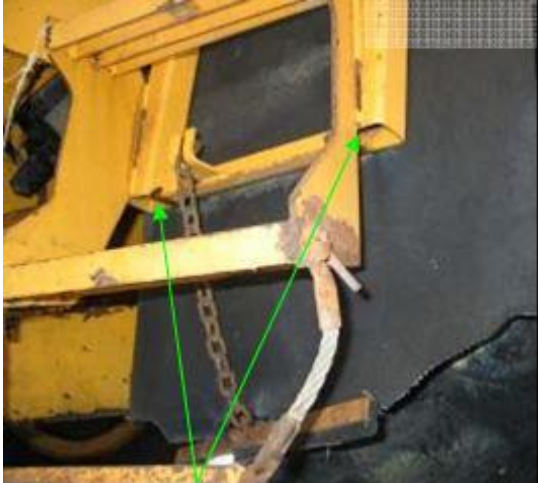
<p>The ladder leading to the cabin may have open-ended channels as those highlighted by the green arrows. Each footstep must be thoroughly cleaned, including the underside (green arrow).</p>

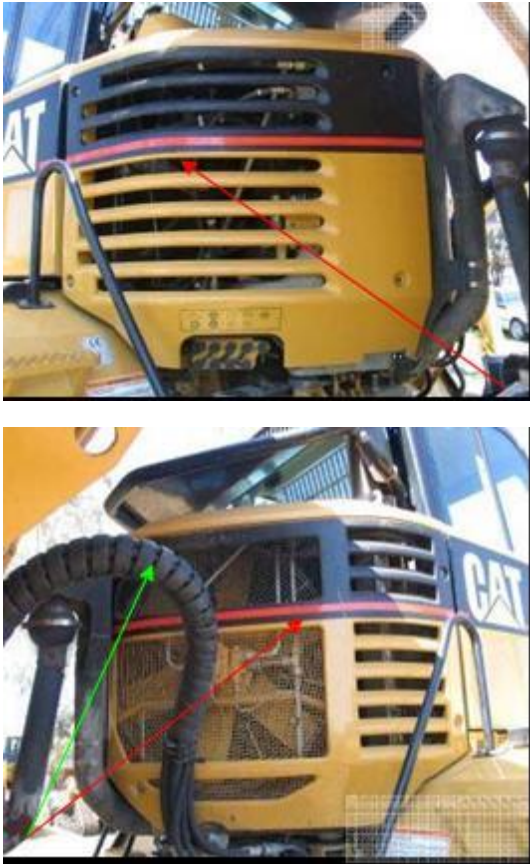
Description	Images
<p>The non-affixed radiator cover panels (red arrow), located behind the cabin. Both must be removed to allow access to the radiator and oil cooler fins, as well as the inside of the radiator shroud. All looming (green arrow) is to be checked for internal cleanliness.</p>

<p>The radiator is not located behind the cabin on this older model, however the non-affixed covers have still been removed, allowing cleaning and inspection access (green arrow).</p>

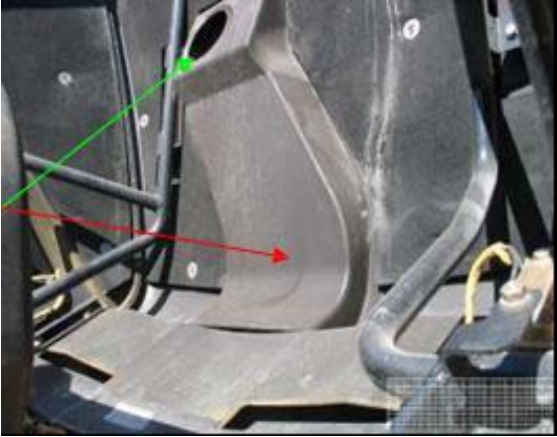
<p>The air intake vent (red arrow) on the inside of the engine housing. The internal surfaces are to be cleaned and inspected.</p>

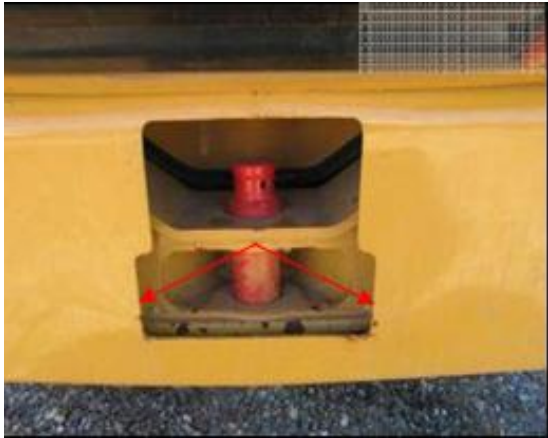
Description	Images
<p>On some models, along the front drawbar is a towing pin. Check this front drawbar for any hollow channels (red arrows).</p>

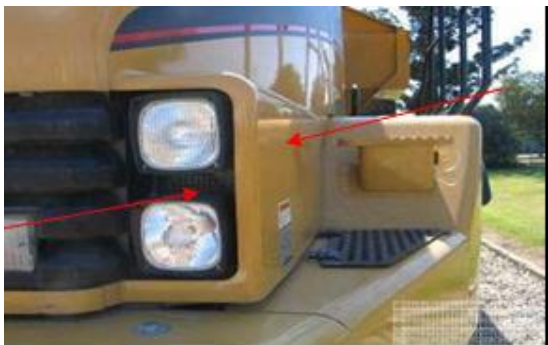
<p>Check for cavities behind all lights that will require access for inspection if not sealed units.</p>

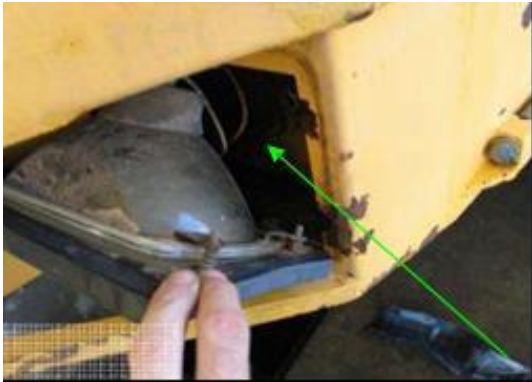
Description	Images
<p>Highlights the recess found behind the light covers (green arrow), which has been found to harbour significant amounts of biosecurity risk material.</p>

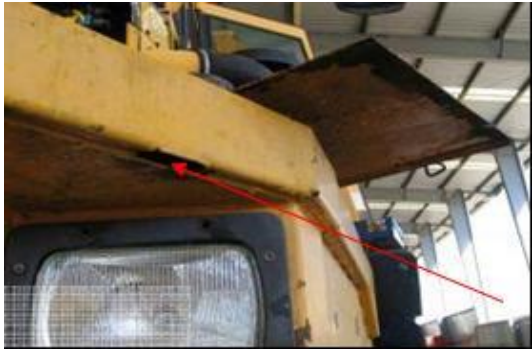
<p>On some of the older models, drainage holes like the one highlighted by the red arrow above the headlight, require flushing to ensure cleanliness.</p>

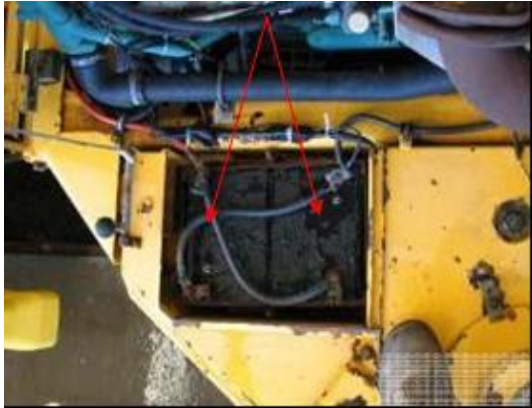
<p>All batteries are to be loosened from tie-down points for underside cleaning and inspection (red arrow).</p>

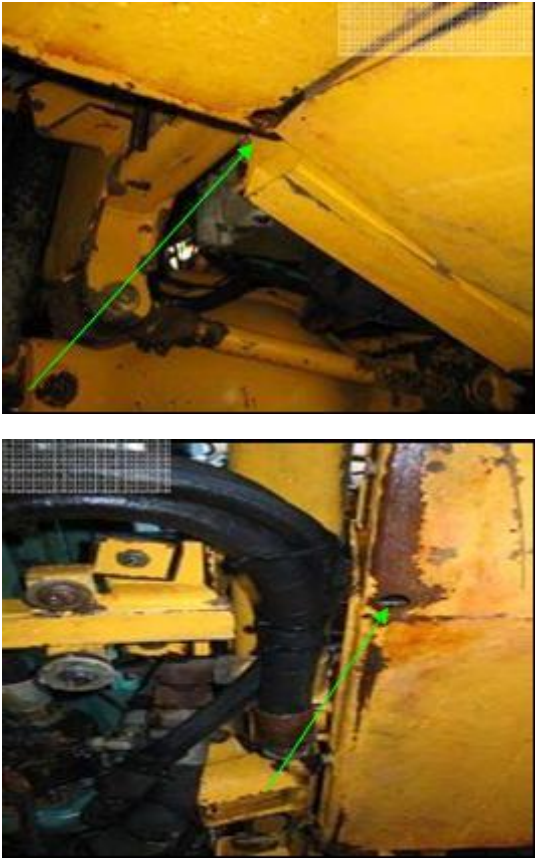
Description	Images
<p>On older models, the drainage holes (green arrows) under the nose may not be as obvious as on the newer models, however these areas also require flushing to verify cleanliness.</p>

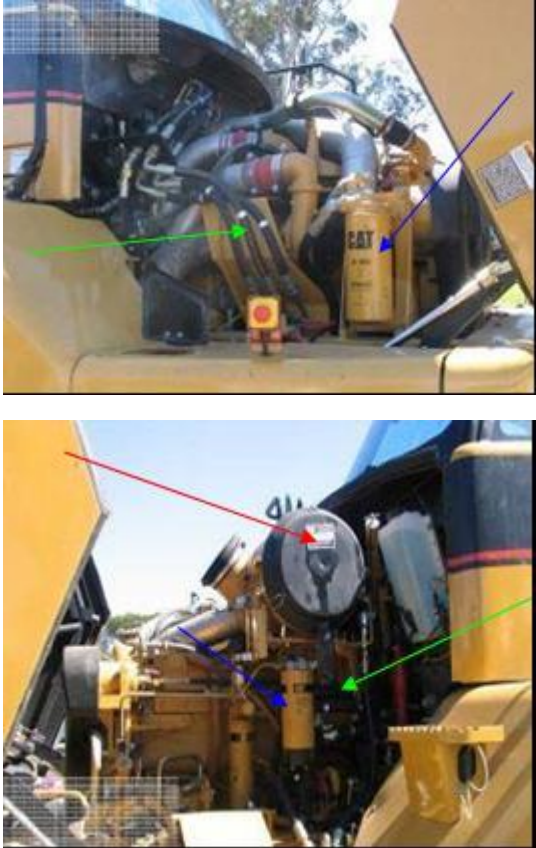
Description	Images
<p>Both sides of the dump truck engine block. All hydraulic hoses (green arrows), oil filters (blue arrows) need to be thoroughly cleaned, as well as the side and front of the block and the air-filter (red arrow).</p>

<p>The images show two views of the engine block of a dump truck. The top image shows a side view with a green arrow pointing to a hydraulic hose, a blue arrow pointing to an oil filter, and a red arrow pointing to the air filter. The bottom image shows a front view with a red arrow pointing to the air filter, a blue arrow pointing to an oil filter, and a green arrow pointing to a hydraulic hose.</p>

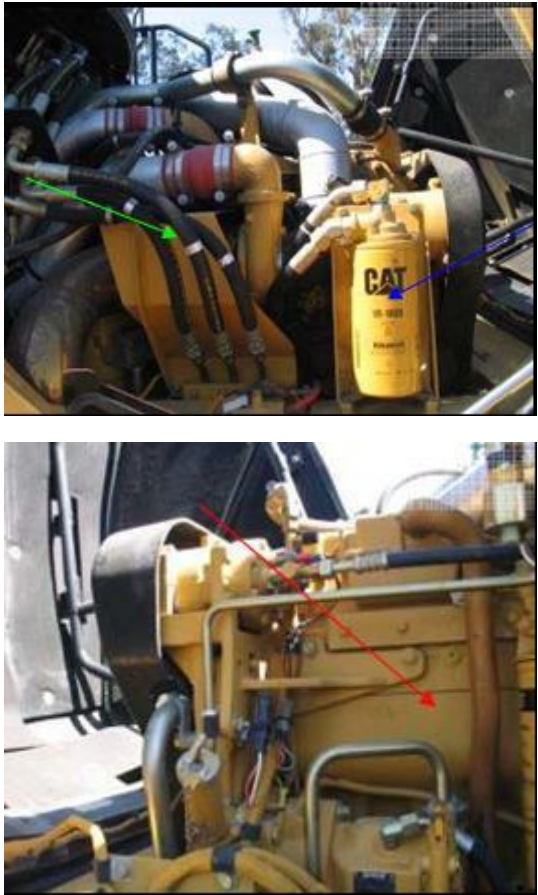
Description	Images
<p>Both sides of the dump truck engine block. All hydraulic hoses (green arrow), oil and fuel filters (blue arrow) need to be thoroughly cleaned, as well as the side and front of the block (red arrow).</p>

<p>The top photograph shows a close-up of the engine compartment with a green arrow pointing to a hydraulic hose and a blue arrow pointing to a yellow CAT fuel filter. The bottom photograph shows a wider view of the engine block with a red arrow pointing to the side and front area.</p>
<p>On the newer models a protective plastic shroud as highlighted by the red arrow covers the harmonic balancers. It must be removed for cleaning and inspection.</p>

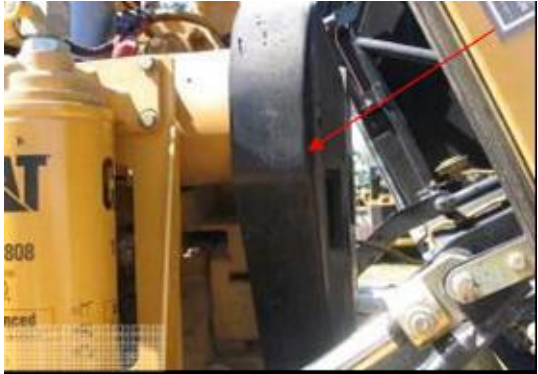
<p>The photograph shows a close-up of a yellow CAT engine component with a red arrow pointing to a black plastic shroud that covers the harmonic balancers.</p>

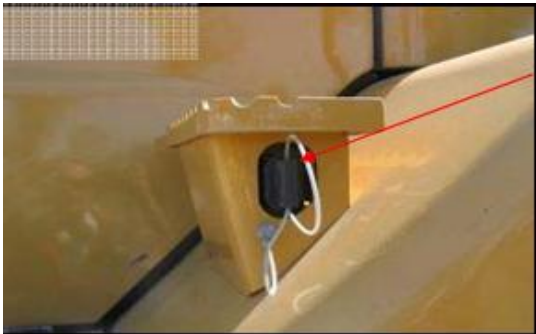
A close-up photograph of a small step on the side of the engine housing. A red arrow points to this step.

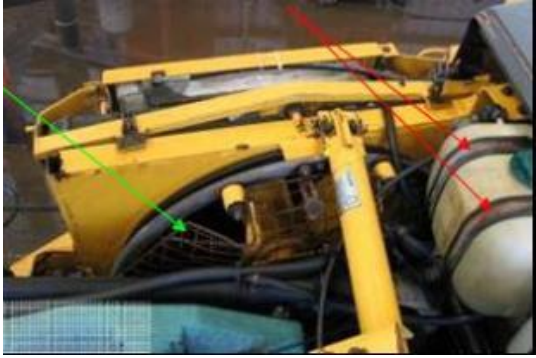
Description	Images
<p>On older models, the radiator is located in front of the cabin. For cleaning and inspection, several non-affixed radiator cover panels have been removed. The shroud grill (green arrow) is still in place, preventing access into the bottom of the shroud. Loosen bands around tanks (red arrows) and flush.</p>

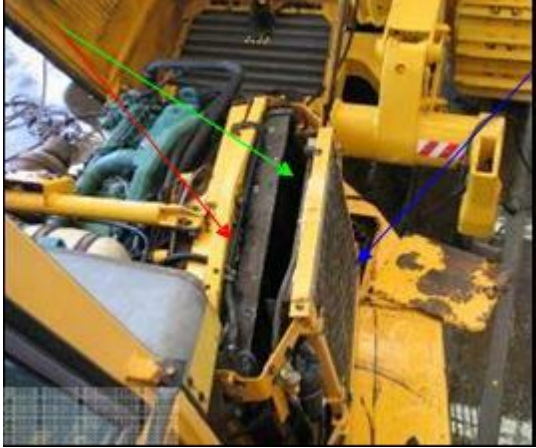
<p>The fins on both the radiator (red arrow) and oil cooler (blue arrow) must be flushed in the presence of the inspecting officer to verify cleanliness. On some models the oil cooler can be unbolted on one end and swung open on hinges to facilitate this access. The green arrow highlights the small recess between the radiator and oil cooler fins, which requires thorough inspection.</p>

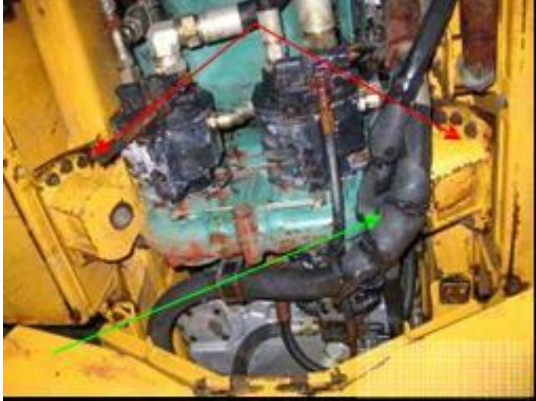
A photograph showing the underside of the engine block. Two red arrows point to the topside of the engine mounts, and a green arrow points to a piece of foam insulation. The surrounding area is yellow-painted metal.
On some older models, foam insulation (green arrows) can be found around some of the hydraulic hoses. This must be internally cleaned and inspected.

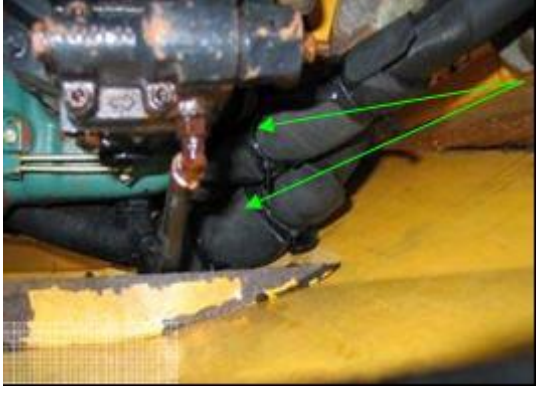
A close-up photograph of hydraulic hoses. Two green arrows point to areas of foam insulation that have been applied around the hoses, which need to be inspected and cleaned.

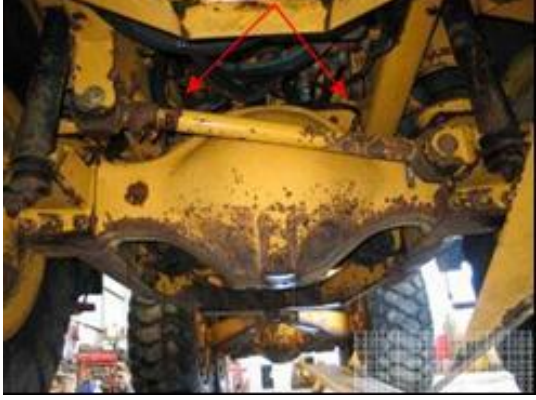
The topside of the differential (red arrows) must be thoroughly cleaned and inspected.

A photograph of the underside of the truck chassis. Two red arrows point to the topside of the differential, which requires thorough cleaning and inspection.

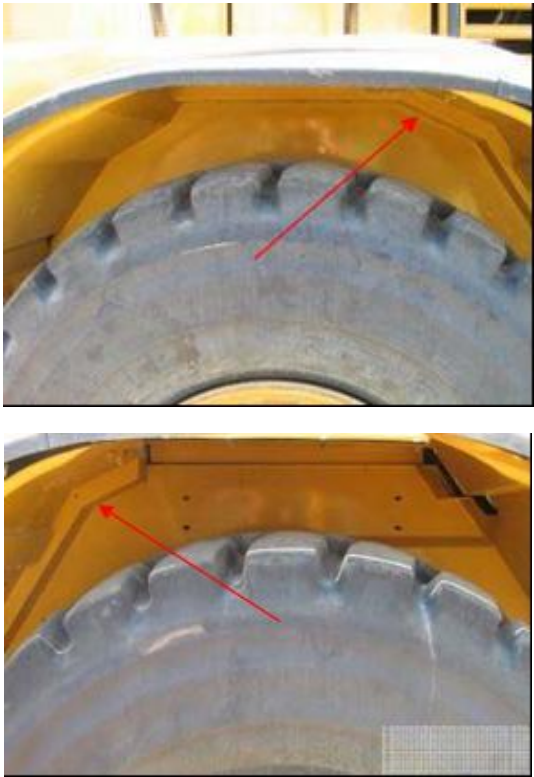
Description	Images
<p>The front wheel arches on the newer models. Check all underside channels (red arrows) for open ends, or drainage holes.</p>

<p>The top image shows a close-up of the wheel arch's underside with a red arrow pointing to a channel. The bottom image shows a similar view from a slightly different angle, also with a red arrow pointing to a channel.</p>
<p>A closer view of the channels inside the front wheel arches. The channels (red arrows) have hollow openings at the bottom (green arrows) and require flushing to verify cleanliness.</p>

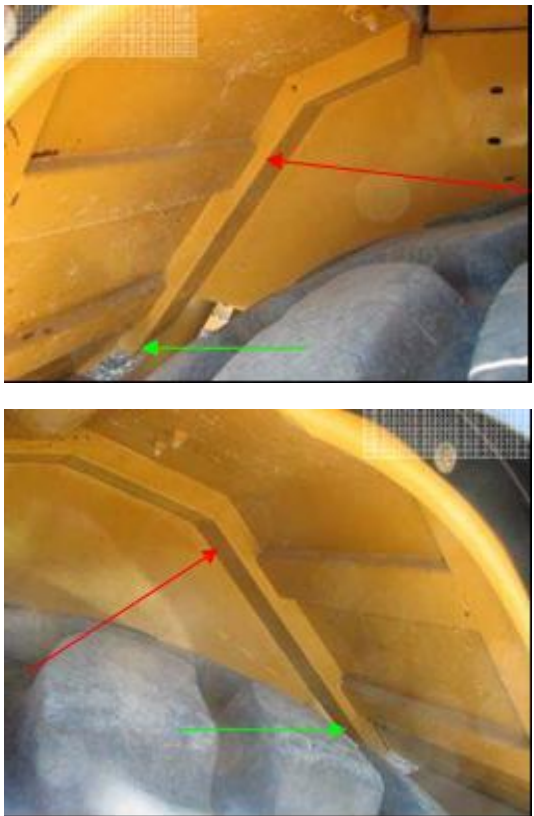
<p>The top image shows a close-up of a channel with a red arrow pointing to it and a green arrow pointing to a hollow opening at the bottom. The bottom image shows another view of a channel with a red arrow pointing to it and a green arrow pointing to a hollow opening at the bottom.</p>

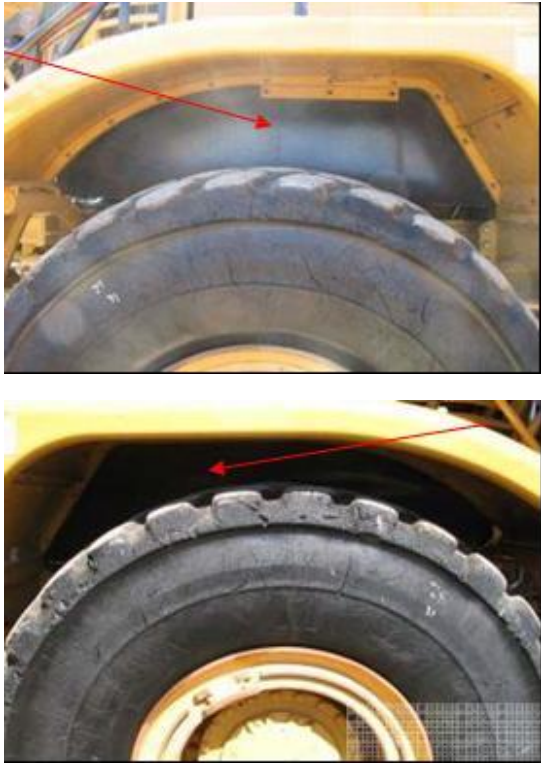
Description	Images
<p>The wheel arches on the earlier models may have black protective shrouds (red arrows) on the inside, which can be removed to facilitate the access to the side of the engine, located under the cabin.</p>

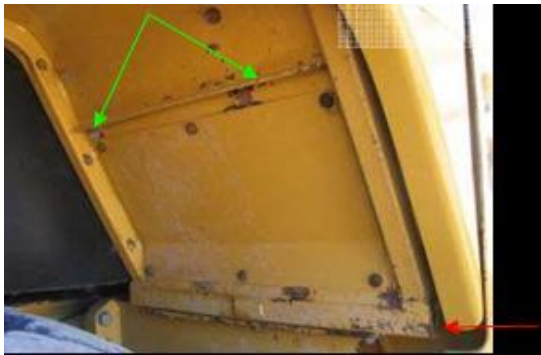
<p>The wheel arches of the earlier models have a combination of hollow channels (red arrow) and ledges (green arrows).</p>

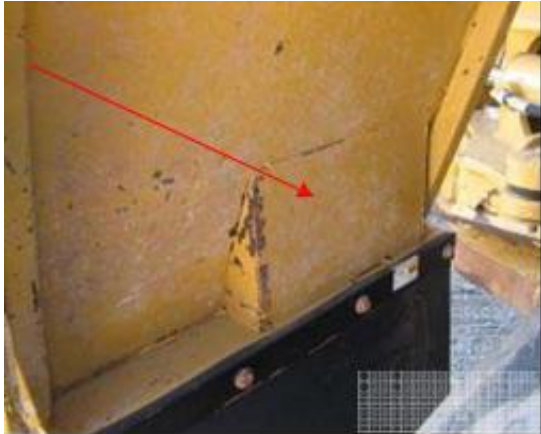
<p>Highlighted by the red arrow is a small box section found inside the wheel arch. This requires checking for drainage holes underside. If spot welded, then the internal cleanliness will require verification.</p>

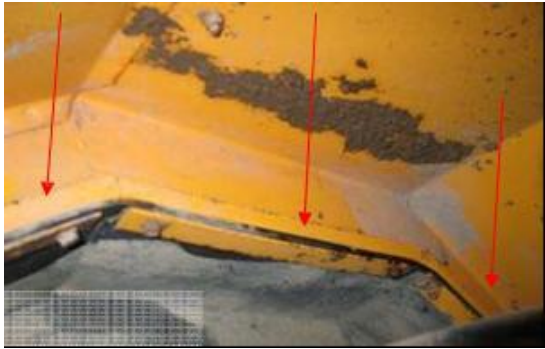
Description	Images
<p>All ledges inside the wheel arch (red arrows) are to be cleaned and verified.</p>

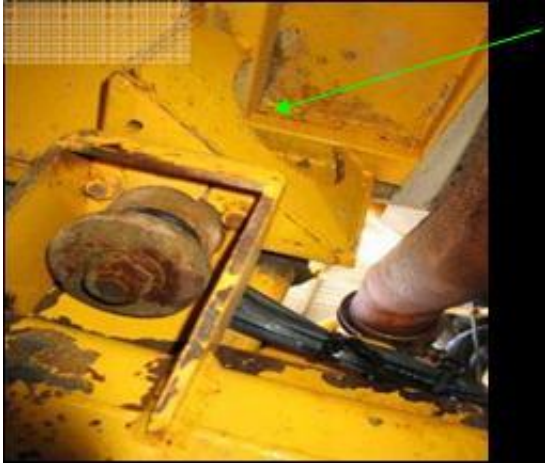
<p>On earlier models, the cavity (green arrow) can be found inside the front wheel, just above the chassis rail. This area can harbour a significant amount of biosecurity risk material.</p>

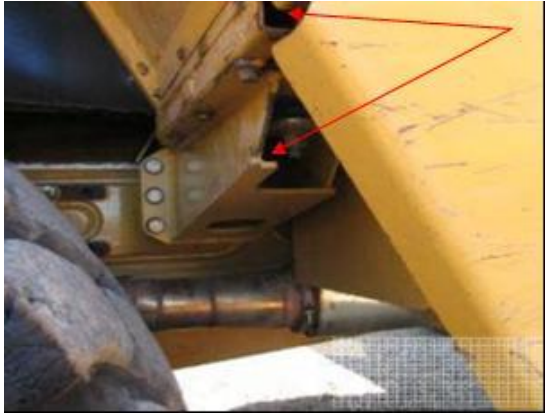
<p>Examples of open and hollow sections (red arrows) located just in front of the front tyre, below the wheel arch.</p>

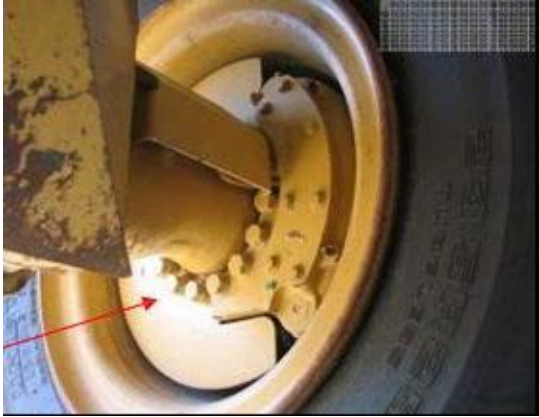
Description	Images
<p>All non-affixed wheel rim covers (red arrow) are to be removed to facilitate the cleaning and inspection process.</p>

A close-up photograph of a yellow wheel rim. A red arrow points to a non-affixed, yellow, curved cover that is partially obscuring the rim's surface. The cover appears to be made of a different material or is a separate piece that can be removed.
<p>Congested rims like the one illustrated may require flushing as well as inspection to verify cleanliness.</p>

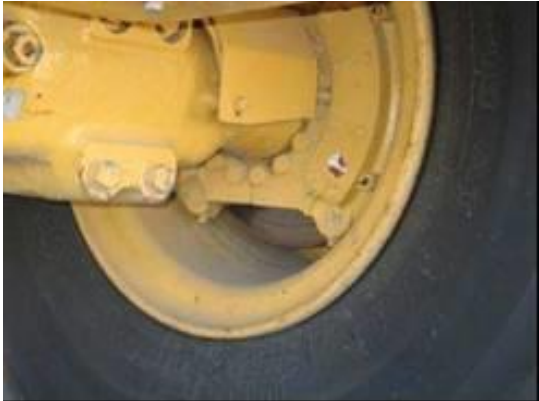
A close-up photograph of a yellow wheel rim. The rim is heavily congested with dirt and debris, making it difficult to see the underlying surface. The overall appearance is very dirty and neglected.

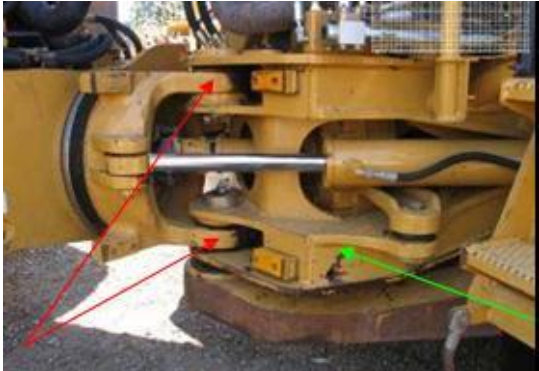
Description	Images
<p>The articulated pivot point behind the cabin. All contaminated grease is to be removed from all pivot points (red arrows), while the green arrows highlight the drainage holes at the rear to the chassis which will be discussed later.</p>

A photograph of the articulated pivot point of a vehicle, located behind the cabin. The pivot point is a complex mechanical assembly with various components. Red arrows point to specific areas where grease is likely to accumulate. Green arrows point to drainage holes at the rear of the chassis, which are used for removing contaminants.

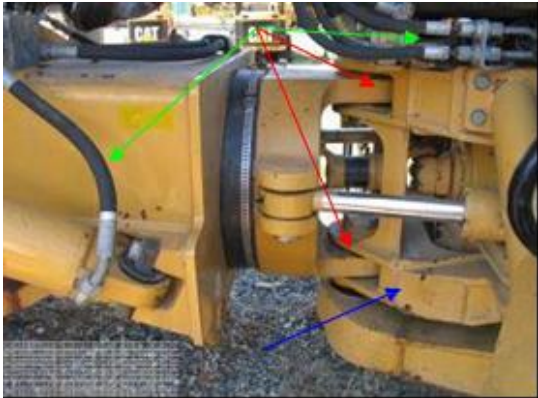
Description	Images
<p>Another view of the articulated pivot point. All contaminated grease is to be removed from the pivots (red arrows), as well as the hydraulic hoses (green arrows). The blue arrow highlights the drainage holes at the rear of the chassis rails.</p>

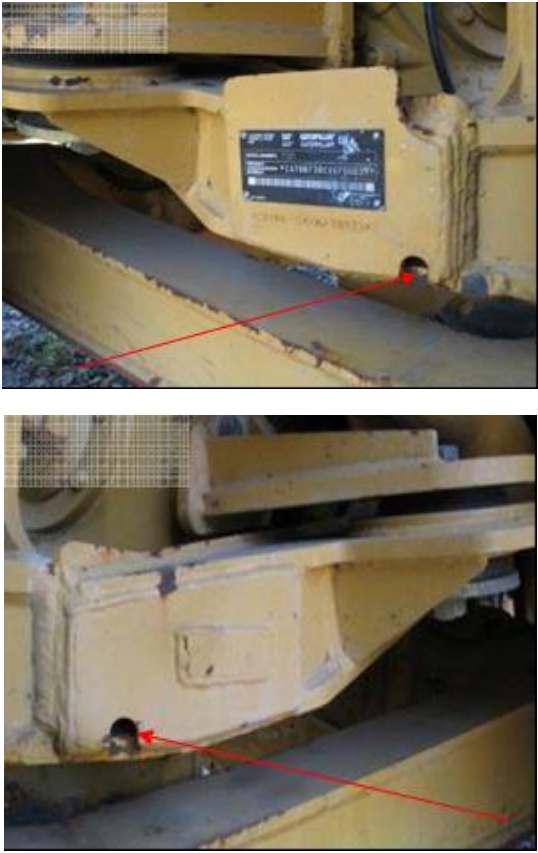
Description	Images
<p>The drainage holes (red arrows) at the rear of the chassis, near the pivot point. These hollow channels must be flushed in the presence of the inspecting officer in order to verify cleanliness.</p>

<p>The images show two views of the rear chassis of a yellow articulated dump truck. In the top image, a red arrow points to a small circular drainage hole on a yellow metal component. In the bottom image, a red arrow points to a similar drainage hole on a different part of the chassis. Both images show the complex metal structure of the truck's rear end, including various beams and components.</p>

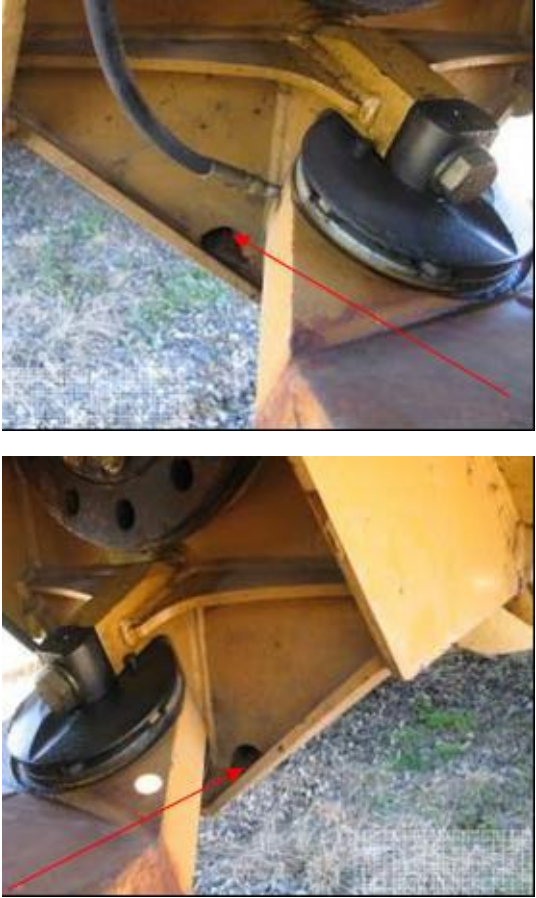
Description	Images
<p>Just behind the pivot point is the start of the rear chassis. Check for drainage holes like those illustrated (red arrows) and flush to verify internal cleanliness.</p>

<p>The first photograph shows a close-up of the rear chassis area, highlighting a small drainage hole indicated by a red arrow. The second photograph shows a similar view from a slightly different angle, also with a red arrow pointing to a drainage hole.</p>

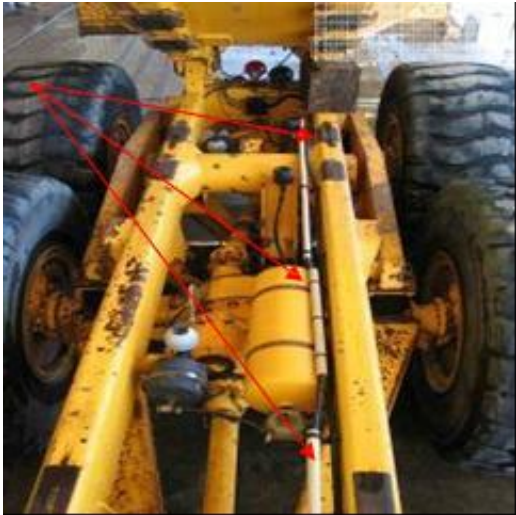
Description	Images
<p>To enable cleaning and inspection of the rear chassis, the dump tray must be lifted (locking pins must be in place). All plastic conduit (red arrows) is to be flushed to verify internal cleanliness.</p>

<p>The photograph shows the rear chassis of a yellow articulated dump truck with the dump tray lifted. Red arrows point to several plastic conduits that need to be flushed to verify internal cleanliness.</p>

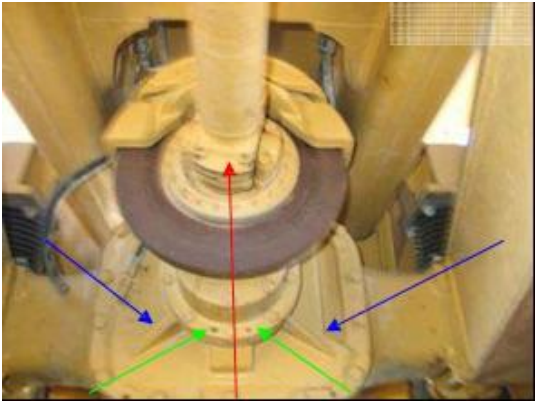
Description	Images
<p>The first universal joint (red arrow) on the rear chassis. All contaminated grease must be removed. Check that all ledges (blue arrows) and countersunk holes (green arrows) are free of biosecurity risk material.</p>

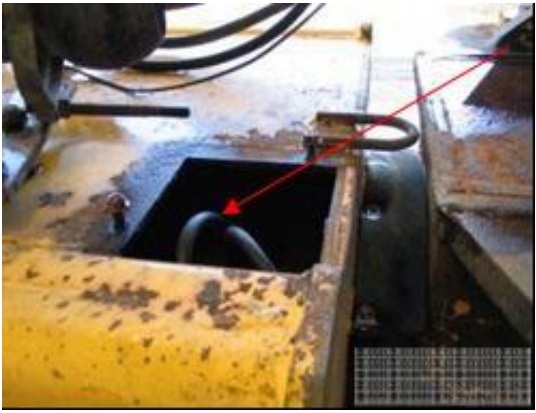
<p>Box sections like the one illustrated are found at the front of the rear chassis. This one has a non-affixed panel at the top, which allows access for cleaning and inspection (red arrow).</p>

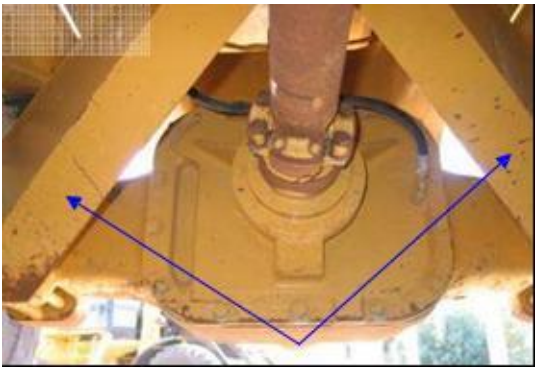
<p>The rear universal joint and chassis rails (blue arrows).</p>

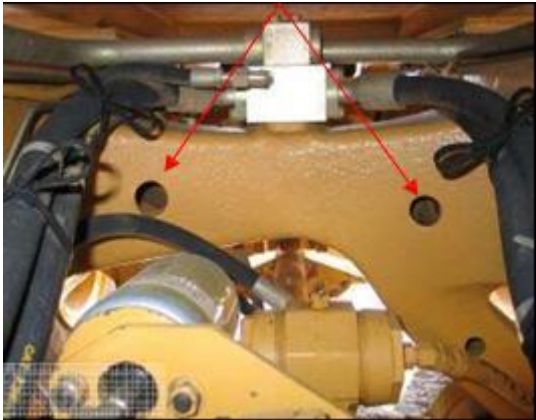
Description	Images
<p>On some models, a cross-member between the two rear chassis rails may be present. The red arrows highlight the access points to this hollow area which must be verified free of biosecurity risk material.</p>

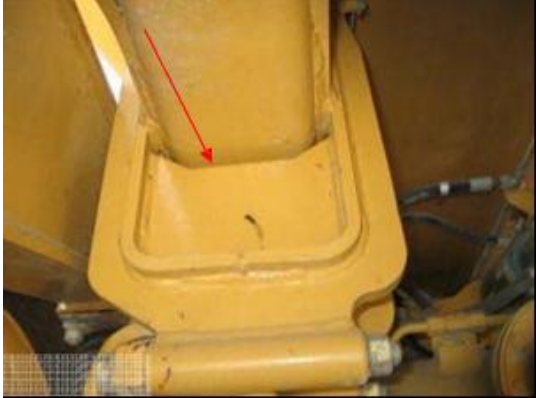
<p>Some sections on the rear chassis may have hollow sections as highlighted by the red arrow and require flushing to verify cleanliness.</p>

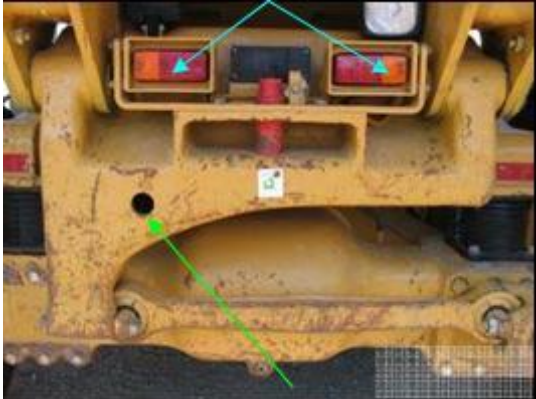
<p>The rear end of the chassis. All light covers (aqua arrows) are to be removed and internally cleaned and inspected. Note the holes in the chassis (green arrow). These hollow cavities must be verified clean.</p>

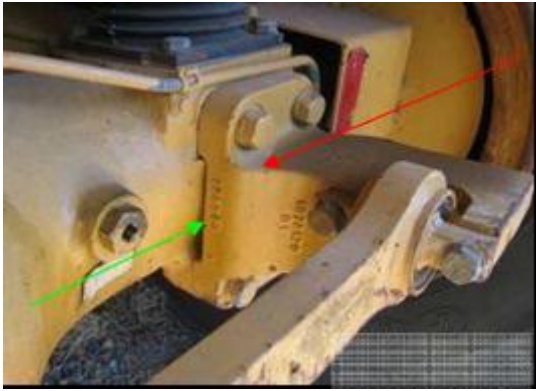
A close-up photograph of the axle bracket on the rear of the truck. A red arrow points to a hollow metal bracket structure. A green arrow points to a small gap between the bracket and the axle housing. The metal is yellow and shows signs of wear and rust.

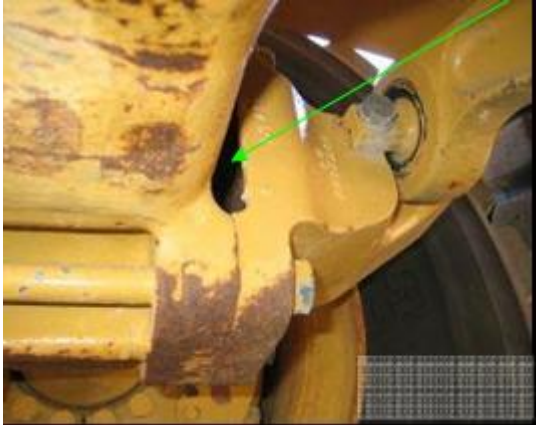
<p>Another view of the small bracket on the rear of the axel, highlighting the small opening (green arrow), where a 90 degree lance can be inserted to flush this area and verify cleanliness.</p>

A close-up photograph of the axle bracket, showing a different angle. A green arrow points to a small, dark opening in the metal structure. The surrounding metal is yellow and heavily rusted.

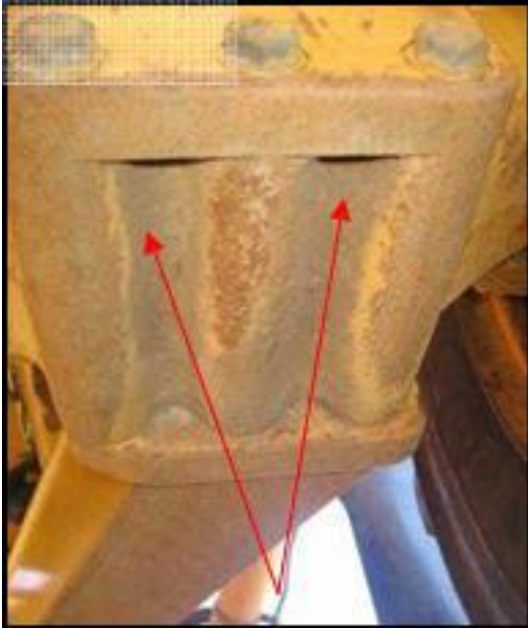
Description	Images
<p>The underside of the axel on the rear chassis. Ensure all biosecurity risk material has been removed from this undulating surface (red arrows).</p>

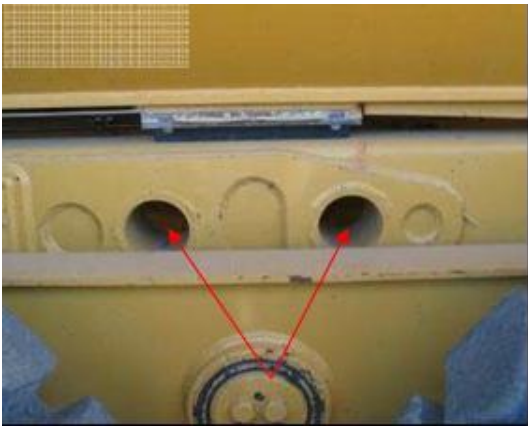
<p>Openings in the chassis rails (red arrows) that require verification.</p>

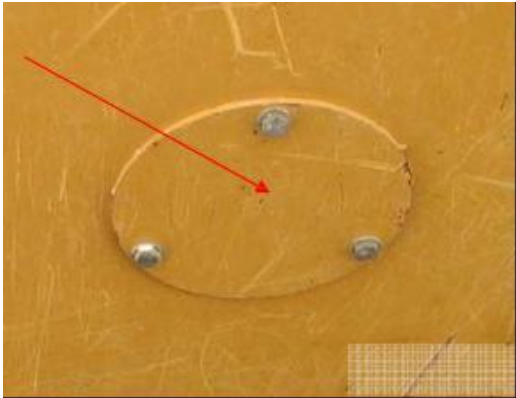
Description	Images
<p>On some models, circular, non-affixed plates such as those highlighted (red arrow) may be found on the chassis rails. If present, these must be removed and the hollow channels verified clean.</p>

A close-up photograph of a yellow metal chassis rail. A circular, non-affixed plate is mounted on the rail. A red arrow points to the center of this plate. The plate has three bolts around its perimeter. The background shows the textured surface of the chassis rail.

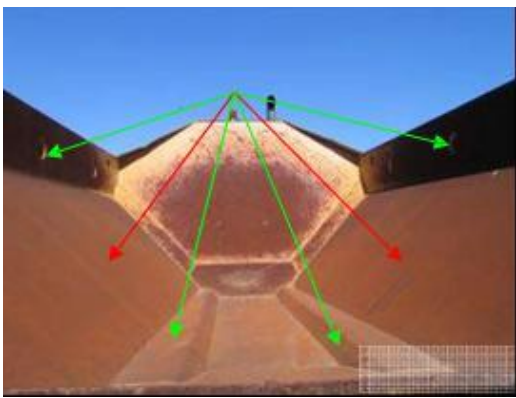
An interior view of the dump truck's tray. The tray is made of rusted metal. Red arrows point to the side walls, and green arrows point to the bottom and side panels, highlighting hollow areas. The background shows a clear blue sky.

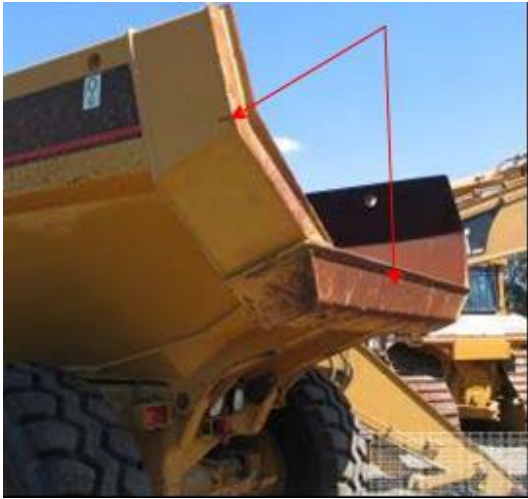
Description	Images
<p>The rear section of the tray also has hollow sections (red arrows) that can harbour biosecurity risk material if cracked, split or breached. Check along weld seams for any evidence of damage or breaches, allowing biosecurity risk material to enter these sections.</p>

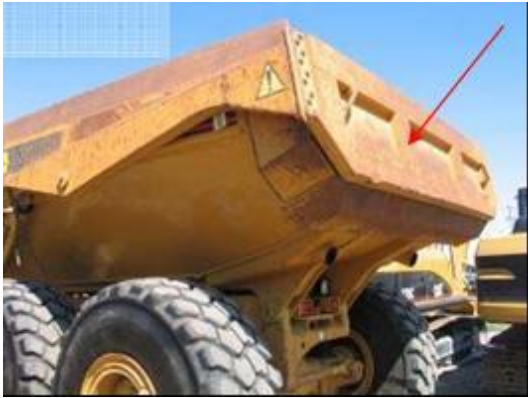
<p>On some models a rear tray door may be present (red arrow). These dump tray doors have hollow sections. Check both the internal and external surfaces as well as the welding seams for any cracks, splits or evidence of repair. If any cracks, splits or evidence of repair is found on any part of the dump tray, these must be investigated and it will be the responsibility of the importer to verify these areas are clean and free of biosecurity risk material.</p>

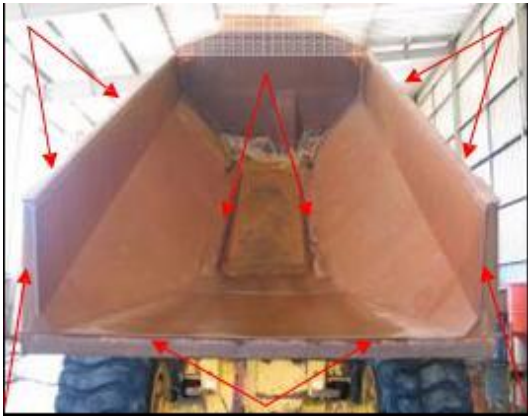
<p>All welding seams (red arrows) must be thoroughly checked for any cracks, splits or evidence of repair.</p>

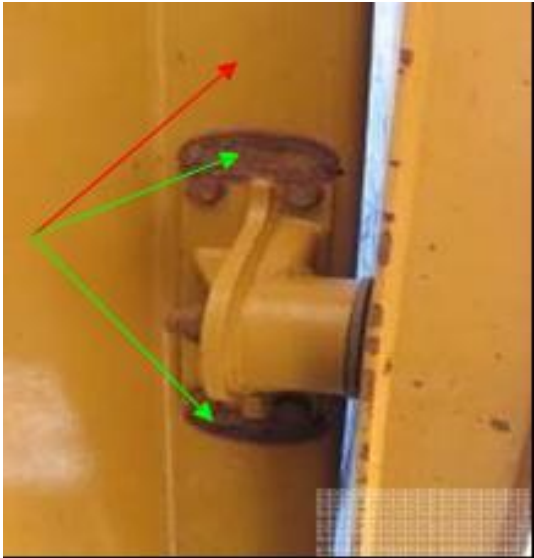
Description	Images
<p>Evidence of repair (green arrows). This illustration was from under the tray, where the hinges for the rear door attach. The section it attaches to is hollow (red arrow) and will require further investigation.</p>

A close-up photograph of a yellow metal hinge assembly. The hinge is mounted on a yellow metal surface. A red arrow points to a circular hole in the metal above the hinge, indicating a hollow section. Two green arrows point to the hinge mechanism, indicating evidence of repair. The background is a plain yellow metal surface.

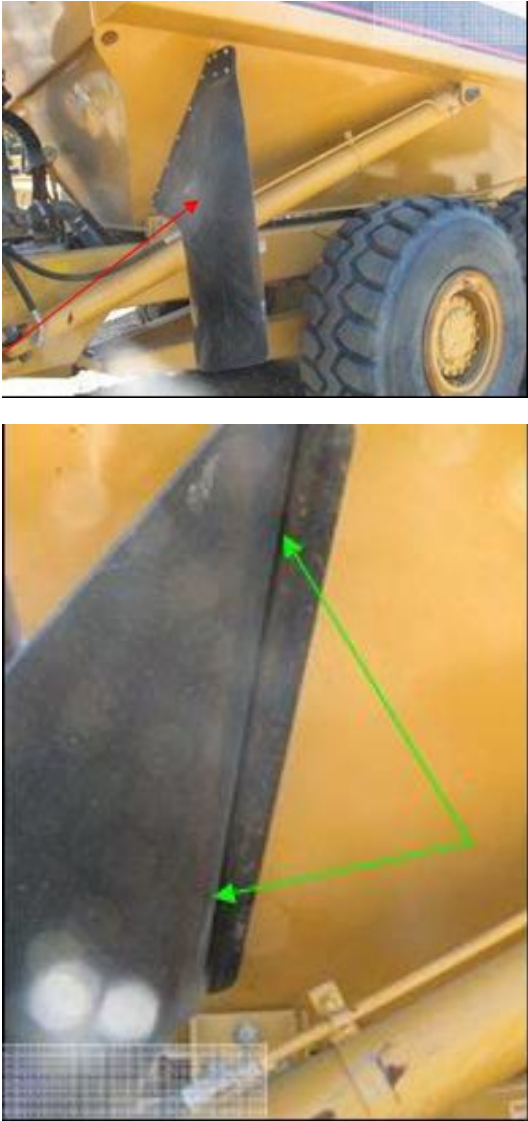
Description	Images
<p>The rear mudguards and the small recess where it attaches to the tray. This area must be flushed to ensure cleanliness (red and green arrows).</p>

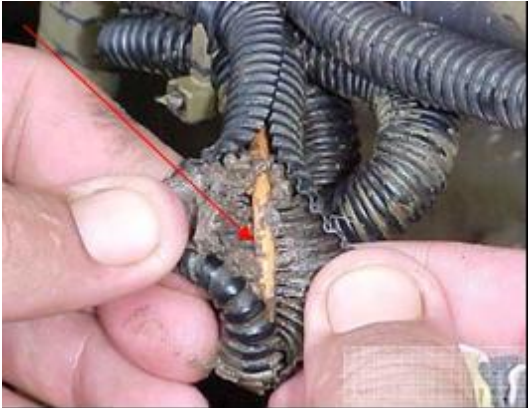
<p>All wiring harnesses must be free of biosecurity risk material and thoroughly checked (red arrow).</p>

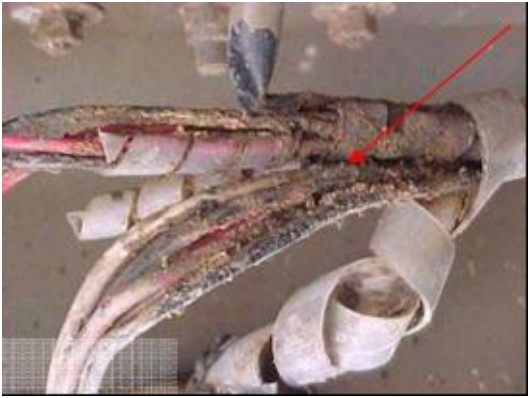
Description	Images
<p>All looming must be free of biosecurity risk material and thoroughly checked (red arrow).</p>

A close-up photograph of the rear of a truck, showing the chassis and various components. A red arrow points to a piece of debris or material on the chassis, indicating a biosecurity risk.
<p>Verify that the internal light fittings are clean.</p>

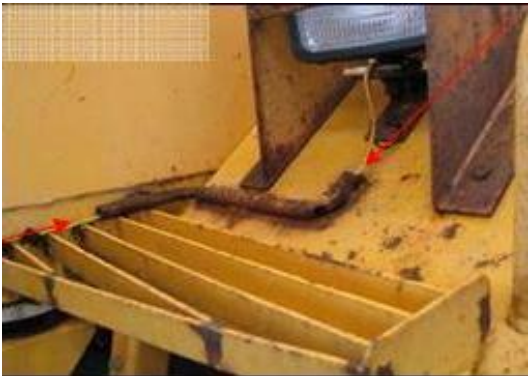
A close-up photograph of the rear light assembly of a truck, showing the orange and white light lenses.
<p>Flush all hollow tubing as highlighted by the red arrows.</p>

A close-up photograph of the chassis of a truck, showing various components and hollow tubing. Red arrows point to specific areas of the tubing, indicating where they should be flushed.
