# Machinery Cleaning Guide - Caterpillar Dozers

## D8, D9, D10 and D11 Series

**Biosecurity**

April 2016

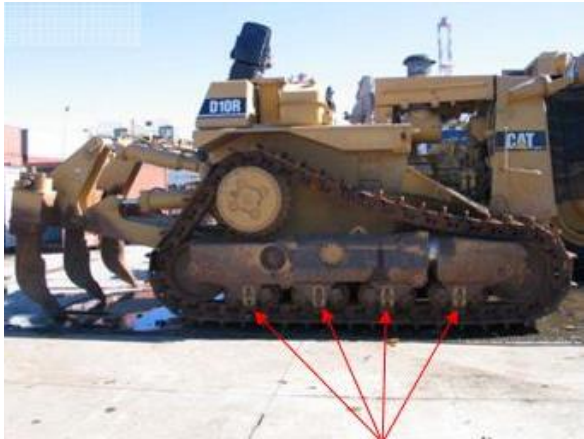
| Description | Images |
|---|--|
| <p>Landscape shot of a typical Caterpillar Dozer. Structurally, the D8, D9, D10 and D11 series are basically the same except for small variations and obviously size differences.</p> <p>Note that the cabin has been removed for shipping purposes as well as the bearing covers (red arrows). There are 16 bearing covers in total. These bearing covers must be removed for cleaning and inspections purposes.</p> | |

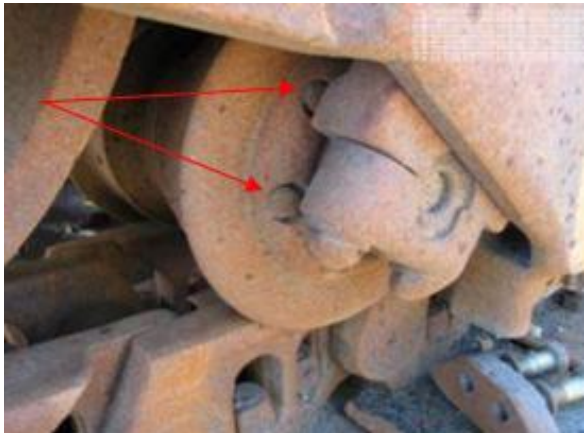
| Description | Images |
|---|--|
| <p>The tracks on any dozer need to be rolled to allow the cleaning and inspection of the countersunk bolt heads (red arrows) on each of the rollers.</p> | |

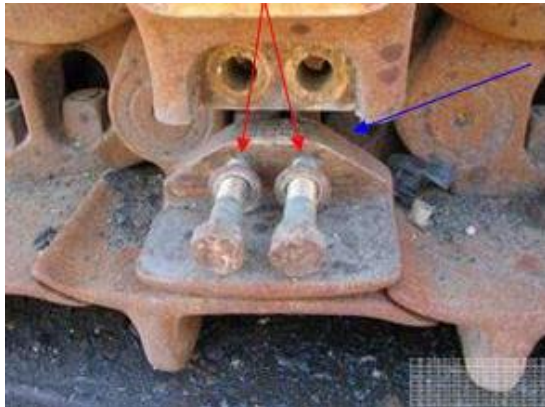
| Description | Images |
|---|--|
| <p>The track guides have been removed for ease of cleaning and inspection. On some models the two bolt ends (red arrows) are countersunk at the rear of the track guide. Ensure that the rear of this guide is checked for any biosecurity risk material (BRM) in these areas (blue arrow).</p> | |

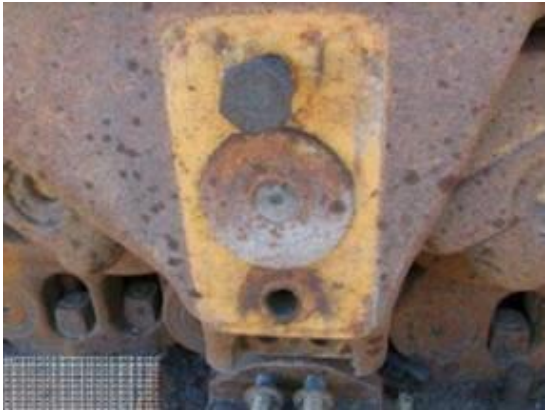
| Description | Images |
|---|--|
| <p>The bearing covers on all dozers need to be removed for cleaning as they are concave and can harbour BRM. Cleanliness of all will be required at the time of inspection.</p> | A close-up photograph of a bearing cover on a dozer track. The cover is a circular, concave metal component, heavily rusted and discolored. It is mounted on a larger metal frame. |

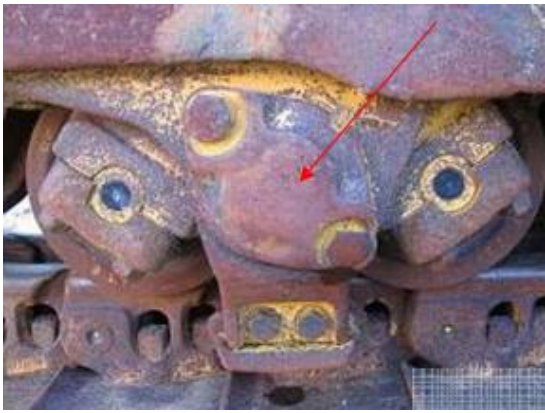
| Description | Images |
|---|--|
| <p>Bearing cover on a D8 still attached (red arrow).</p> | A photograph showing a bearing cover on a D8 dozer still attached to the track. A red arrow points to the cover, which is a circular metal component. The surrounding track and frame are heavily rusted and discolored. |

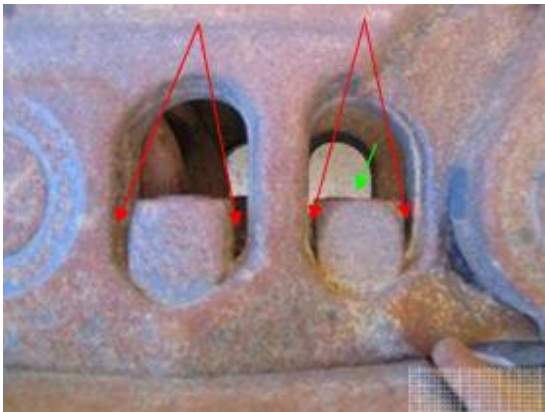
| Description | Images |
|---|--|
| <p>This image shows the small gaps between the track pad nuts, which require careful cleaning and inspection (red arrows). To inspect the rear of these nuts, either use a small inspection mirror or inspect the backside of the outside nuts from the inside of the track frame and vice versa.</p> | A close-up photograph of track pad nuts. Red arrows point to the small gaps between the nuts, which require careful cleaning and inspection. A green arrow points to the backside of one of the nuts. |

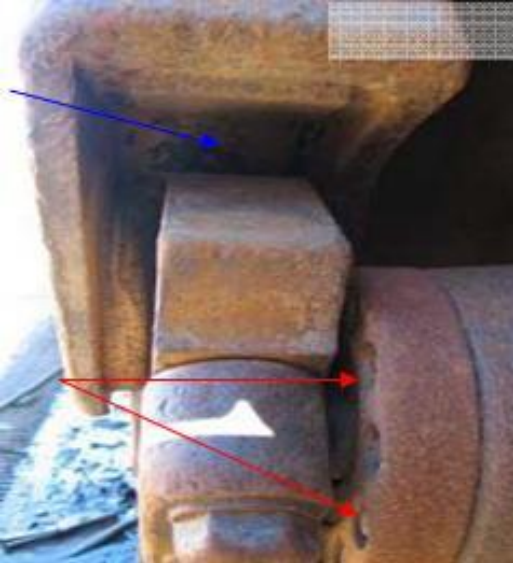
| Description | Images |
|--|--|
| <p>This image shows the cover above the front idler wheel. The tracks must be rolled for cleaning and inspection of the countersunk bolts (red arrows) and flush up inside the housing (blue arrow).</p> | |

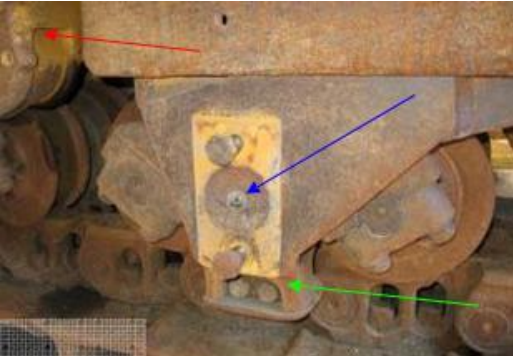
| Description | Images |
|--|--|
| <p>This image shows the side of the track frame, rollers and a bearing cover (blue arrow) removed. The track guide (green arrow) is still in place, but needs to be removed for cleaning and inspection. Flush and carefully inspect all pivot points (red arrow).</p> | |

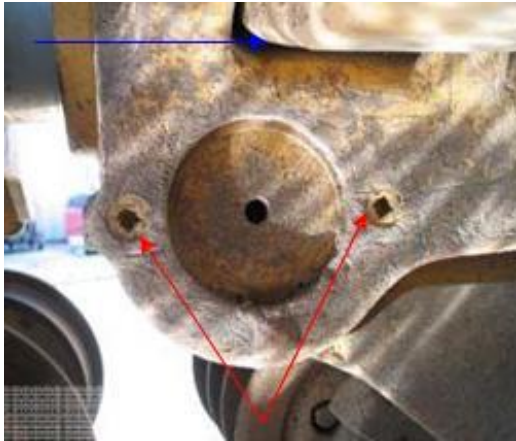
| Description | Images |
|---|---|
| <p>The small plastic covers (red arrows) are open-ended and can harbor BRM. Most can be accessed from the inside of the track frame. Those that are not accessible must be removed for cleaning and inspection. Ensure where the sway bar joins the track frame (blue arrow), is clean and free of all contaminated grease.</p> | |

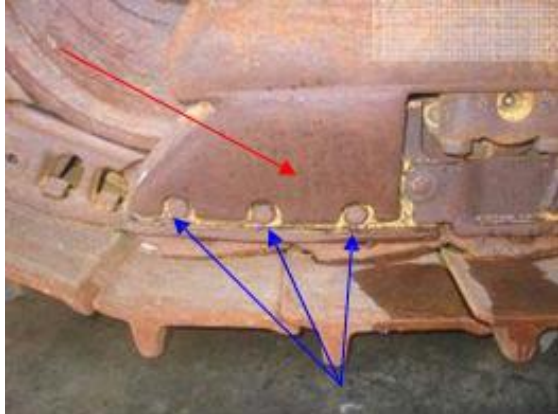
| Description | Images |
|---|---|
| <p>On the ends of some models will be protective plates (red arrow). The structures are generally hollow and need to be flushed via the small open gaps at the bottom (blue arrows) to ensure cleanliness.</p> | |

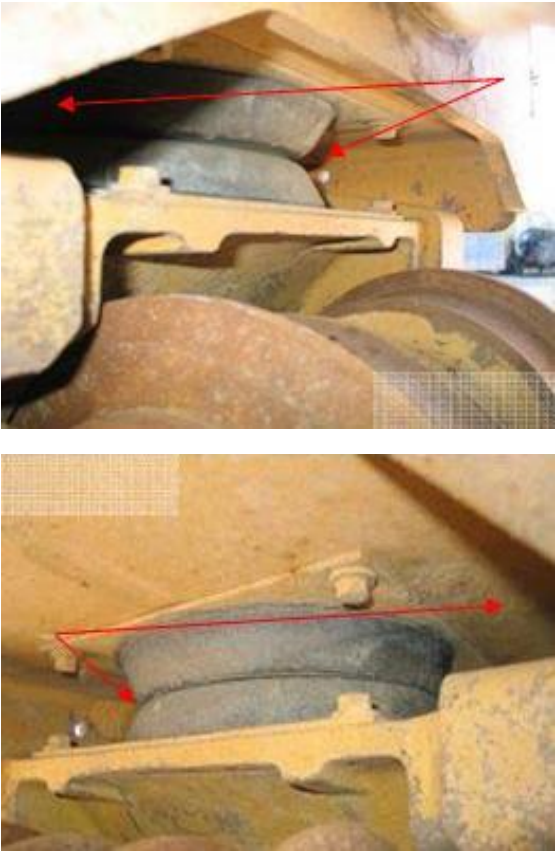
| Description | Images |
|--|--|
| <p>This image shows inside the track frame highlighting the rubber mounts and horizontal ledges that can be found inside many track frames (red arrows). The inside of all track frames needs to be thoroughly cleaned and inspected.</p> | |

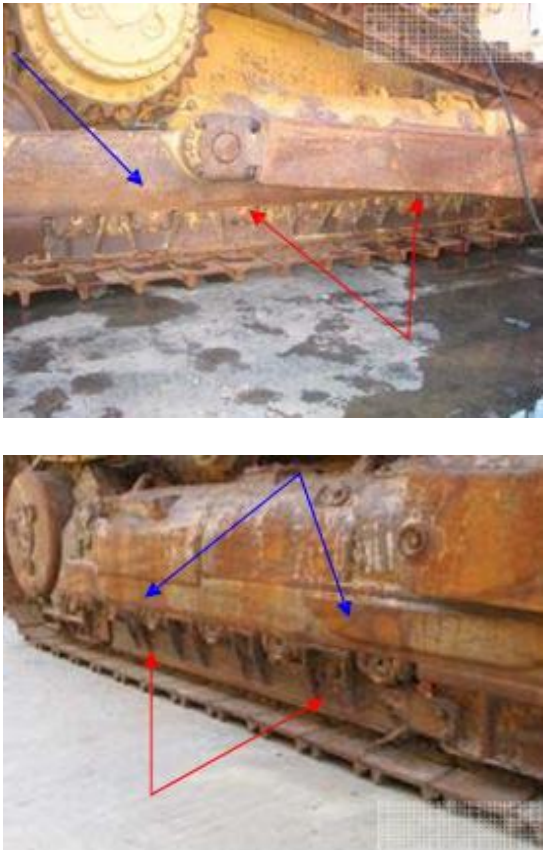
| Description | Images |
|--|--|
| <p>Several images of rock guards (red arrows) attached to dozer tracks. If rock guards are present, these must be removed from both the outside and inside of the track frame to allow access for both cleaning and inspection. The channel above the rock guards (blue arrows) is hollow and must be flushed via the bolt holes once the rock guards have been removed. See general section for example of hollow from above rock guards.</p> | |

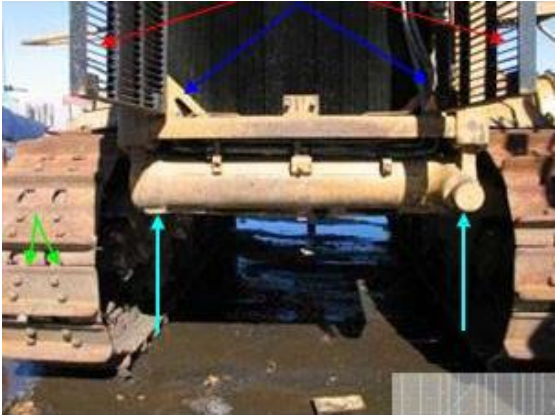
| Description | Images |
|---|--|
| <p>The radiator grill (red arrows) has been opened, allowing access to the radiator fins. If the grill cannot be opened as illustrated it must be removed at the time of inspection. The green arrows show the track pads slightly opened. The aqua arrows highlight where the bolts holding the belly plates in place have been removed. This chassis is hollow and will require the removal of the belly plates and flushing via the bolt holes to ensure cleanliness (in the presence of the inspecting officer). The blue arrows are to highlight the two vertical pillars either side of the radiator. These are hollow and can generally be accessed for flushing via small drainage holes, located in behind the radiator grill.</p> | |

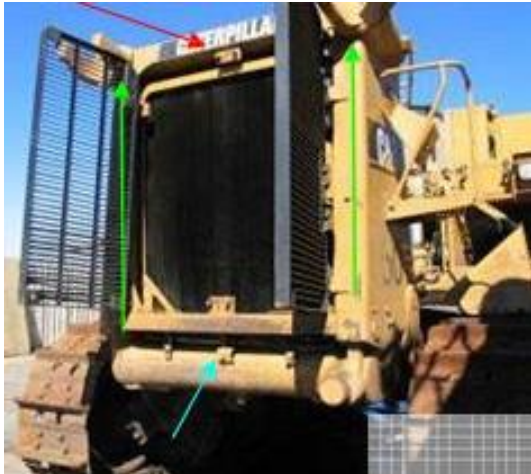
| Description | Images |
|---|--|
| <p>The green arrow highlights the hollow vertical pillars either side of the radiator. Flush in the presence of the inspecting officer if these are not sealed. Check for any ledges or open-ended channels as above the radiator core (red arrow). In this instance, the circular nose bar is hollow and can be accessed for flushing via the belly plate bolt holes (see aqua arrow and the following image). All radiators must be flushed in the presence of the inspecting officer to verify cleanliness.</p> | |

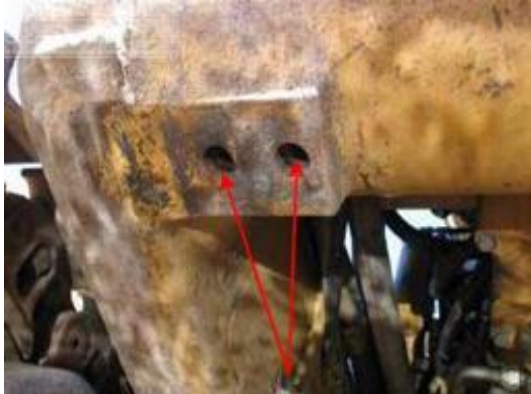
| Description | Images |
|---|--|
| <p>This image shows the bolt holes where the belly plate has been removed, allowing access to the circular nose bar (red arrows). This area must be flushed in the presence of the inspecting officer to verify cleanliness.</p> | |

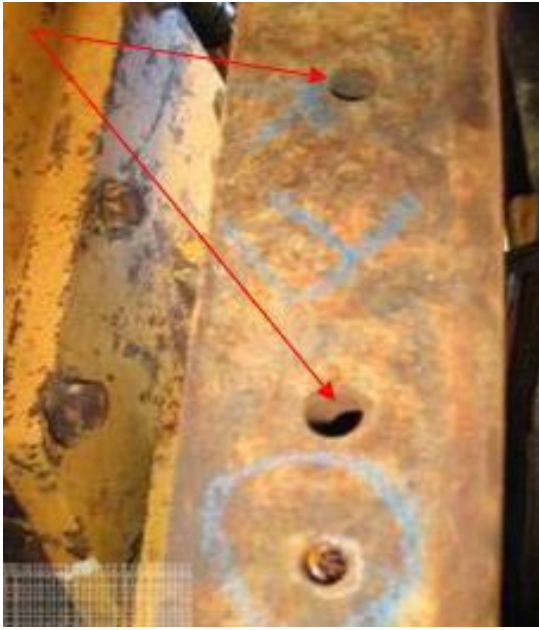
| Description | Images |
|--|--|
| <p>This image shows where the belly plate bolts have been removed, allowing access to the hollow side chassis rail (see red arrows in the image below). This area must be flushed in the presence of the inspecting officer to verify cleanliness.</p> | |

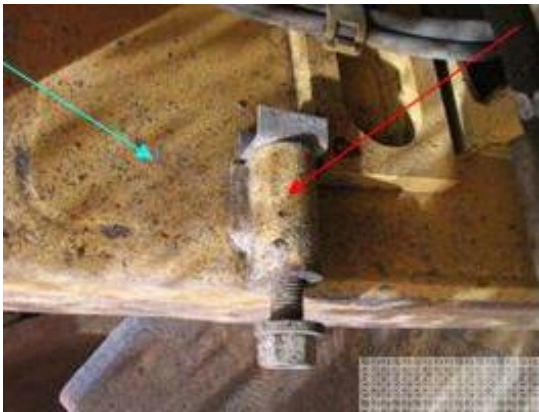
| Description | Images |
|--|--|
| <p>The aqua arrow highlights the hollow side chassis rail that can be accessed via the belly plate bolt holes. The red arrow highlights other belly plate bolts that must be removed from the sheath to verify cleanliness.</p> | |

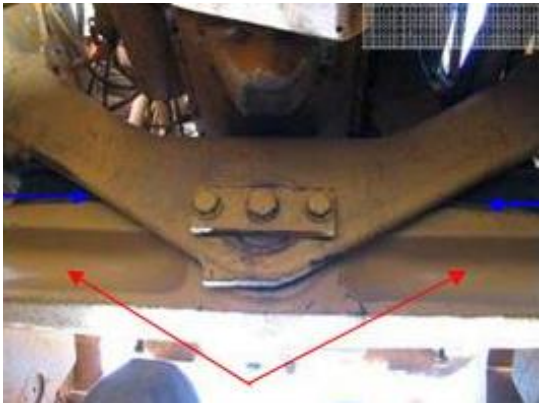
| Description | Images |
|--|--|
| <p>The red arrows highlight the sway bar found under the front of the Dozer. Ensure that all contaminated grease is removed and flush this area to verify clean (blue arrows).</p> | |

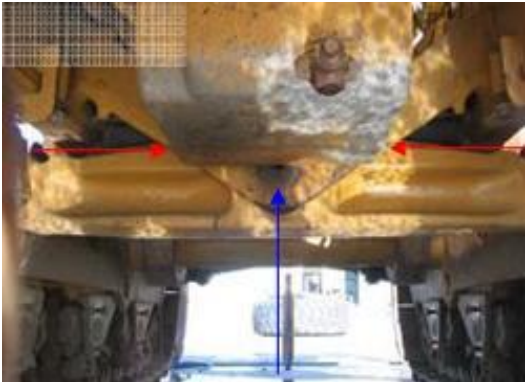
| Description | Images |
|---|--|
| <p>The sump under the front end of the Dozer. Ensure that this area has had all contaminated grease removed. The blue arrow highlights a small hole at the front of the sway bar. The red arrows again highlight the gap above the sway bar, which requires flushing to verify cleanliness. Check all small openings for cleanliness.</p> | |

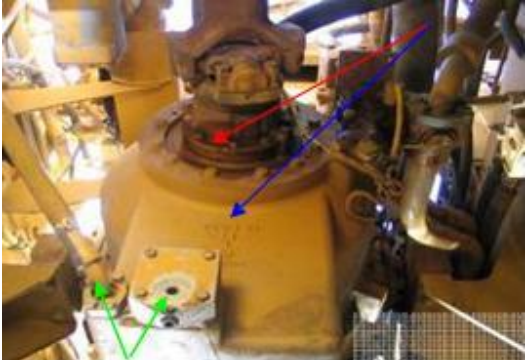
| Description | Images |
|---|--|
| <p>The red arrow highlights the universal joint and the blue the bell housing. A protective cover has been removed from around the universal joint to allow cleaning and inspection.</p> | |

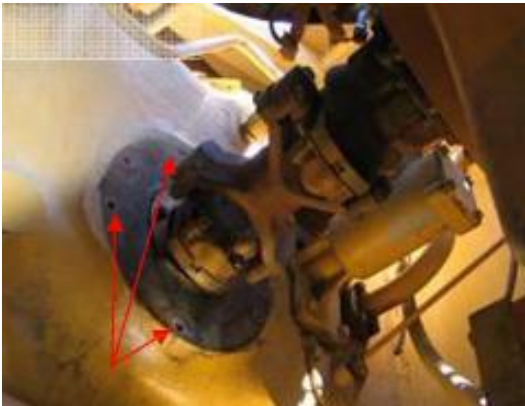
| Description | Images |
|---|--|
| <p>Another view of the bell housing. Note the countersunk holes (red arrows) left once the protective cover has been removed.</p> | |

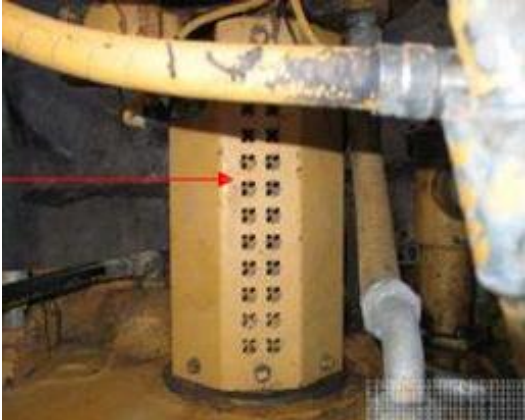
| Description | Images |
|---|--|
| <p>The protective plate that must be removed to allow cleaning of the universal joint (red arrow).</p> | |

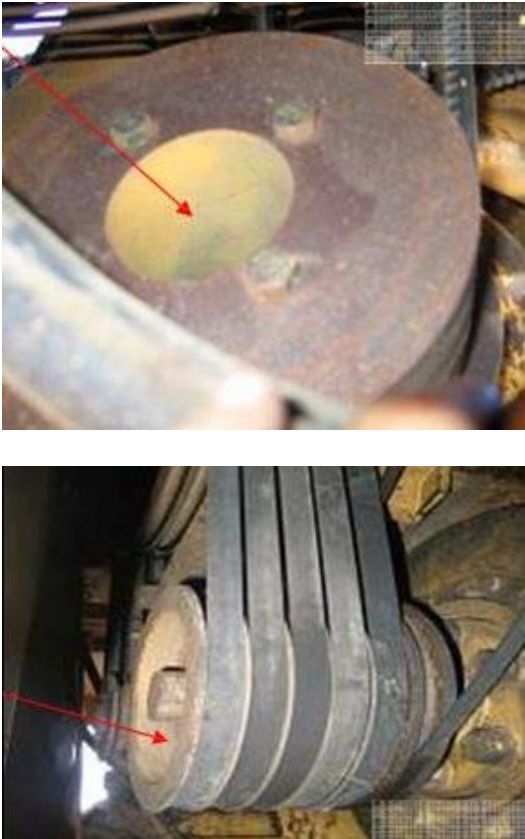
| Description | Images |
|--|---|
| <p>Examples of harmonic balancers (red arrow) that are found at the front of the engine block. These areas are generally hollow and can harbour BRM.</p> | |

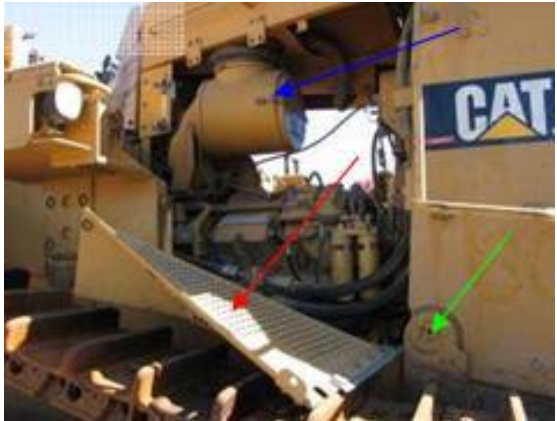
| Description | Images |
|--|--|
| <p>The right-handed side of the dozer engine housing. All non-affixed engine covers have been removed for cleaning and inspection. The red arrow highlights the checker plate inside the engine cover, which will require flushing at the time of inspection. The air-filter (blue arrow) will need to be removed from the housing and verified clean (high pressure air). Remove all contaminated grease from pivot points (green arrow).</p> | |

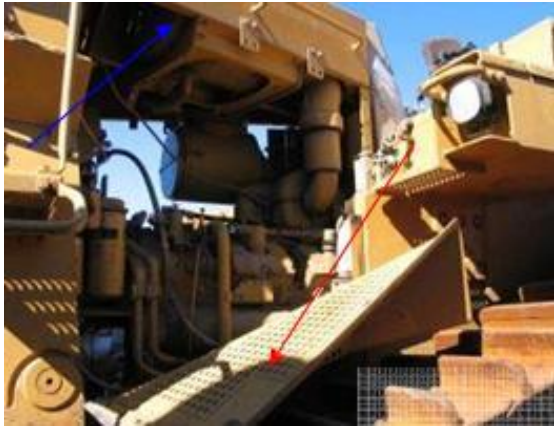
| Description | Images |
|--|--|
| <p>This image shows the left hand side of the dozer engine housing. All non-affixed engine covers are to be removed for cleaning and inspection. The red arrow highlights the checker plate inside the engine cover, which will require flushing at the time of inspection. Check all framework inside the engine cover for hollow channels which will require flushing if not completely sealed (blue arrow).</p> | |

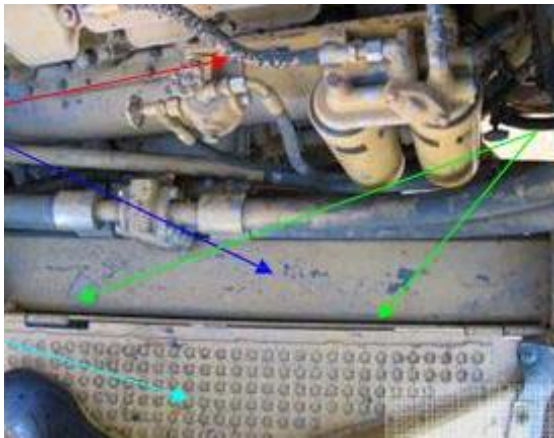
| Description | Images |
|--|--|
| <p>This image shows the side of the engine block (red arrow) and hollow chassis rail (blue arrow). The engine cover has been laid back on the hinge, exposing a small gap (green arrows) between the side cover and the chassis rail. Flush along this small opening to remove all BRM. Flush checker plate (aqua arrow).</p> | |

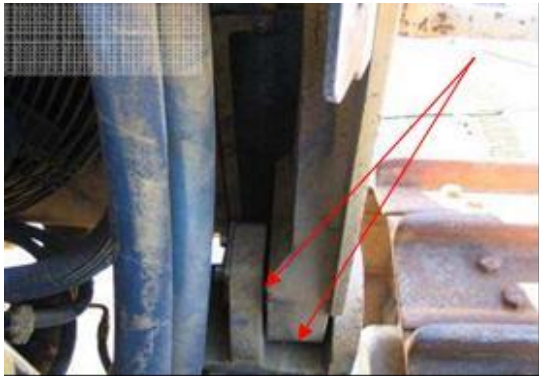
| Description | Images |
|--|--|
| <p>Check that all pivot points (red arrows) such as the one either side of the radiator have been thoroughly cleaned and all contaminated grease removed.</p> | |

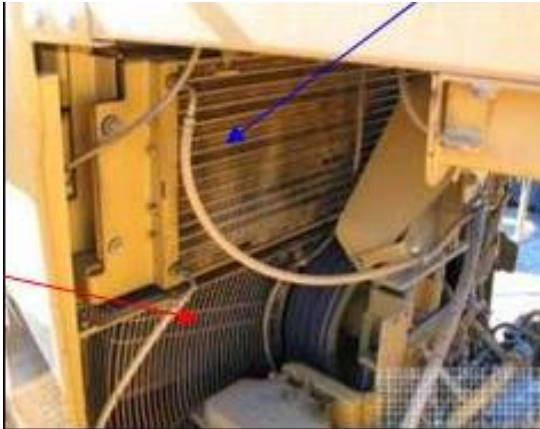
| Description | Images |
|--|---|
| <p>This image shows the front end of the engine block, the oil cooler and the radiator grill. The radiator grill (red arrow) must be removed, allowing access to the inside of the radiator shroud. The oil cooler (blue arrow) needs to be flushed in the presence of the inspecting officer to verify cleanliness of the fins.</p> | A photograph showing the front end of a Caterpillar dozer engine. A red arrow points to the radiator grill, and a blue arrow points to the oil cooler. The engine is yellow and has various hoses and components visible. |

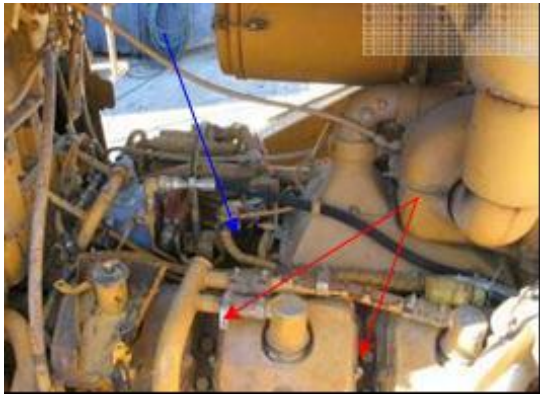
| Description | Images |
|--|---|
| <p>The image shows the topside of a typical dozer block. Check between each tappet cover (red arrows) and along the centre of the block. It is best to flush these areas after visual inspection to ensure all BRM has been removed.</p> | A photograph showing the topside of a Caterpillar dozer engine block. Red arrows point to the tappet covers, and a blue arrow points to the center of the block. The engine is yellow and has various hoses and components visible. |

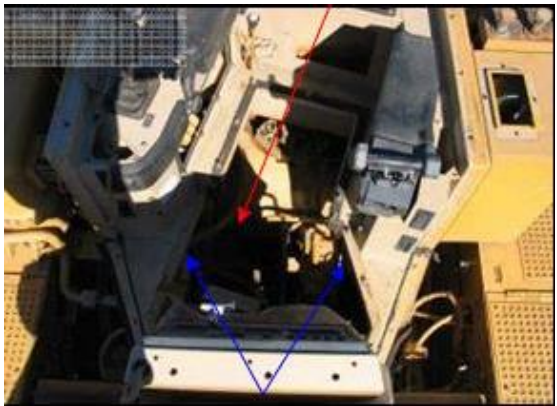
| Description | Images |
|---|--|
| <p>The floor pan (red arrow) and seat have been removed, allowing access to the hollow framework (blue arrows) below the floor pan and the top of the transmission.</p> | A photograph showing the interior of a Caterpillar dozer cabin. The floor pan and seat have been removed, revealing the hollow framework below. A red arrow points to the floor pan, and blue arrows point to the hollow framework. The cabin is yellow and has various components visible. |

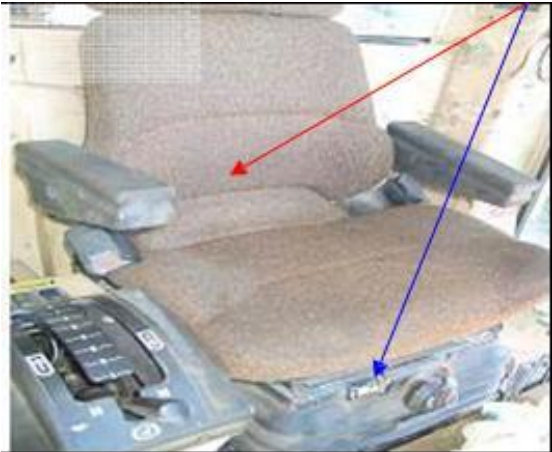
| Description | Images |
|--|---|
| <p>The seat must be removed (red arrow) to allow the floor pan to be taken out, allowing access to the top of the transmission and inside the joystick control panels (see following images). Once the seat has been removed, ensure the rubber seat shroud is clean inside (blue arrow).</p> | |

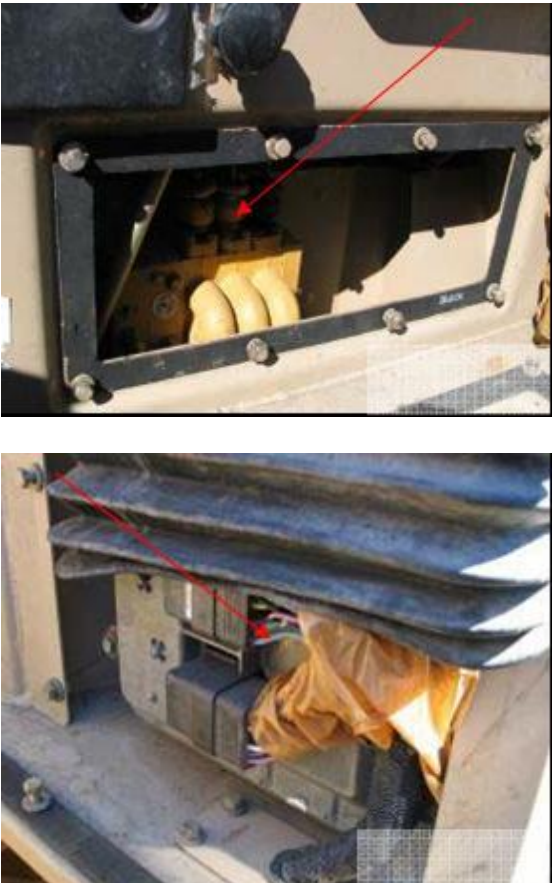
| Description | Images |
|--|---|
| <p>These images illustrate the joystick control panels located either side of the seat. All non-affixed panels have been removed, allowing access for cleaning and inspection. These areas sometimes have ledges inside which harbour BRM and need to be thoroughly inspected. The joystick control on the right houses the electronics and care must be taken when inspecting this area (red arrows).</p> | |

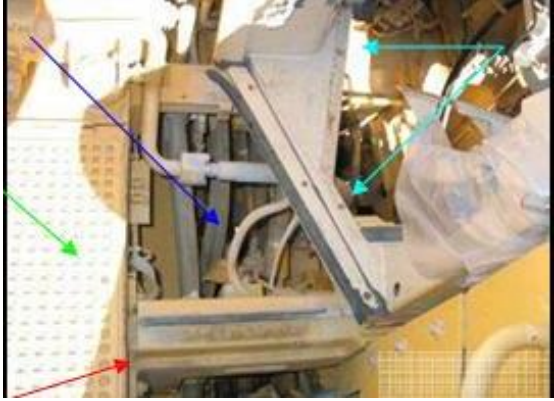
| Description | Images |
|--|---|
| <p>The red arrow indicates the open-ended box channel that runs along the front of the cabin, below the instrument panel. The floor panel just outside the door has been removed, allowing access to this hollow open-ended channel (blue arrow). All checker plate flooring (green arrow) and hollow channels must be flushed at the time of the inspection. The aqua arrows highlight where the floor pan attaches to the base. These channels are open-ended also and will be illustrated later.</p> | |

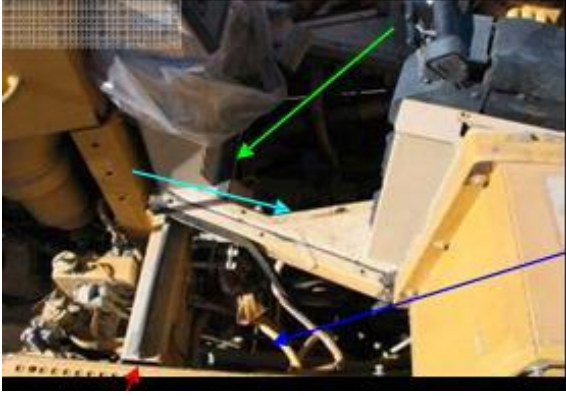
| Description | Images |
|--|---|
| <p>The opposite side of the cabin, again showing the open-ended hollow channel below the floor pan (red arrow). The blue arrow indicates where the floor panel has been removed from outside the cabin, exposing this channel. On smaller dozers this channel may not be open-ended, but rather have a small opening on the underside, in the centre, as indicated by the green arrow. The aqua arrows highlight where the floor pan attaches to the base. These channels are open-ended also and will be illustrated later.</p> | |

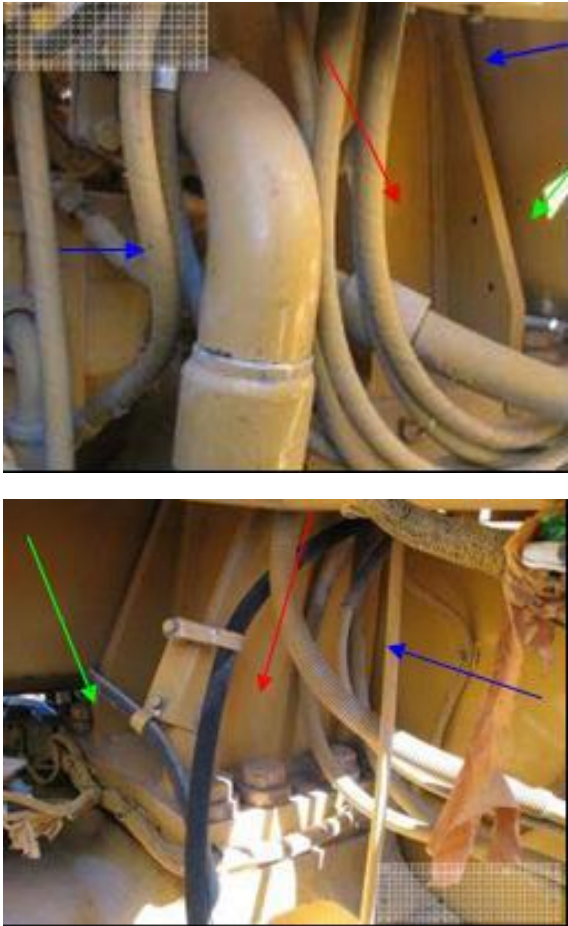
| Description | Images |
|---|--|
| <p>The base supports of the roll over protection system (ROPS) are below the floor pan and towards the rear (red arrows). These do not sit flush against the side wall of the dozer and will require flushing along these seams (blue arrows) to verify cleanliness. There are a series of bolts along the backside (out of view but highlighted by the green arrows), which require thorough inspection.</p> | |

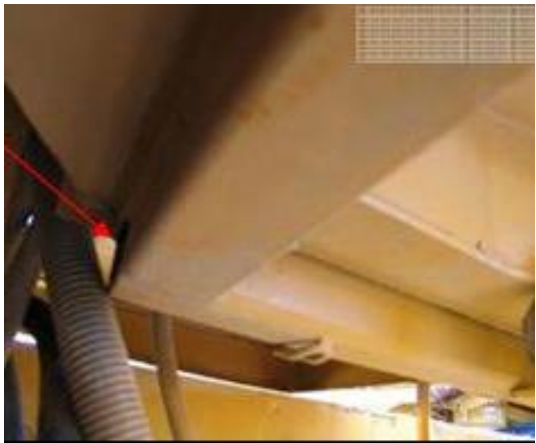
| Description | Images |
|---|--|
| <p>This image shows the hollow channels located just below the floor pan. The red arrow indicates where the opening can be found. These channels require flushing to verify cleanliness.</p> | |

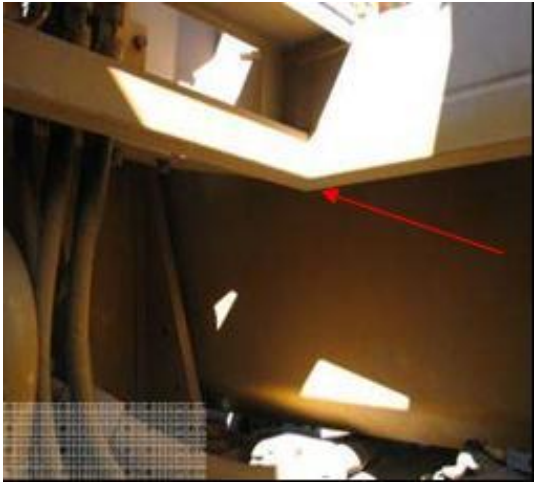
| Description | Images |
|--|--|
| <p>Another view of the hollow open-ended channels (red arrow) highlighting the opening located just below the floor pan. These channels require flushing to verify cleanliness.</p> | |

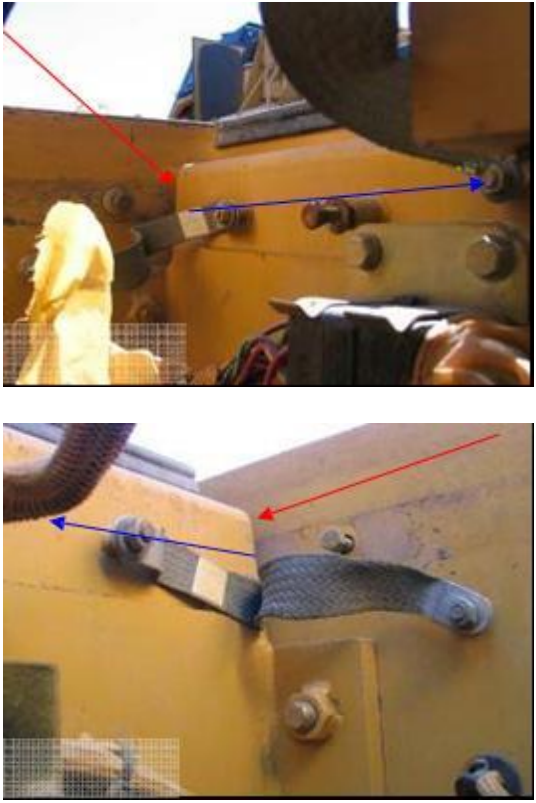
| Description | Images |
|--|--|
| <p>Another view of the open-ended box channel that runs along the front of the cabin, below the floor pan. The red arrows highlight the access points where these can be flushed.</p> | |

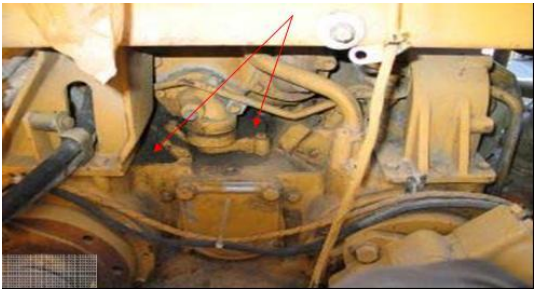
| Description | Images |
|--|--|
| <p>The back of the engine block as seen from below the floor pan. The firewall has been removed, allowing access. Note the red arrow highlighting the BRM at the rear of the block. The firewall must be either removed or loosened to allow inspection of the back of the engine block.</p> | |

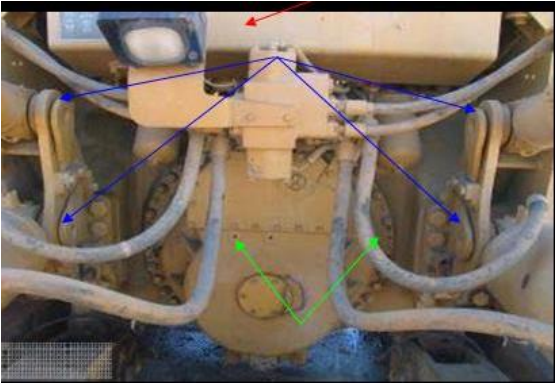
| Description | Images |
|---|---|
| <p>This image shows the rear end of a typical dozer. The panel below the fuel cell (red arrow) must be removed allowing access to the topside of the bell housing and the rear of the ROPS. Each of the ripper cradle pivot points must be totally free of contaminated grease (blue arrows). Check all countersunk holes to ensure all are free of BRM (green arrows).</p> | |

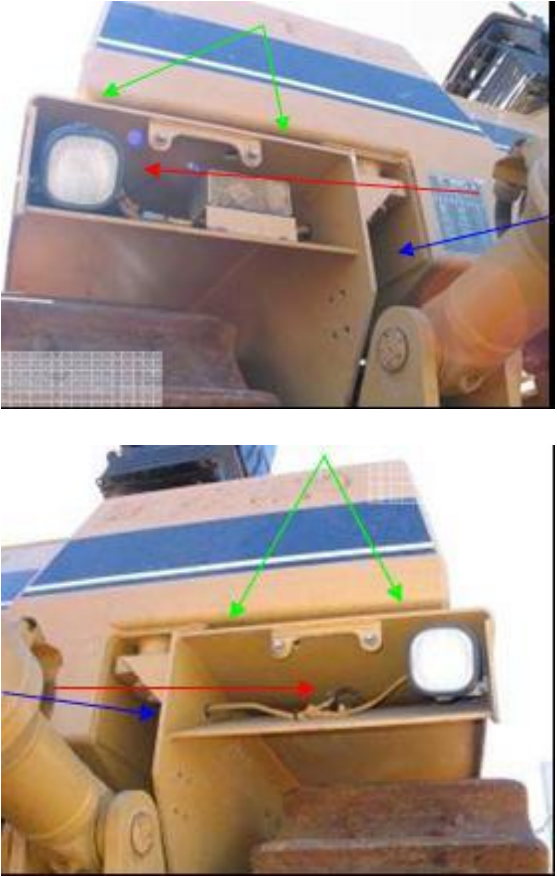
| Description | Images |
|---|---|
| <p>The rear tail lights and hollow cavities. The plates have been removed allowing access to these areas (red arrows). Check inside the small cavity highlighted by the blue arrows. Ensure that the small recess (green arrows) between the bottom of the fuel cell and the top of the arch is free of all BRM.</p> | |

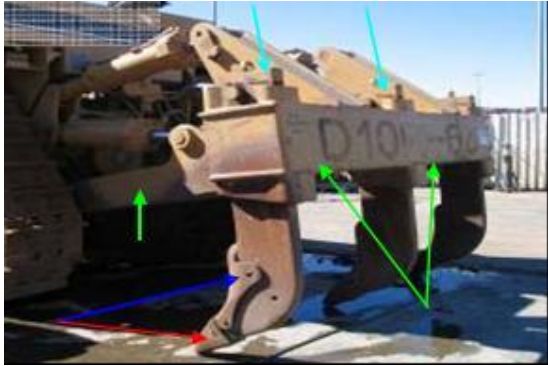
| Description | Images |
|---|--|
| <p>A typical ripper cradle and cutting teeth. The cutting teeth (red arrows) and wear plates (blue arrow) must be removed from each blade to allow cleaning and inspection. Check the underside of the ripper cradle for the drainage holes (see green arrows and the following images). Ensure that the small gap between the blade and the cradle (aqua arrows) is flushed at the time of inspection.</p> | |

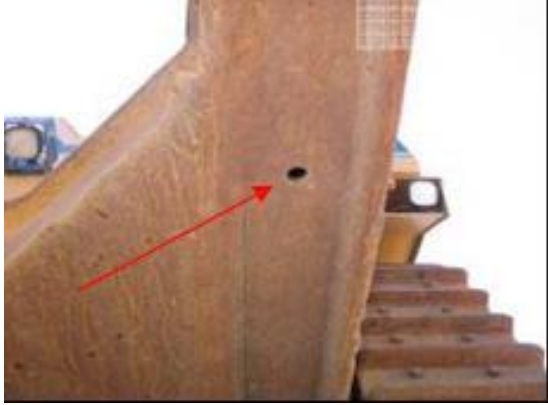
| Description | Images |
|---|--|
| <p>The underside of a typical ripper cradle with a drainage hole (red arrow). If the drainage hole is present, this hollow cavity will need to be flushed in the presence of the inspecting officer in order to verify cleanliness.</p> | |

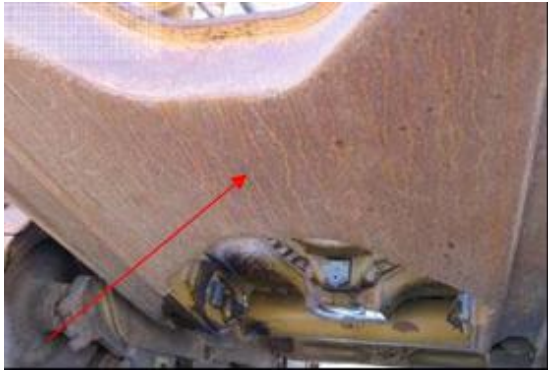
| Description | Images |
|---|--|
| <p>The middle of the ripper cradle (red arrow) is also hollow and may not have any drainage holes. If no drainage holes are located, check carefully for cracks, splits or evidence of repair.</p> | |

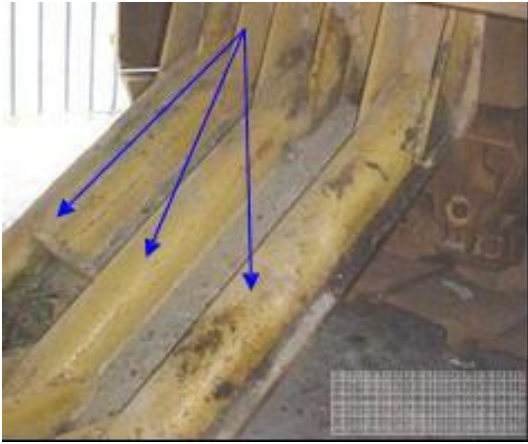
| Description | Images |
|---|---|
| <p>The inside of a typical belly plate. Check along each of the gussets (blue arrows) as on some models these are open ended and require flushing in the presence of the inspecting officer in order to verify cleanliness.</p> | |

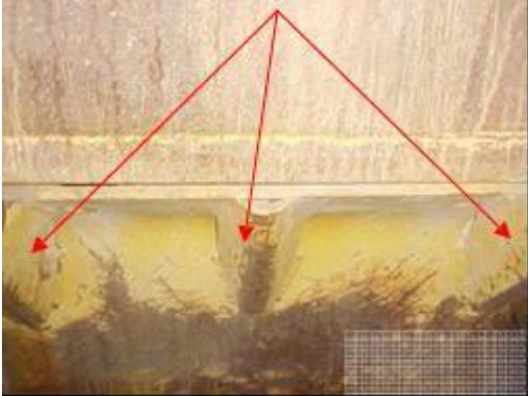
| Description | Images |
|---|---|
| <p>On some belly plates, gussets can be found on the outside of the belly plate, as highlighted by the red arrows. These need to be flushed to verify clean.</p> | |

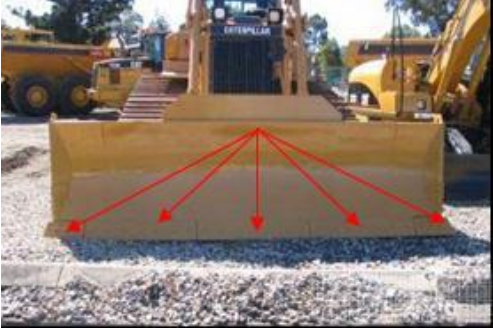
| Description | Images |
|--|--|
| <p>A typical blade on a dozer. All cutting teeth (red arrows) must be loosened and flushed to verify cleanliness. Check for any cracks, splits or evidence of repair to all surfaces. If detected, the internal of the blade will have to be verified clean.</p> | |

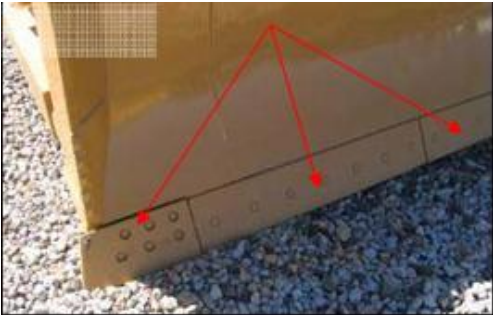
| Description | Images |
|--|--|
| A close up of the cutting teeth on a blade that needs to be loosened and flushed to verify cleanliness (red arrows). | A close-up photograph of a yellow dozer blade. Three red arrows point to the cutting teeth on the blade, indicating areas that need to be loosened and flushed for cleanliness. |

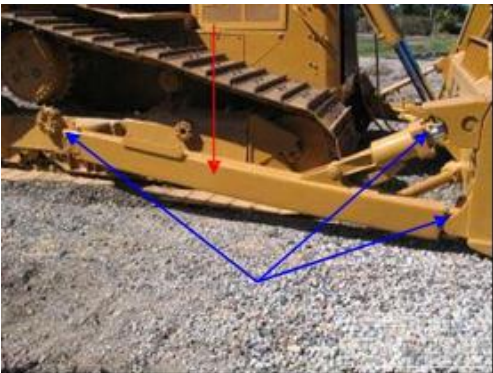
| Description | Images |
|--|--|
| The push arms (red arrow) on a dozer. These are generally sealed units, but check for any cracks, splits or evidence of repair. Ensure all contaminated grease is removed from pivot points (blue arrows). | A photograph of a dozer's push arms. A red arrow points to a push arm, and two blue arrows point to pivot points on the arms, indicating areas to check for damage and grease. |

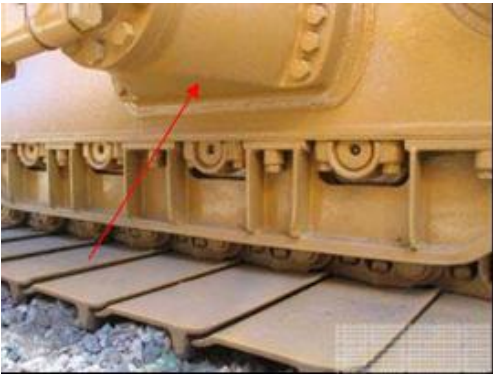
| Description | Images |
|--|--|
| Illustrates where the push arms attach to the track frames. These units may have drainage holes underside (red arrow), which will require flushing if present. | A close-up photograph of the attachment point between a dozer's push arm and the track frame. A red arrow points to a drainage hole on the underside of the attachment, indicating a potential area for flushing. |

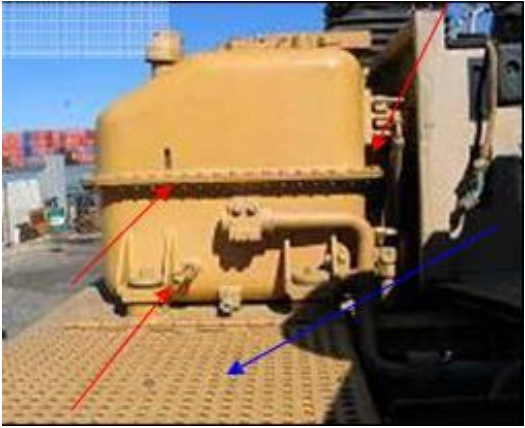
| Description | Images |
|--|--|
| <p>The oil tank located outside the cabin. The rear and underside (red arrows) require thorough cleaning and inspection. All checker plates (blue arrow) require flushing in the presence of the inspecting officer.</p> | |

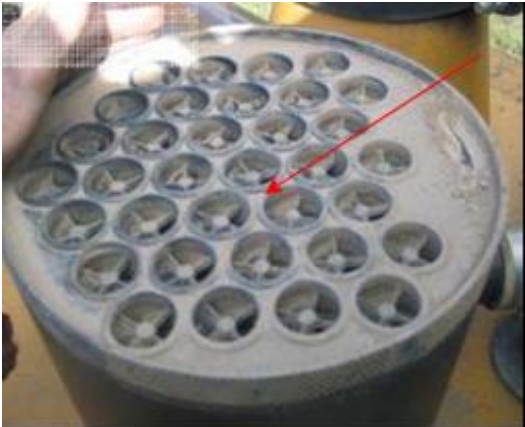
| Description | Images |
|--|--|
| <p>Air-filter pre cleaners or dust collectors must have the covers removed and be cleaned (red arrows).</p> | |

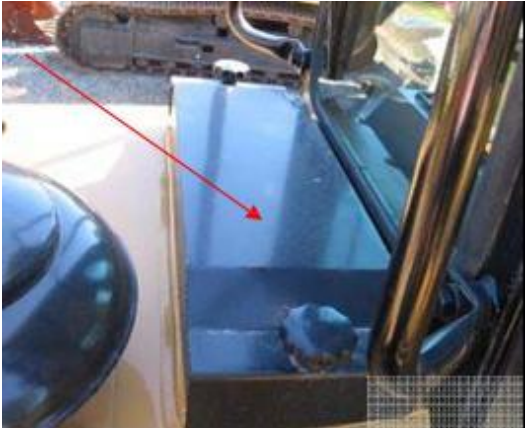
| Description | Images |
|--|--|
| <p>On some models the air-conditioning filter can be found on the topside of the engine cover, just below the windscreen. Remove filter, check for cleanliness. The filter housing will also require inspection (red arrow).</p> | |

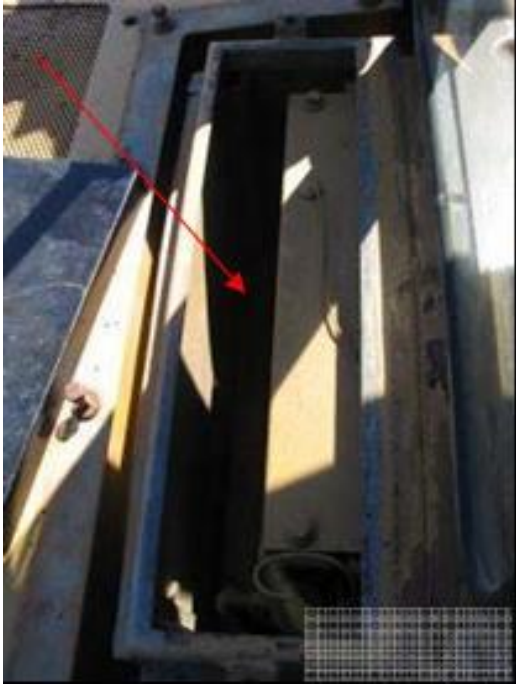
| Description | Images |
|--|--|
| <p>Check the air-filter housing for internal cleanliness (red arrow).</p> | |

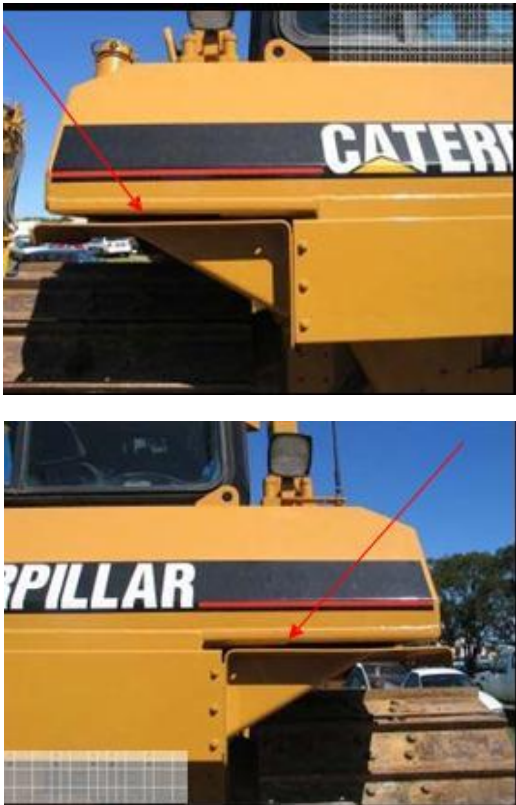
| Description | Images |
|--|--|
| <p>All surfaces of the fuel cell need to be carefully cleaned and inspected, particularly the back and underside (red arrows).</p> | |

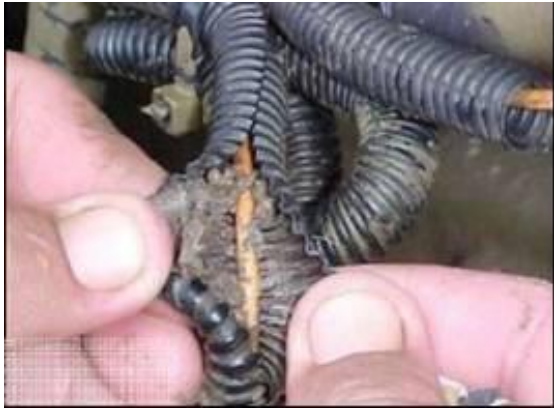
| Description | Images |
|---|--|
| All wiring harnesses are to be carefully cleaned and inspected. | A close-up photograph showing a person's hands holding a black, braided wiring harness. A section of the harness is frayed and damaged, with the outer sheath missing, exposing the internal copper wires. The person's fingers are visible, one holding the harness steady while the other points to the damaged area. |

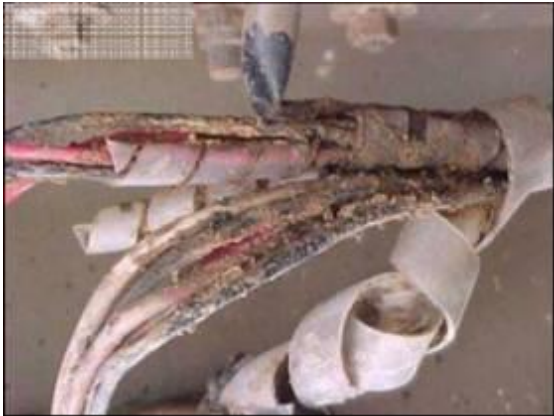
| Description | Images |
|---|--|
| All looming around hydraulic hoses is to be carefully cleaned and inspected. | A photograph showing a bundle of hydraulic hoses wrapped in white looming tape. The tape is peeling and flaking off, revealing the underlying hoses and some red-painted metal components. The scene is set in a confined space, likely the interior of a vehicle or machine. |

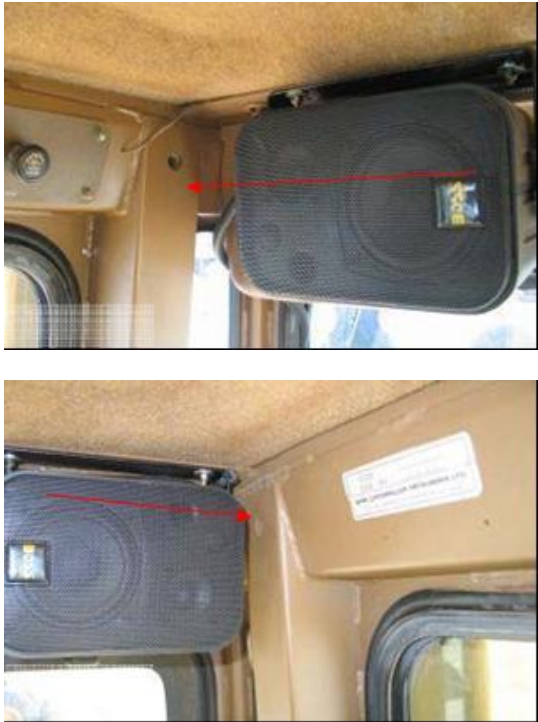
| Description | Images |
|---|--|
| Check all internal cabin framework for small holes. If present, flush to verify clean (red arrows). | Two photographs showing the interior of a vehicle cabin. The top photo shows a black speaker mounted on a tan-colored metal panel. A red arrow points to a small hole in the metal panel above the speaker. The bottom photo shows a similar view from a different angle, with a red arrow pointing to another small hole in the metal panel near a window. |

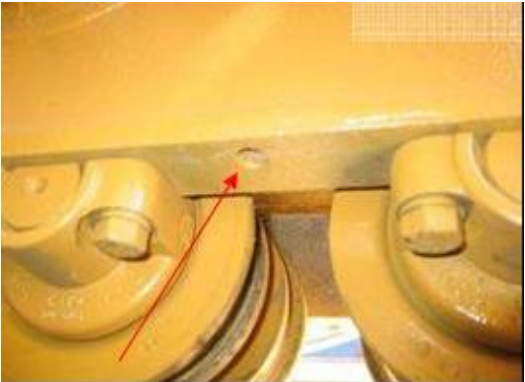
| Description | Images |
|--|---|
| <p>If rock guards are present they must be removed for cleaning and inspection. The red arrow highlights where the rock guard bolt has been removed, allowing access to the hollow section above. These must be flushed in the presence of the inspecting officer to verify cleanliness.</p> | A close-up photograph of a yellow metal rock guard bolt on a Caterpillar dozer. A red arrow points to the top of the bolt, indicating where it has been removed to provide access to the hollow section above. |

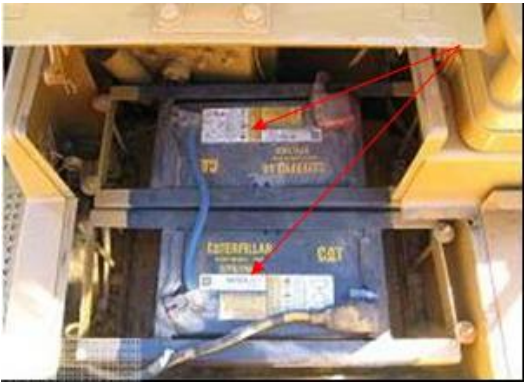
| Description | Images |
|--|---|
| <p>All batteries are to be loosened from the tie-down points for cleaning and inspection (red arrow).</p> | A photograph showing the interior of a Caterpillar dozer's battery compartment. Two blue batteries are visible, secured with metal tie-downs. Red arrows point to the tie-down points, indicating they should be loosened for cleaning and inspection. The batteries have "CATERPILLAR" and "CAT" branding. |
