Australian Government
Department of Agriculture
and Water Resources

Machinery Cleaning Guide - Compactors

April 2016

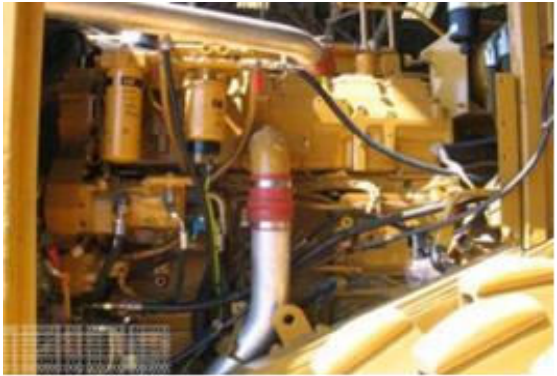
Description	Images
<p>The right hand side of the compactor engine block. All non-affixed panels have been removed to facilitate cleaning and inspection.</p>

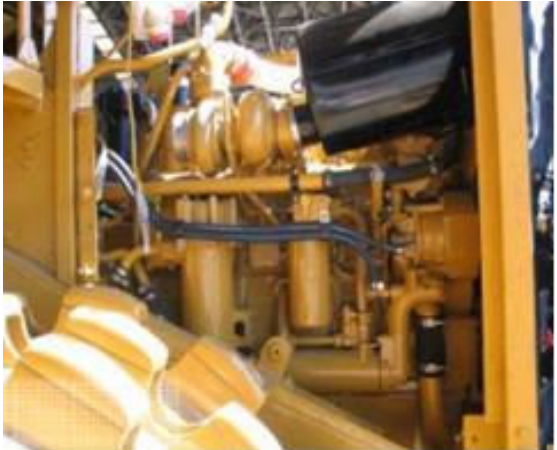
<p>The left hand side of the compactor engine block. All non-affixed panels have been removed to facilitate cleaning and inspection.</p>

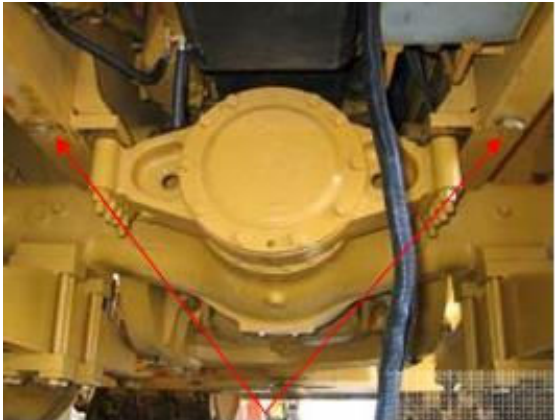
<p>All belly plates have been removed exposing the underside of the engine block for cleaning and inspection. The hollow chassis rails (red arrows) must be flushed in the presence of the inspecting officer to verify cleanliness.</p>

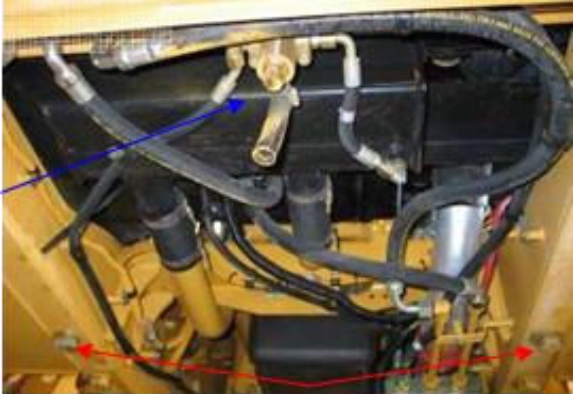
Description	Images
<p>The underside of the radiator and shroud (blue arrow). The bolt hole access to the hollow chassis rail is highlighted again (red arrows).</p>

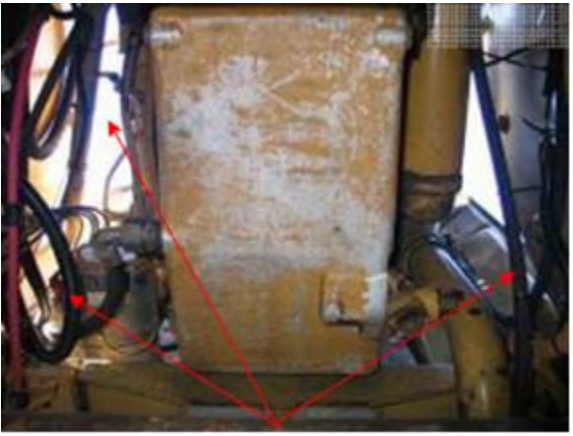
<p>The sump under the front end of the Compactor. Ensure that this area has had all contaminated grease removed. All hydraulic hoses and wiring harnesses (red arrows) must be thoroughly cleaned and inspected.</p>

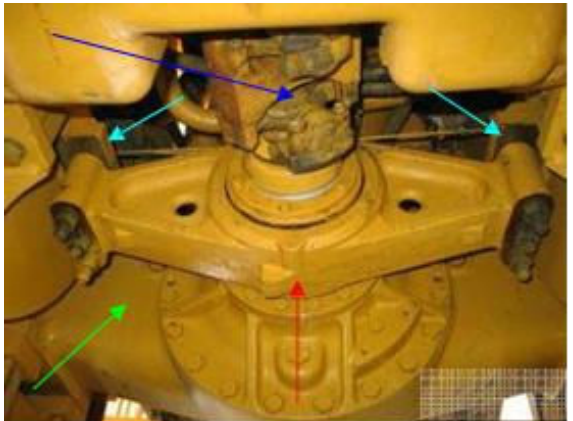
<p>The rear sway bar (red arrow), universal joint (blue arrow) and diff (green arrows). All contaminated grease must be removed from all universal joints. Check all countersunk holes and ledges. Ensure all topside of the engine mounts (aqua arrows) are clean.</p>

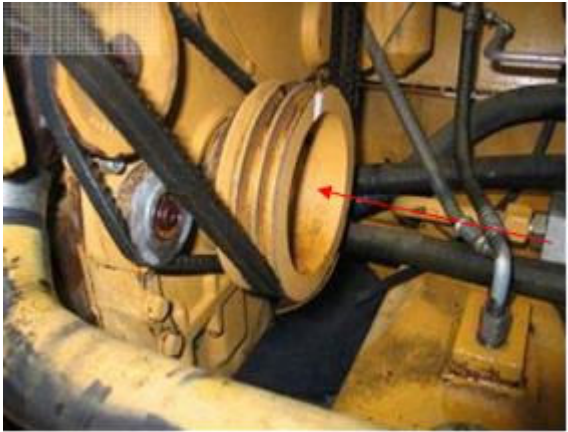
Description	Images
<p>At the rear of the engine block are the harmonic balancers or flywheels (red arrow). These are generally concave and can harbour significant amount of biosecurity risk material (BRM).</p>

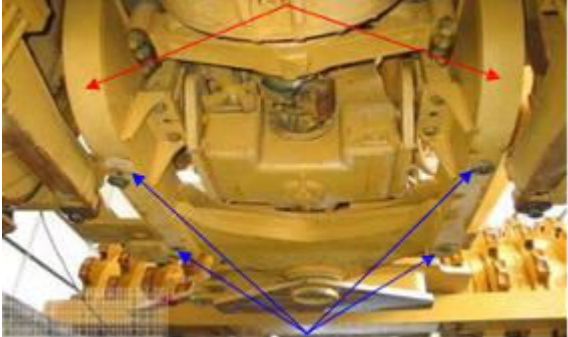
<p>The front hollow chassis rails (red arrows). The four belly plate bolts (blue arrows) are still in place in this illustration, however all must be removed and the area flushed to ensure cleanliness.</p>

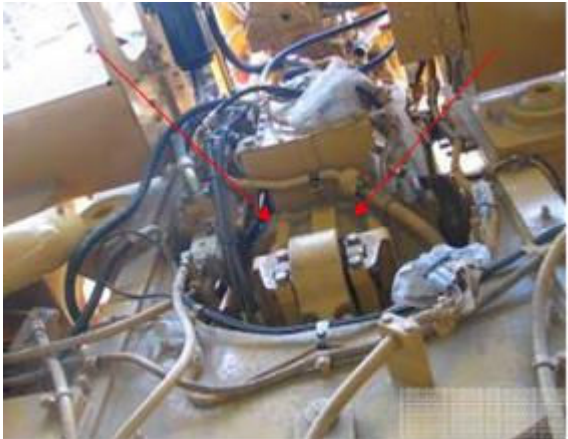
<p>This image depicts a rare sight because the cabin has been removed from the compactor. The top of the block directly under the cabin is one of the most difficult areas to clean and inspect. The bell housing (red arrows) with the undulating surface can harbour BRM.</p>

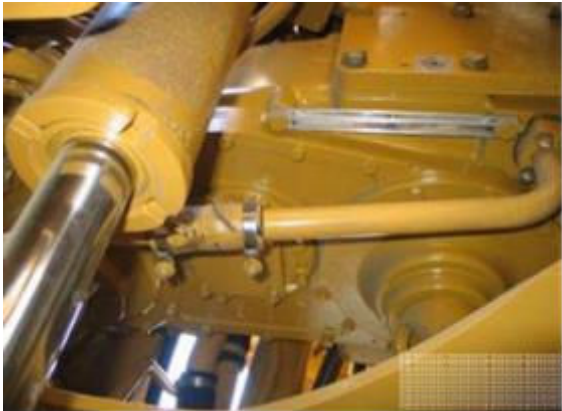
Description	Images
<p>The front of the engine as seen from the pivot point. This area contains a myriad of ledges, hydraulic hoses and countersunk holes that require thorough cleaning and inspection.</p> <p>Ensure all engine mounts are free of BRM including the reverse side.</p>

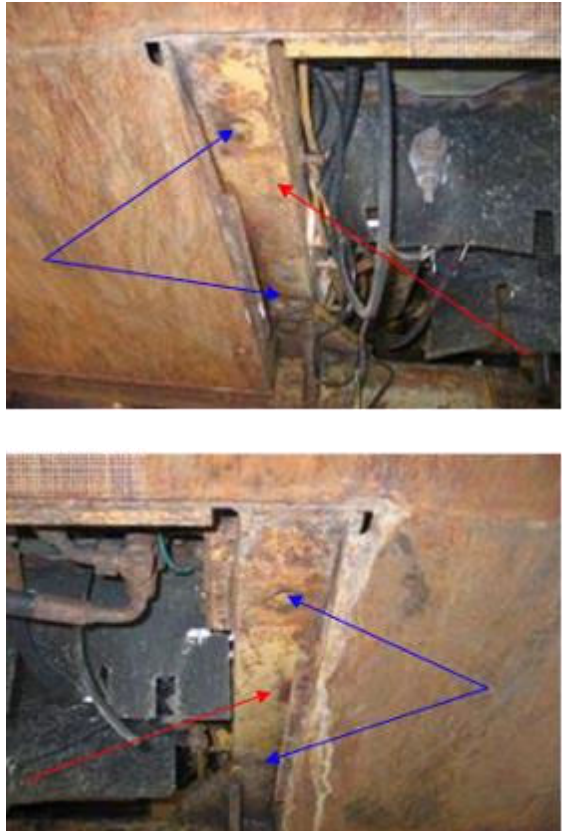
<p>These illustrations highlight the hollow chassis rails (red arrows) and drainage holes (where the belly plate bolts have been removed – blue arrows). The area will require flushing to ensure cleanliness.</p>

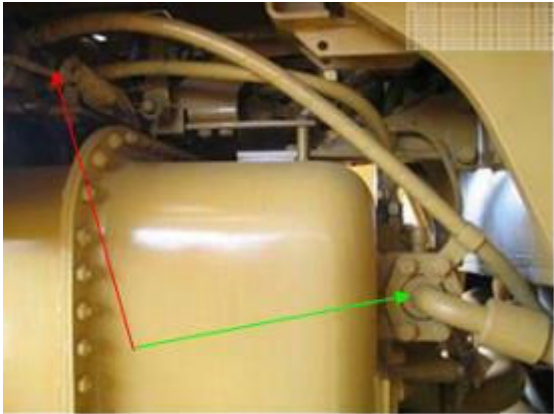
Description	Images
<p>The topside of the oil tank and under the cabin step. There can be numerous hollow channels (red arrow), ledges and hydraulic hoses and couplings (green arrow) that require thorough cleaning and inspection.</p>

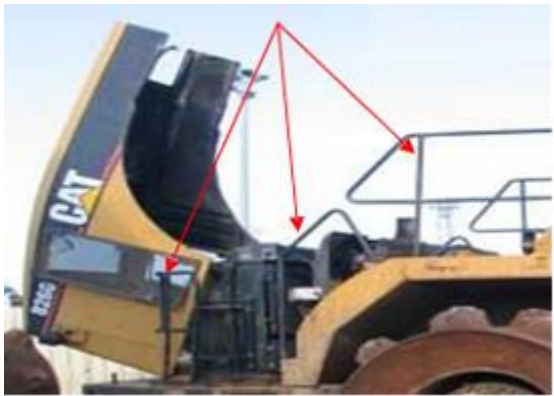
<p>Some engine covers may tilt rearwards as illustrated, exposing the topside of the engine block. The engine covers must be checked for hollow rails, if present they require to be flushed. Check all handrails (red arrows) for open ends or drainage holes that can be flushed.</p>

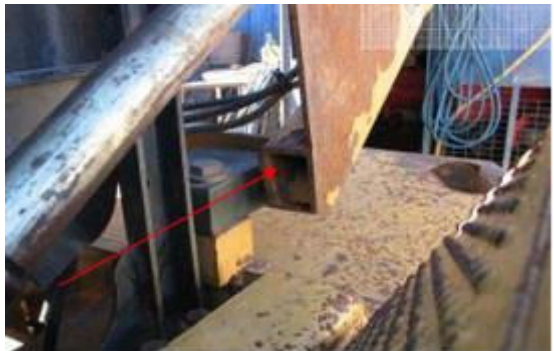
<p>An illustration of a hollow channel in the engine cover (red arrow) of the Compactor. This will require flushing to ensure cleanliness.</p>

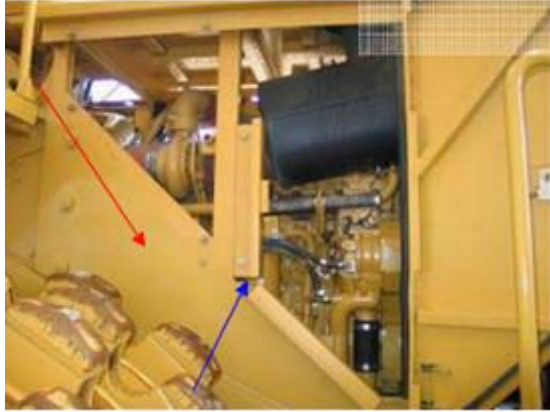
Description	Images
<p>A fixed compactor engine housing with non-affixed panels (red arrow) and hollow framework (blue arrow).</p>

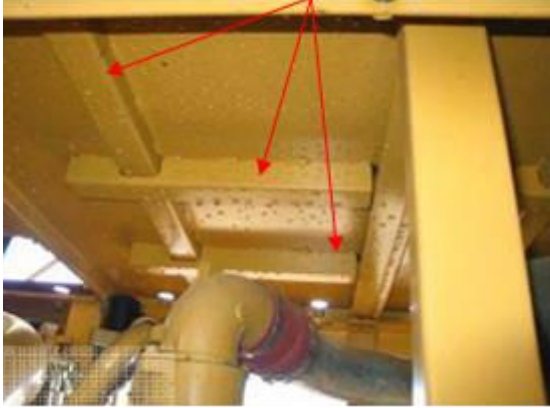
A photograph showing the interior of a yellow engine housing. A red arrow points to a non-affixed panel, and a blue arrow points to a hollow framework structure.
<p>The underside of the engine housing, where hollow, open-ended support channels (red arrows) may be located. All must be flushed to ensure cleanliness.</p>

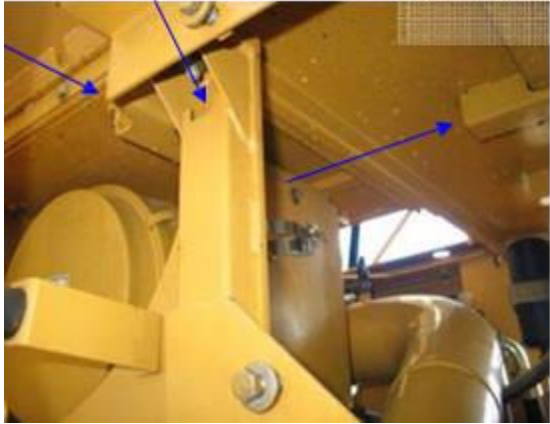
A photograph showing the underside of the engine housing. Red arrows point to hollow, open-ended support channels.
<p>Further illustrations of the hollow support framework that may be located under the engine cover.</p>

A photograph showing the hollow support framework under the engine cover. Blue arrows point to various parts of the framework.

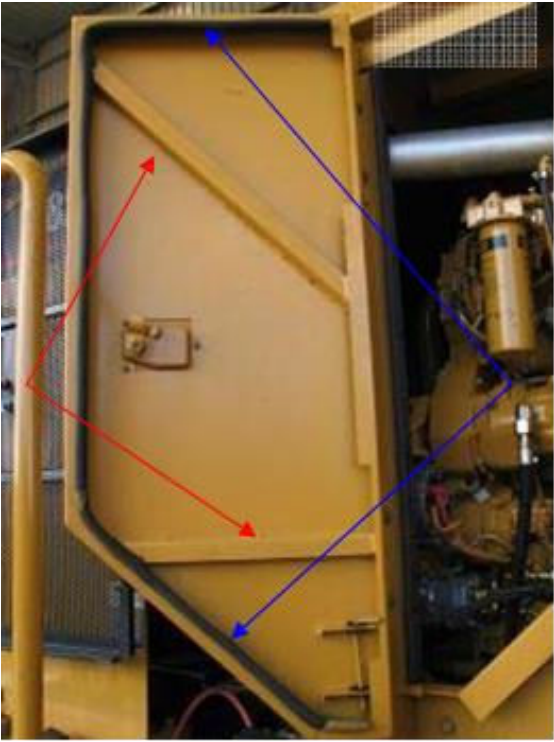
Description	Images
<p>The hinged door to the engine bay has been opened, revealing spot welded support frames that are hollow (red arrows) and will be inspected by a biosecurity officer for cleanliness. All engine door rubbers must be cleaned and inspected (blue arrows).</p>

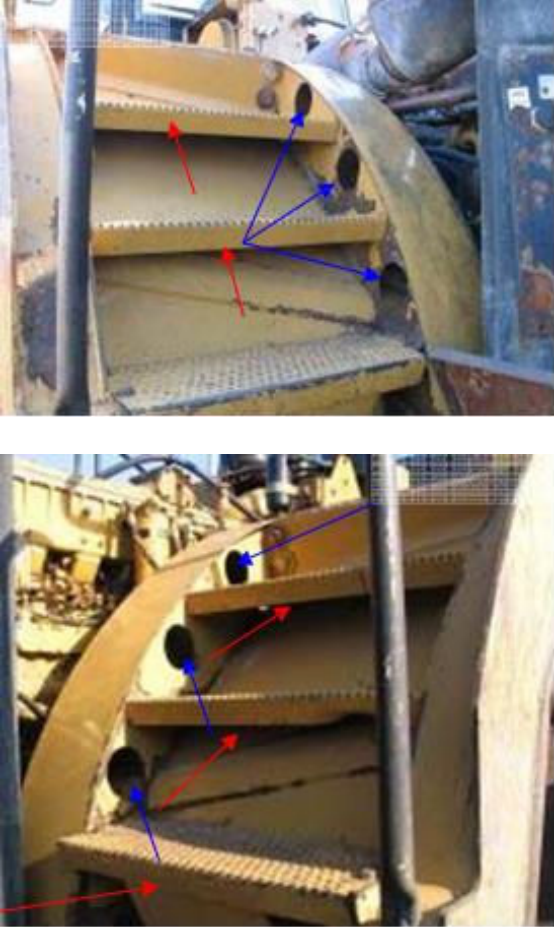
<p>On some of the larger model compactors, above the rear drum and along the side of the block, a small set of steps may be located. The underside of each footstep (red arrows) must be verified clean, but also the hollow cavities as highlighted by the blue arrows.</p>

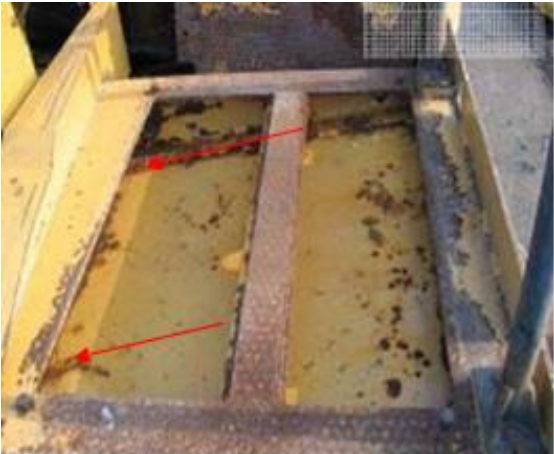
Description	Images
<p>At the top of these steps seen in the last illustration, a non-affixed panel has been removed, allowing access for cleaning and inspection.</p>

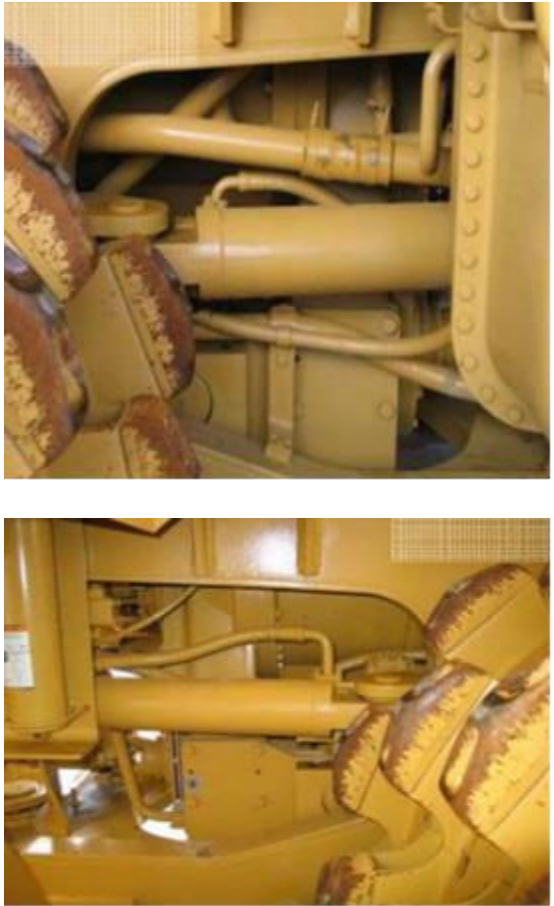
<p>The left and right hand side of the compactor, just in front of the rear drums. On this model there are no non-affixed panels, allowing sufficient access to the side of the engine block for cleaning and inspection. On other models, non-affixed panels will need to be removed to allow this access.</p>

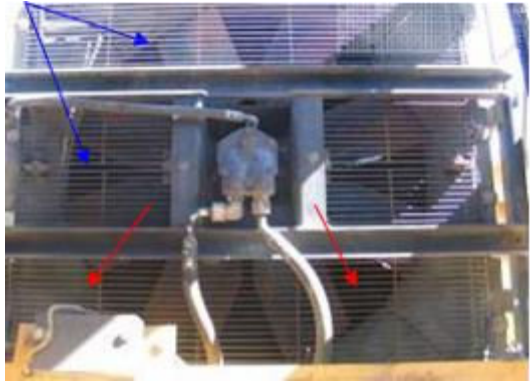
Description	Images
<p>The rear end, highlighting the radiator grill (blue and red arrows), which must be removed to allow cleaning and inspection access inside the bottom of the shroud.</p>

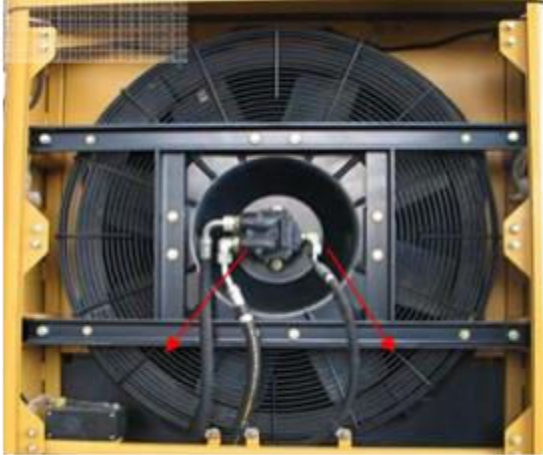
<p>Another radiator grill on a different model of compactor. This must be removed to allow access for cleaning and inspection inside the bottom of the shroud (red arrows).</p>

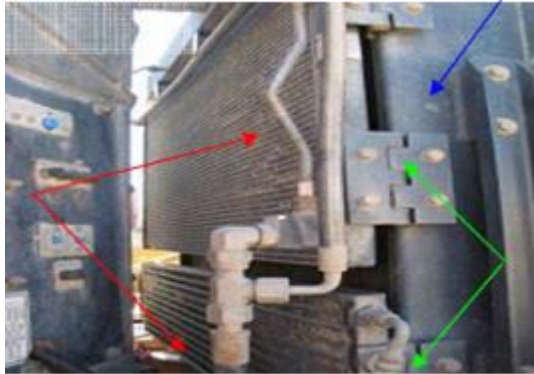
<p>The rear side of the radiator (blue arrow) and oil cooler (red arrows), which require flushing of the fins to ensure cleanliness. On this model the cooler is hinged (green arrows), allowing the oil cooler to be opened (see next illustration) from the radiator fins and be flushed.</p>

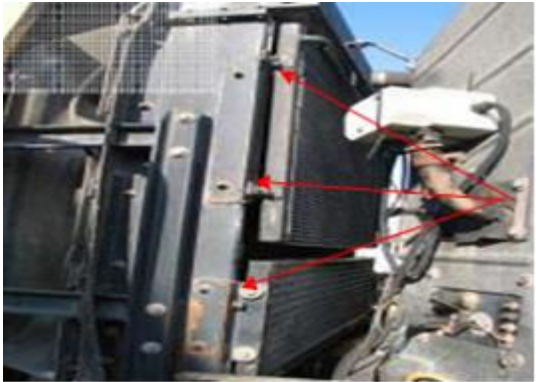
Description	Images
<p>The opposite side of the radiator and oil cooler showing the bolts that can be removed (red arrows), allowing the oil cooler to be swung open so both the radiator and oil cooler can be flushed.</p>

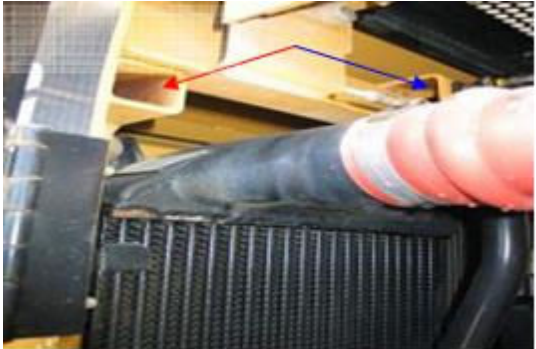
<p>On some models there may be hollow channels (red arrow) and ledges (blue arrow) above the radiator that must be free of all BRM.</p>

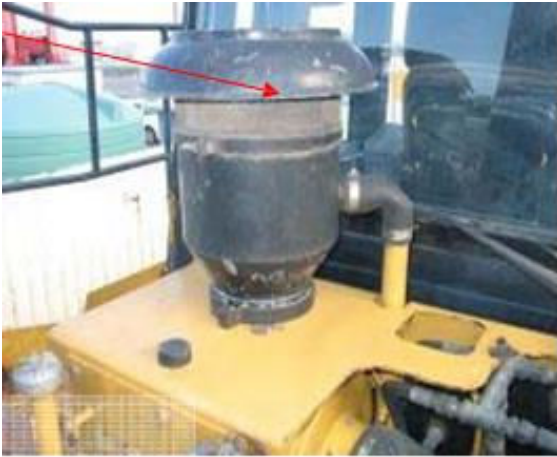
<p>All air-filter pre-cleaner covers are to be removed to allow cleaning and inspection access (red arrow).</p>

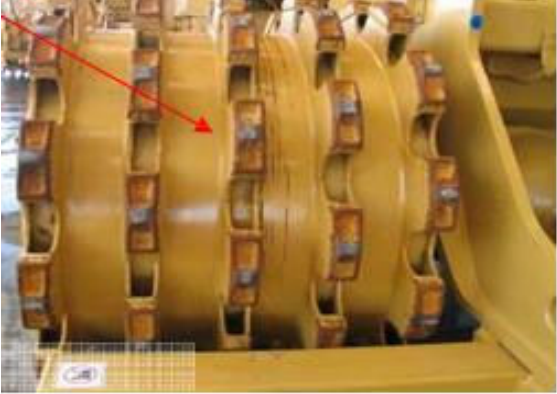
Description	Images
<p>An example of some of the styles of boots that may be found on compactors (red arrow). These boots are hollow and have an access point on the underside (illustrated next), and all must be flushed to ensure cleanliness.</p>

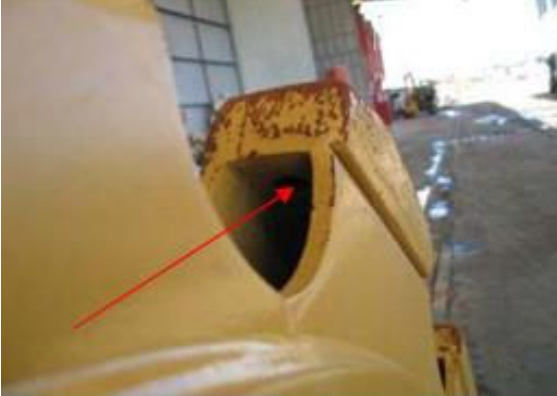
<p>The underside of the boot on this style of compactor. Although not easily seen, there is a hole on the underside (where red arrow is highlighting) and these must all be flushed to ensure cleanliness.</p>

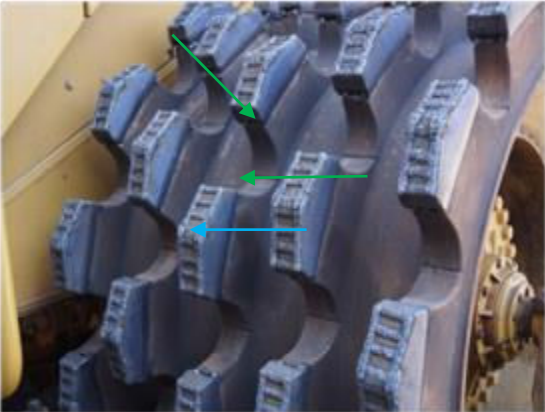
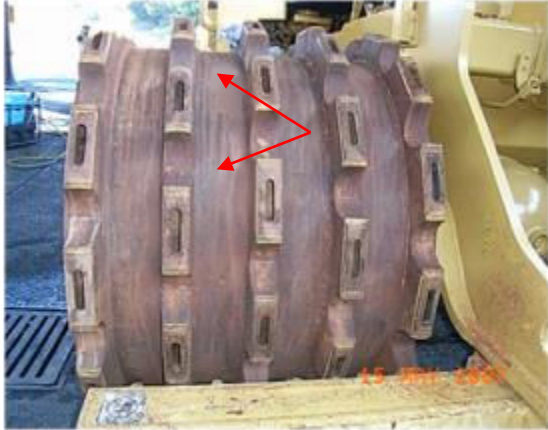
<p>A view of this boot reveals that it is not completely sealed (only spot welded) in place. The green arrow highlights the small recesses, allowing contaminants inside this hollow cavity (blue arrow). These will require further investigation to verify cleanliness. Flushing via these small recesses with a pin jet, will not suffice in removing BRM or verifying internal cleanliness. All boots must be removed (illustrated in second image). Once removed, access is easy for verifying (red arrow).</p>

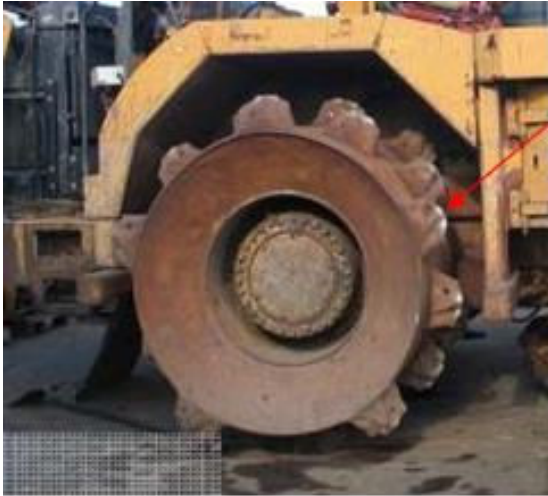
<p>Another example of some of the styles of boots that may be found on compactors (red arrow).</p>

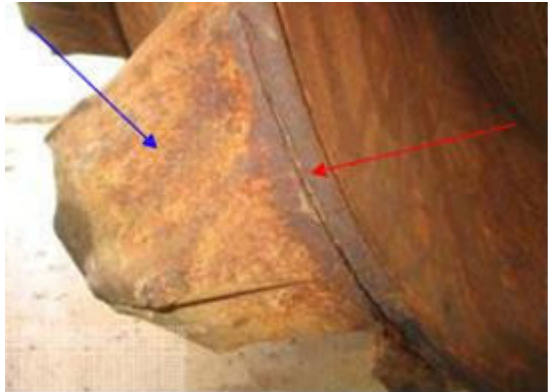
<p>A close view of this boot reveals that it is not completely sealed (only spot welded) in place. The red arrow highlights the small recess, allowing contaminants inside this hollow cavity (blue arrow). These will require further investigation to verify cleanliness. Flushing via this small recess with a pin jet, will not suffice in removing BRM or verifying internal cleanliness.</p>

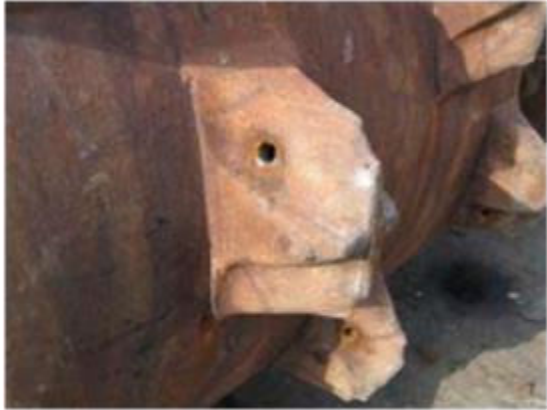
Description	Images
<p>These boots were only spot welded into place and the importer chose to remove the internal BRM by inserting a small access point into each boot. There may be evidence on some drums that the boots have been repositioned at some stage (old welding tracks present). In this instance, the internal cleanliness of these boots will also be required.</p>

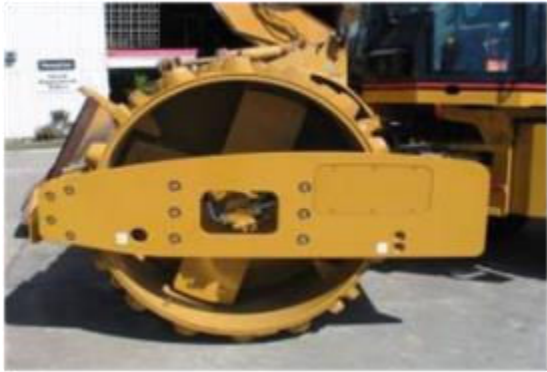
<p>Another example of some of the styles of boots that may be found on compactors. The boots illustrated in this shot are spot welded onto a semi-circular drum that is fitted to a roller wheel.</p>

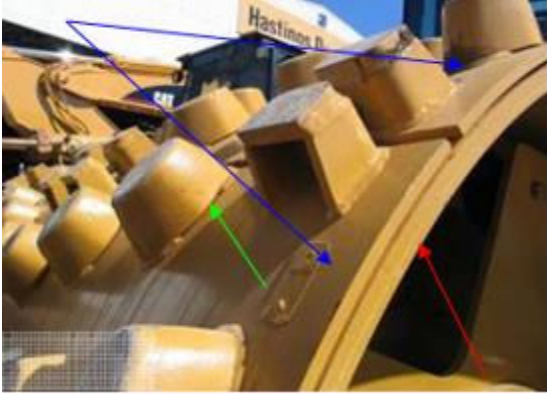
<p>A close illustration highlighting the roller wheel (red arrow) and the semi-circular drums (blue arrows). These semi-circular drums must be removed to allow access for cleaning and inspection. The internal cleanliness of each spot-welded boot (green arrow) must also be verified.</p>

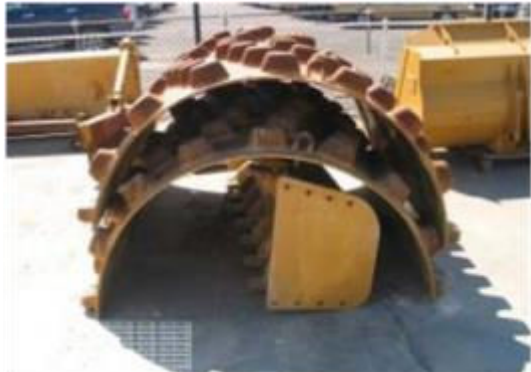
<p>The semi-circular drums removed for cleaning and inspection.</p>

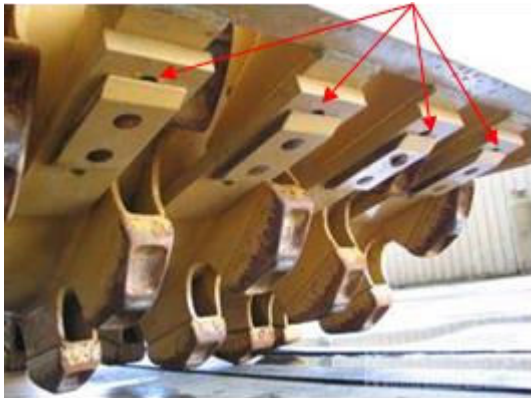
Description	Images
<p>An example of the cleaning bars that remove trash from between the boots when operating. Note the small holes on the underside (red arrows), which can harbour BRM and must be verified clean.</p>

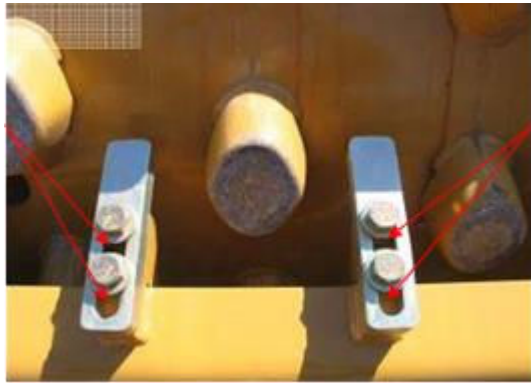
<p>Another example of the cleaning bars found on compactors. These cleaning bars also have small recesses (red arrows) where BRM can accumulate.</p>

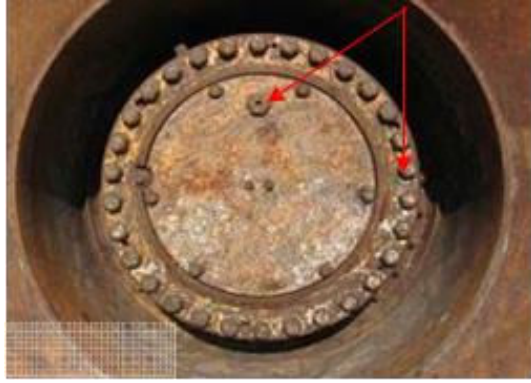
<p>The outside of the compactor rim. Check that all countersunk holes and around each nut is free of BRM (red arrow).</p>

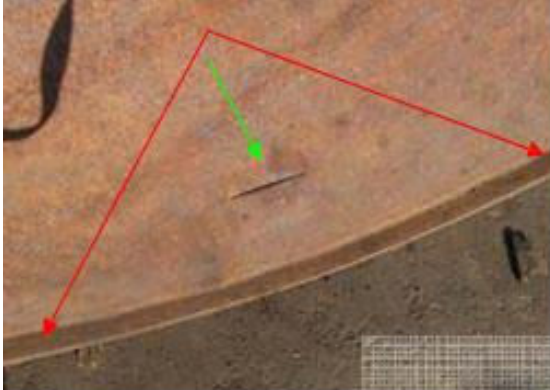
<p>Check all surfaces of the rim (red arrows) for any cracks, splits or evidence of repair. The green arrow is highlighting a small seam (common on some models), which is not a split or repair. This seam will require flushing to verify cleanliness.</p>

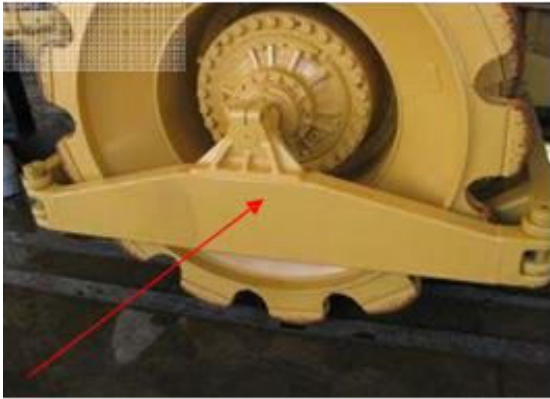
Description	Images
<p>Another example of the outside rim, this time partly obscured by the cleaning bar (red arrow). Check that all countersunk holes and around each nut are free of BRM.</p>

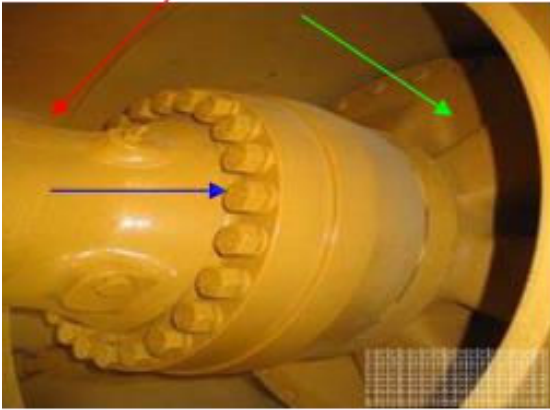
<p>An example of an inside rim with no cover plates. Ensure that the top of the axel (red arrow), around each nut (blue arrow) and the undulating surfaces inside the rim (green arrow) are free of BRM.</p>

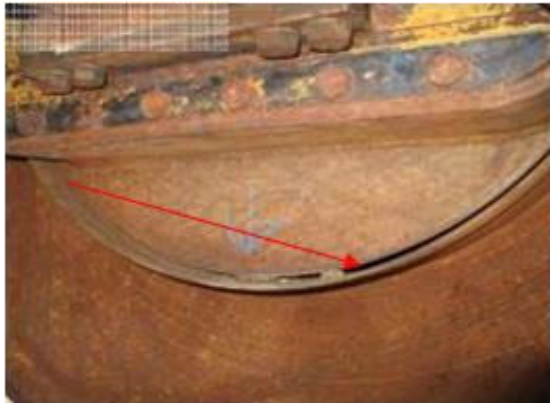
<p>An inside rim cover with a large recess behind. Access may be required to verify cleanliness (red arrow).</p>

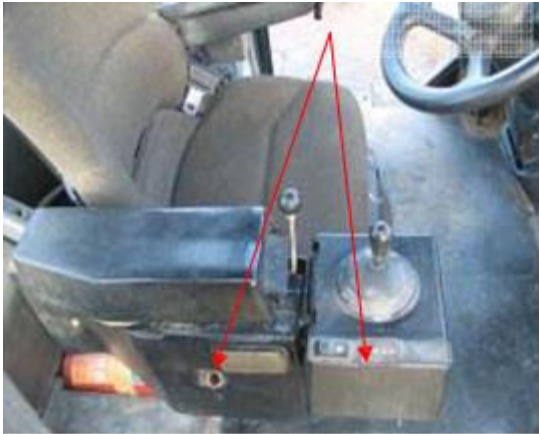
Description	Images
Access will be required to the joystick control panels to verify internal cleanliness (red arrows).

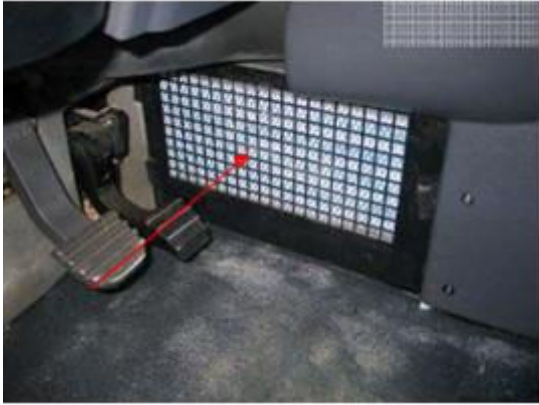
Remove the air-filter cover (red arrow) and verify the cleanliness of the filter (pressurised air).

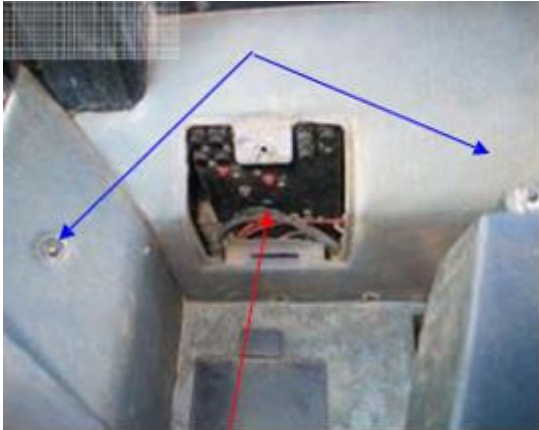
All internal cabin compartments (red arrow) are to be checked and all internal padding (blue arrows) must be cleaned and inspected (and behind).

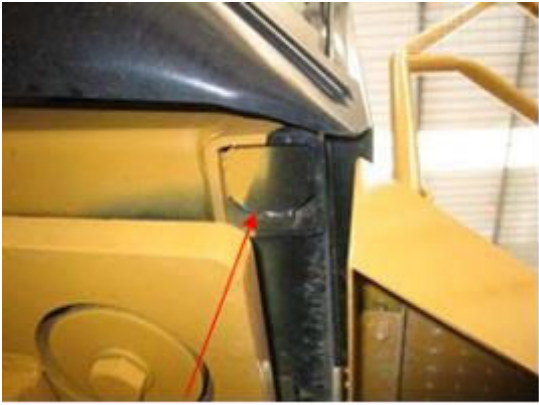
Description	Images
<p>Underneath the cabin, the framework may be open-ended as illustrated (small triangular corners missing) and will require flushing to verify cleanliness (red arrow).</p>

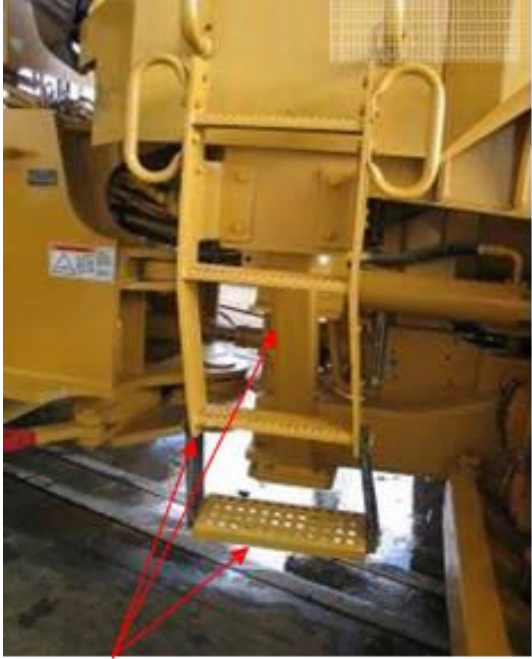
<p>Check all footsteps for cleanliness (including underside – see red arrow).</p>

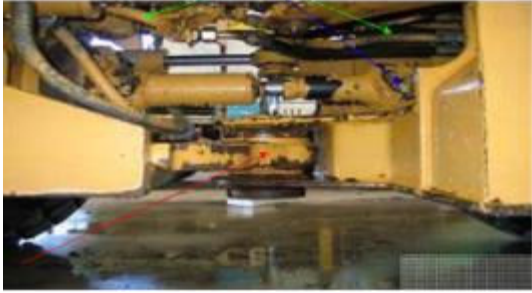
Description	Images
<p>The bottom pivot-point (red arrow) as generally seen on compactors. This area is signified by several pivot points (above), universal joints (blue arrow) and a myriad of hydraulic hoses (green arrows), all requiring thorough cleaning and inspection.</p>

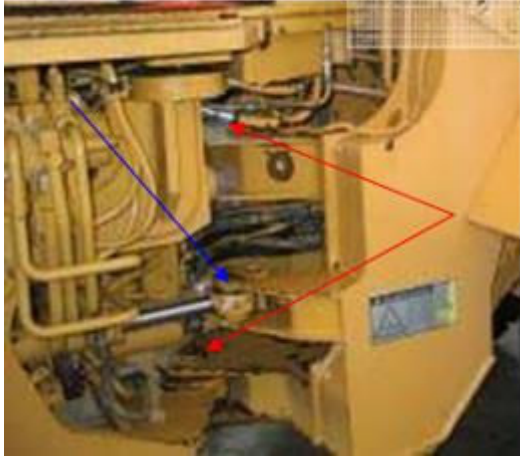
Description	Images
The pivot-points (red arrows) and hydraulic rams (blue arrow). All non-affixed panels and shrouds have been removed, allowing access for cleaning and inspection.

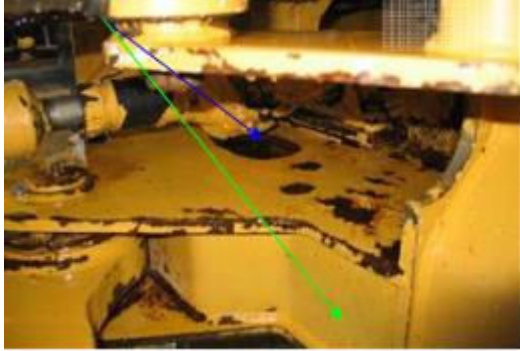
A close-up photograph of the internal mechanical components of a compactor. The image shows a complex arrangement of metal parts, including what appear to be pivot points and hydraulic rams. Two red arrows point to specific pivot points, and a blue arrow points to a hydraulic ram. The background is a yellow-painted metal structure.
The bottom pivot point from a slightly elevated angle. Check all hollow framework (green arrow) for entrance holes (blue arrow) or drainage holes underside. This area can harbour a significant amount of BRM and must be verified clean.

A close-up photograph of the bottom pivot point of a compactor, viewed from a slightly elevated angle. The image shows a yellow-painted metal structure with a hollow framework. A green arrow points to the hollow framework, and a blue arrow points to a potential entrance hole. The area appears to be a complex mechanical assembly with various components and wiring.

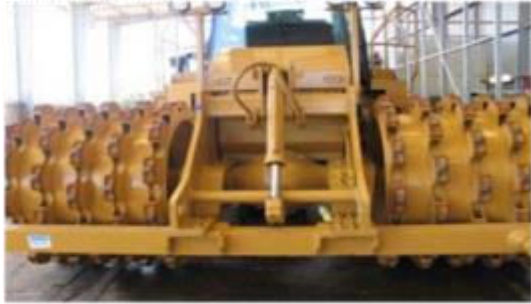
Description	Images
Illustration of the front end of a compactor.

A photograph showing the front end of a yellow compactor. The machine is positioned in a large, well-lit industrial or warehouse setting. The front view shows the compactor's frame, wheels, and the front-mounted compaction mechanism. The background shows the interior of a large building with high ceilings and structural beams.

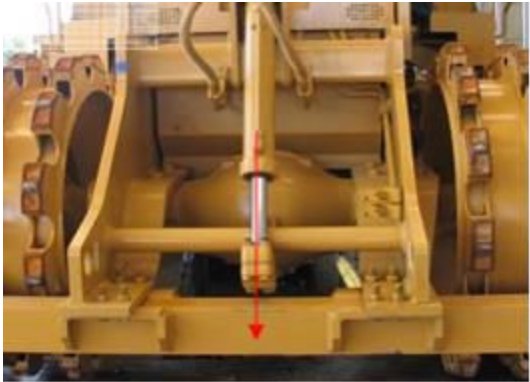
Description	Images
<p>Check the cleaning bar (red arrow) for any cracks, splits, drainage holes or evidence of repair.</p>

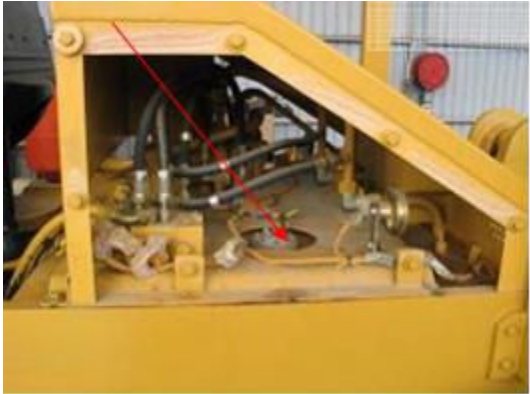
<p>The non-affixed housing has been removed, allowing access for cleaning and inspection. This cover can be completely removed, if required. There are small recessed areas (red arrows) that will require flushing to verify cleanliness.</p>

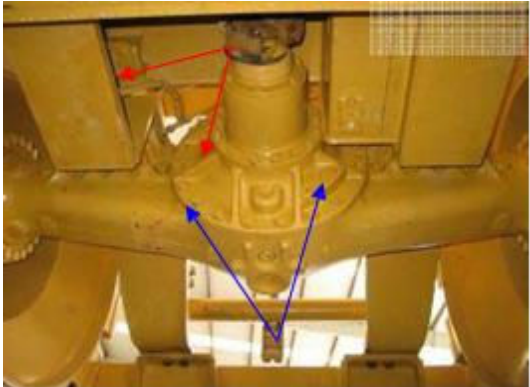
<p>The front axle and differential. All ledges (red arrow), top of axels, countersunk holes (blue arrows) and inside wheel rims must be thoroughly cleaned and inspected.</p>

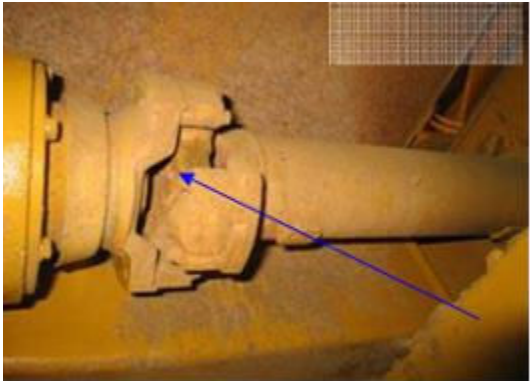
<p>All contaminated grease is to be removed from all universal joints (blue arrow).</p>

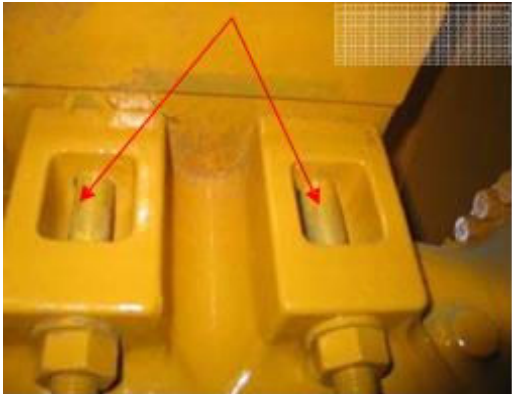
Description	Images
<p>Axle mounts are generally concave as illustrated and require cleaning and inspection (red arrow).</p>

A close-up photograph of two yellow axle mounts. Two red arrows originate from a single point at the top and point to the concave inner surfaces of the mounts.

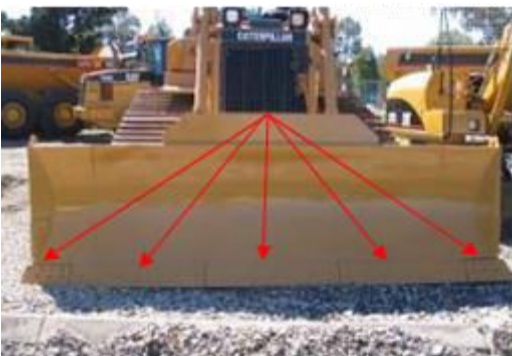
Description	Images
<p>A typical blade on a compactor. All cutting teeth (red arrows) must be loosened and flushed to verify cleanliness. Check for any cracks, splits or evidence of repair to all surfaces. If detected, the interior of the blade will have to be verified clean.</p>

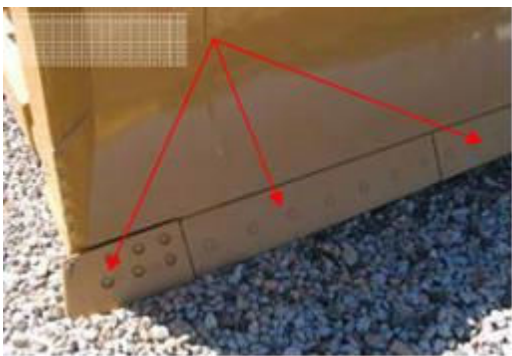
A wide-angle photograph of a yellow compactor's blade. Five red arrows point from a central point above the blade to various cutting teeth along its length.
<p>A close up of the cutting teeth on a blade that need to be loosened and flushed to verify cleanliness (red arrows).</p>

A close-up photograph of the cutting teeth on the blade. Three red arrows point to the teeth, highlighting the areas that need to be inspected and cleaned.

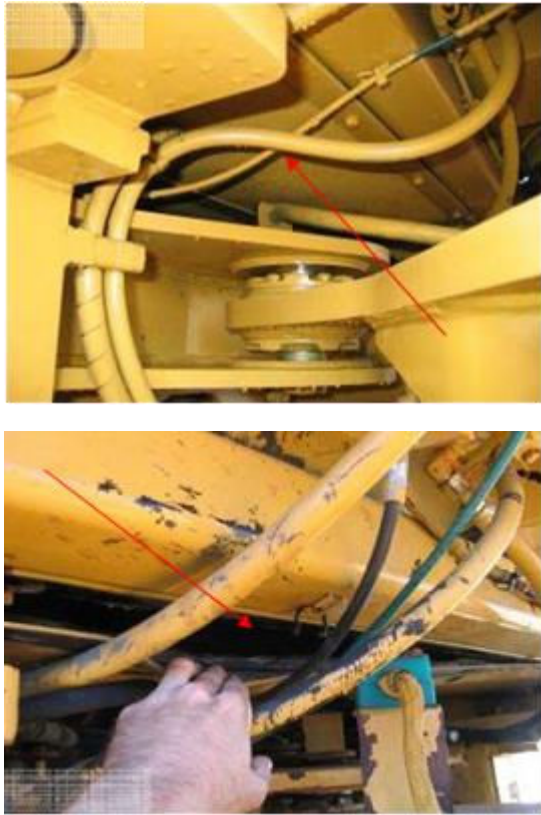
Description	Images
<p>On some models of compactors, under the cabin may be a false floor (red arrow). These are reasonably common and worth illustrating as this area can harbour a significant amount of BRM. The false floors can be made from hard rubber or compressed fibreboard and can be unbolted to allow access for cleaning and inspection.</p>

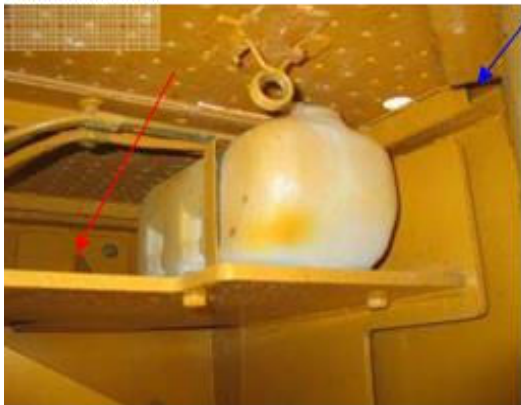
<p>This illustrates the compartment under the cabin step. Like the oil tank on the other side, this area has ledges (red arrow) and hollow channels (blue arrow) that require cleanliness verification.</p>

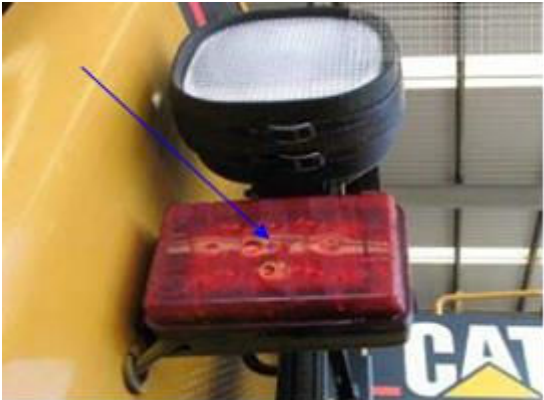
Description	Images
Remove all light covers and check the internal surfaces (blue arrow).

A photograph showing a red rectangular light cover mounted on a yellow piece of heavy machinery. A blue arrow points to the top surface of the red cover, which is the internal surface to be checked. The background shows a white wall with a 'CAT' logo.
Check all wiring harnesses for internal cleanliness.

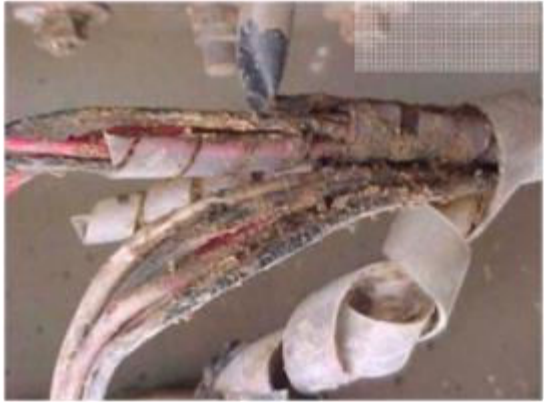
A close-up photograph of a wiring harness. A blue arrow points to a specific area where the wires are bundled together, showing a significant amount of dirt and grime on the internal surfaces.
Check all looms around hydraulic hoses for internal cleanliness.

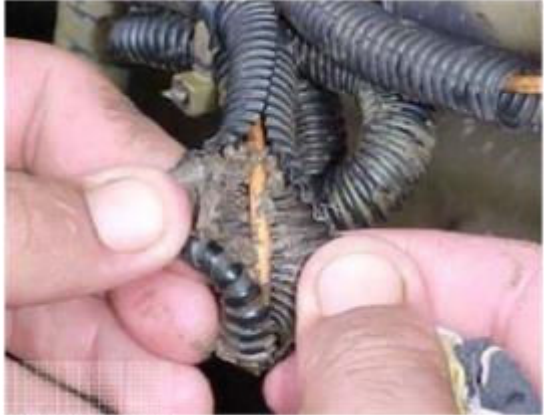
A close-up photograph showing a person's hands holding a black corrugated hydraulic hose loom. A blue arrow points to the internal surface of the loom, which is heavily contaminated with dirt and debris.

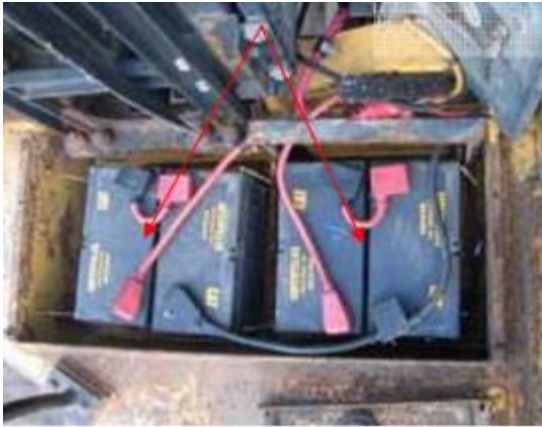
Description	Images
<p>Batteries are to be loosened from the tie down points for cleaning and inspection (red arrows).</p>

A photograph showing a battery compartment with several blue batteries. Red arrows point to the tie-down points where the batteries are secured.
<p>All non-slip checker plate is to be flushed to verify cleanliness (red arrow).</p>

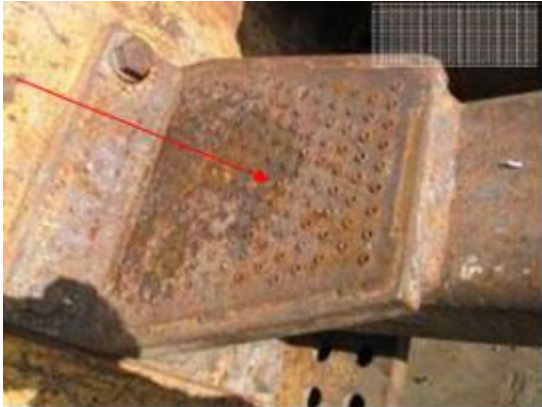
A close-up photograph of a non-slip checker plate. A red arrow points to the surface of the plate.
<p>The wheel arch as illustrated on some models. Note the small drainage holes (red arrows) on the underside of the support framework. These will require flushing to verify cleanliness.</p>

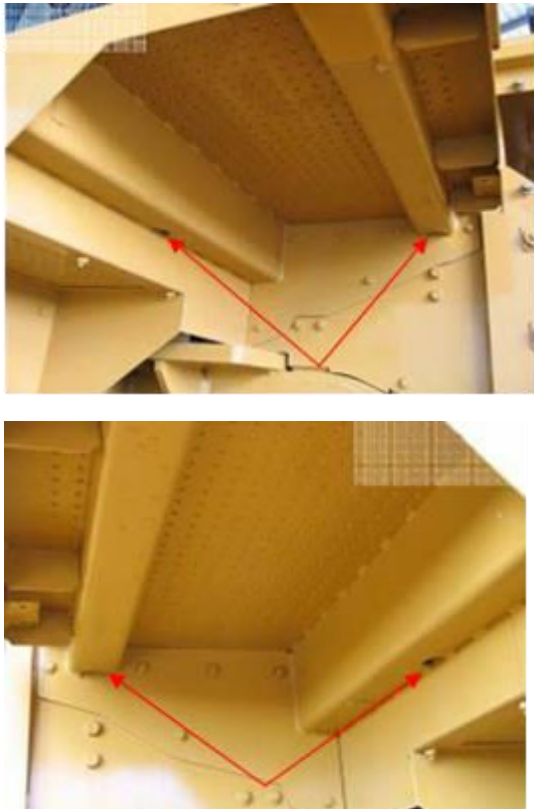
Two photographs showing the underside of a support framework. Red arrows point to small drainage holes on the underside of the support framework.
