Australian Government
Department of Agriculture
and Water Resources

Machinery Cleaning Guide - Caterpillar and Komatsu Dump Trucks

April 2016

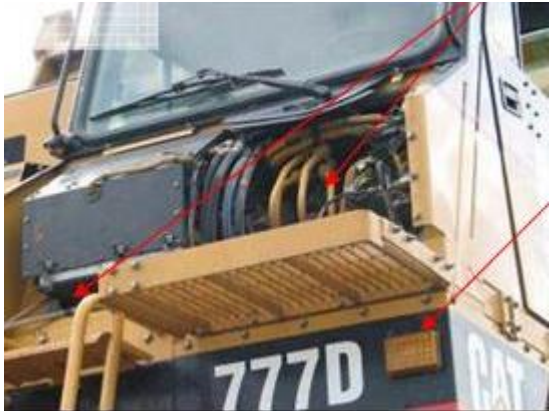
Description	Images
<p>This photo shows the front cabin panels removed, allowing access to the air-conditioning and electrics. Best to use a telescopic or flexible mirror to inspect all areas inside. All light covers must be checked (red arrows).</p>

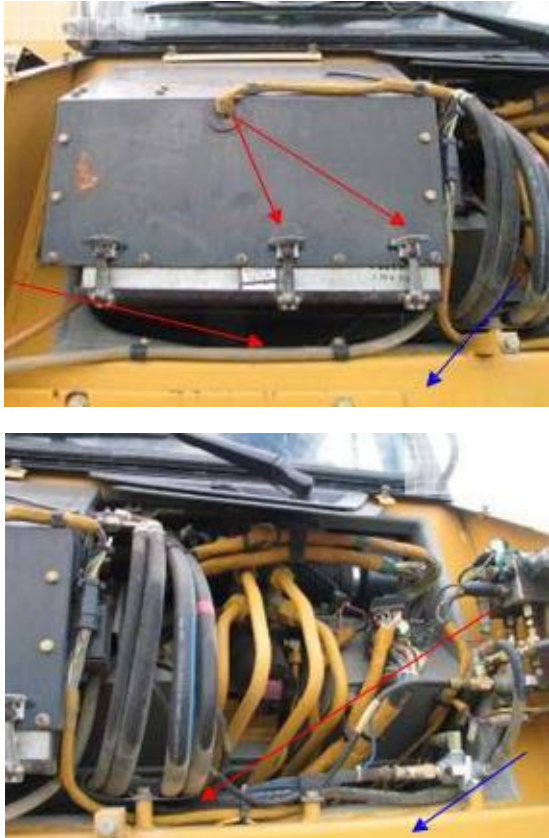
<p>Close ups of the air-conditioning and electrical systems found behind the panels at the front of the cabin. On the left, these tie-down hooks (red arrows) must be loosened off to reveal inside the air-conditioning unit – check filters. The blue arrows in each photo indicate part of the box channel housing of the cabin air-con and electrics inspect in behind this box channel. The use of telescopic or flexible mirrors can facilitate the inspection.</p> <p>N.B. This area can also be accessed when the panel under the cabin floor has been removed – See page 7. Access from the underside of the cabin does not negate the need to remove these front panels.</p>

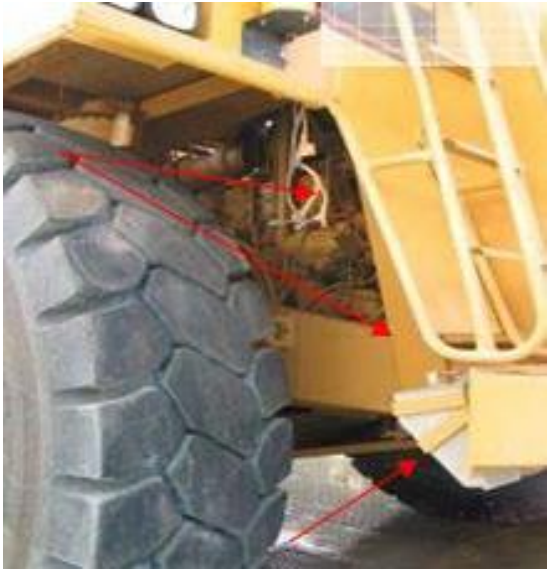
Description	Images
<p>The two red arrows on the centre of the photo show the vertical section of the chassis. These sections are hollow, have drainage holes and require flushing in the presence of the inspecting officer. See next series of photos.</p>

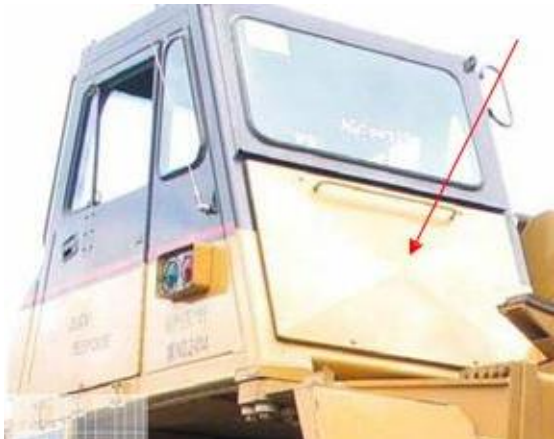
Description	Images
<p>Dump truck cabin. The red arrow shows the rear panel before it is removed.</p>

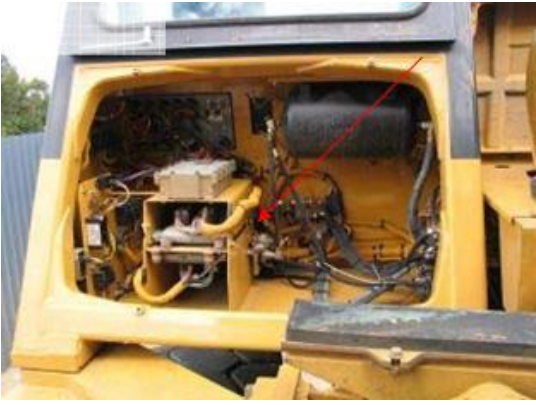
Description	Images
<p>This photo shows the rear panel removed. This area can contain the computer chips (red arrow) so cleaning can be difficult and it is best to clean with a damp rag. This area is usually well sealed, however biosecurity risk material has been found in these areas.</p>

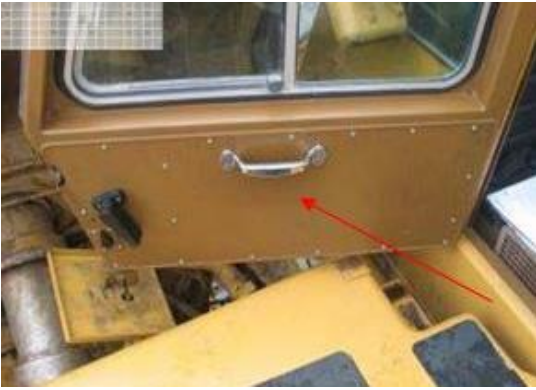
A photograph showing the rear panel of a yellow truck cab removed, revealing internal components. A red arrow points to a specific part, likely a computer chip, as mentioned in the text.
<p>Depending on the configuration, the internal door void (red arrow) may harbour biosecurity risk material.</p>

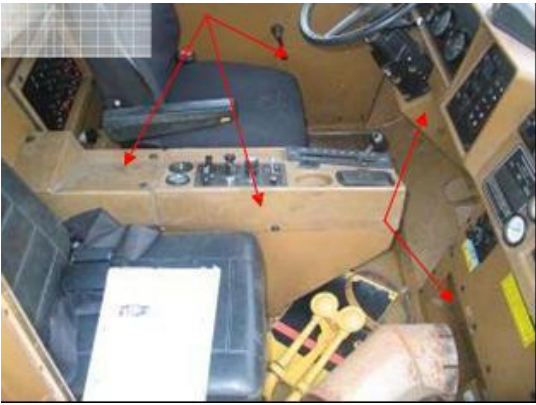
A photograph of the interior of a truck cab, focusing on the door area. A red arrow points to a gap or void between the door and the cabin structure.
<p>The internal of any cabin requires extensive cleaning and inspection. Biosecurity risk material has previously been found in some air-conditioning vents and therefore is an area of interest to the department (red arrows).</p>

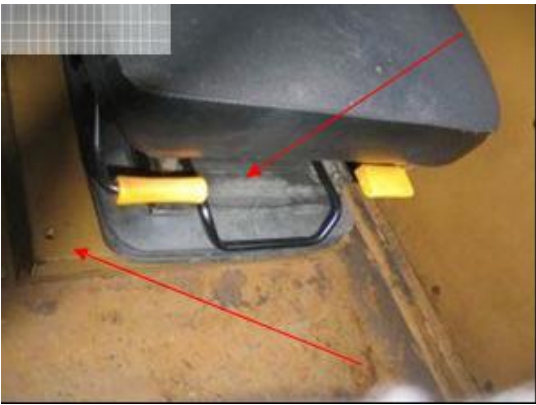
<p>All seats need to be removed to allow proper inspection of the underside of the seat and the rubber shroud. Below the seat, like in the illustration, there is a small hollow box section, which also needs to be inspected (red arrows). Without removing the seat, access may not be possible.</p>

A photograph showing the underside of a truck seat. Red arrows point to the underside of the seat and a small hollow box section below it.

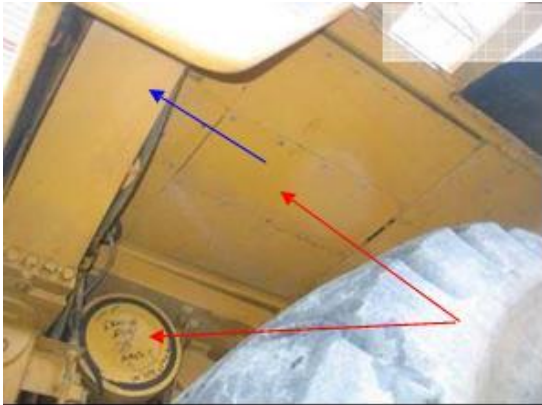
Description	Images
<p>A view of the bottom of the cabin floor as seen from underneath. All non-affixed panels need to be removed to enable thorough cleaning and inspection. Once these panels are removed, this allows rear access to the cabin air-conditioning and electrics as shown on page 3. All air-filters need to be removed and blown with air to verify cleanliness.</p>

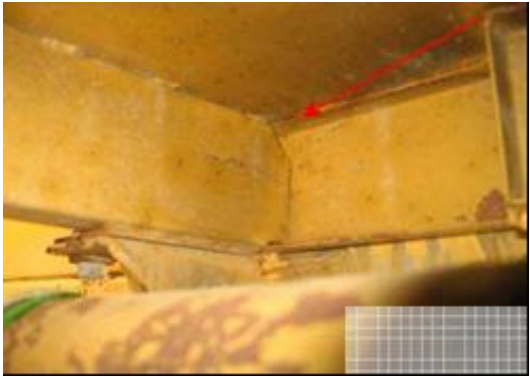
<p>Opposite view of box channel where engine cover hinges attach. Note the small triangular access point (red arrows), located at either end of this box section. This must be flushed in the presence of the inspecting officer.</p>

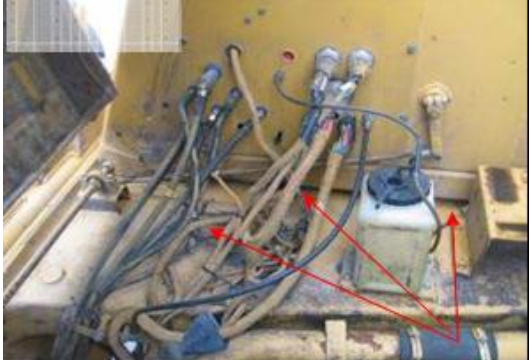
<p>The myriad of electrical cables exiting the side of the cabin wall to various parts of the machine. All need to be checked for cleanliness. The red arrow on the right shows the small gap under the cabin, which also requires flushing.</p>

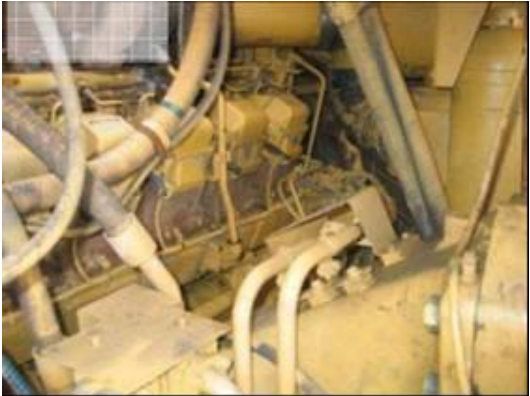
<p>Side view of the right hand side of the engine block. As well as checking all other areas, the gap between the tappet covers can harbour biosecurity risk material. Some flushing in this area is required.</p>

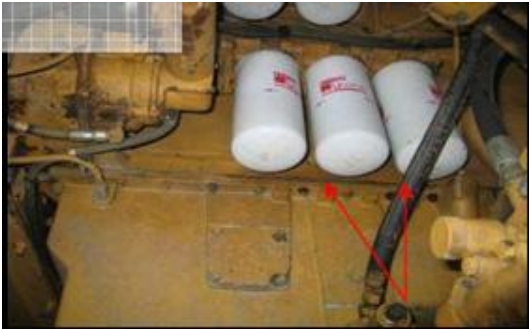
<p>Ensure that the back surfaces of components such as the oil filters are clean (red arrow).</p>

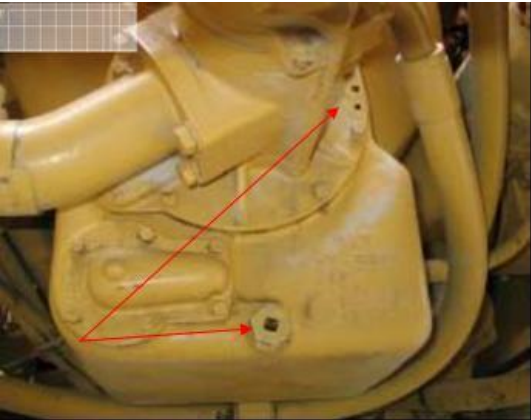
Description	Images
<p>Large areas like these are easy to clean and inspect, however the small countersunk holes (red arrows) are often overlooked.</p>

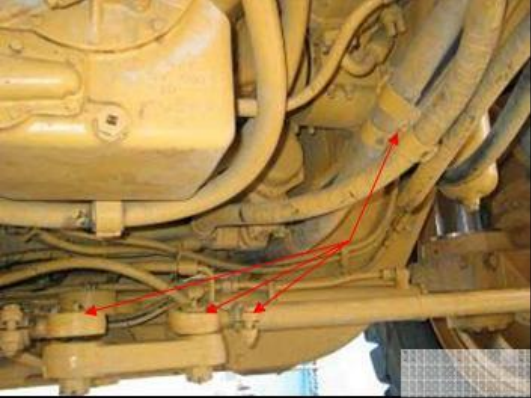
<p>Pivot points and a myriad of hydraulic hoses (red arrows) – all require thorough cleaning and inspection. In some instances, zip-ties may need to be removed to facilitate the cleaning process.</p>

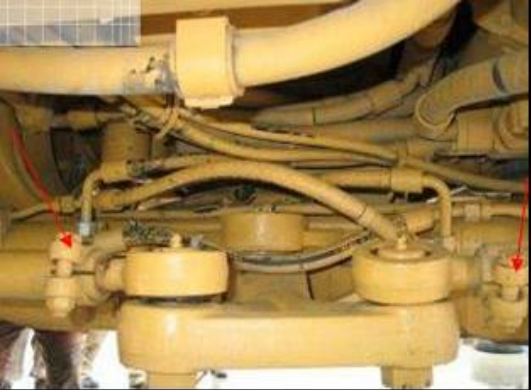
<p>The small openings at the end of the pivot points are often overlooked when cleaning (red arrows). The image to the right shows the area above belly plate (along front of wishbone) that requires thorough inspection.</p>

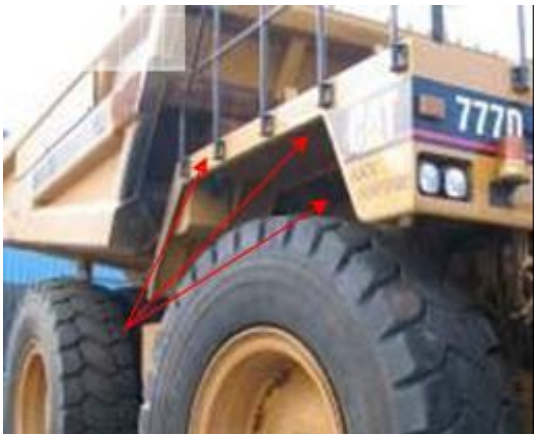
Description	Images
<p>The right hand wheel arch on most dump trucks is the most difficult to clean and inspect (red arrows). These wheel arches consist of box channels, most of which have small triangular openings at the ends. These openings are further demonstrated in this series of photographs. Check all open ended hand rail tubing (will require flushing) and circular tubing around the wheel arch for any drainage points (if present, they will also require flushing).</p>

<p>The photograph shows the right-hand side of a dump truck's wheel arch. Three red arrows point to specific areas: one points to a small triangular opening in the upper part of the arch, another points to a gap between the arch and the wheel well, and the third points to a circular opening near the bottom of the arch. The truck's body and a license plate with the number '7770' are visible in the background.</p>

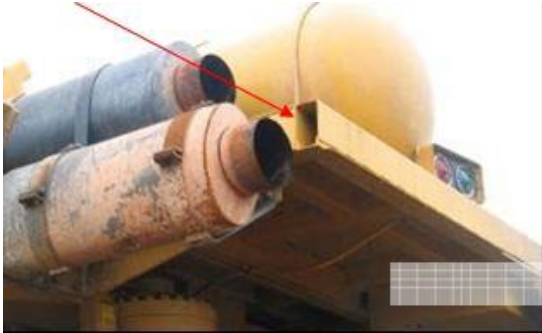
Description	Images
<p>The outside channelling is sometimes open ended (red arrows), as seen above. These areas require flushing to remove all biosecurity risk material.</p>

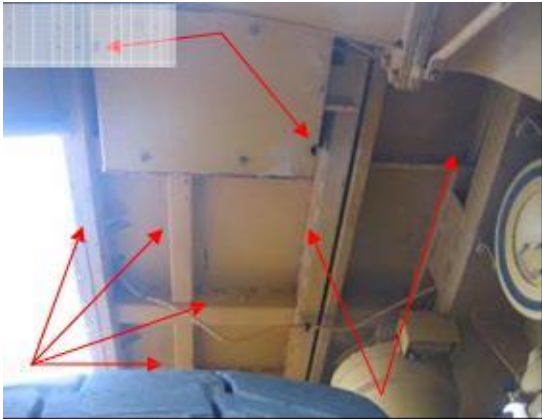
<p>View of the underside of the right hand wheel arch. All these highlighted channels (red arrows) are hollow and have small triangular openings on the ends. All require flushing with a 90-degree lance in the presence of the inspecting officer. If spot welded, they still require verification.</p>

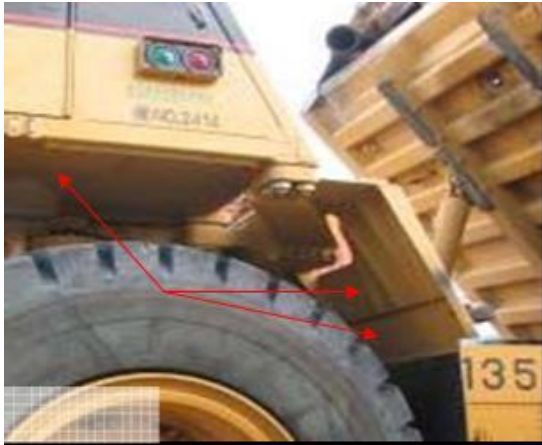
<p>The left hand wheel arch is not quite as complicated, but still requires that the panelling from under the cabin is removed. Check the ledges behind the tyre for biosecurity risk material (red arrows). On some Komatsu models, these ledges are covered but still have access and flushing points.</p>

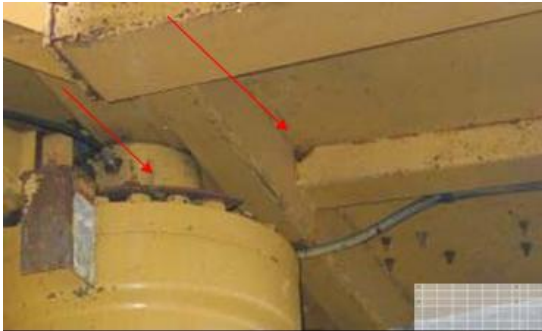
<p>Red arrows indicate the small triangular openings that are found at the ends of these box sections.</p>

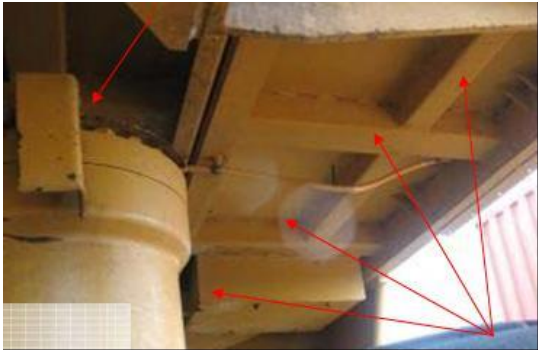
Description	Images
<p>More box sections from another view (red arrows). Remove all contaminated grease from the struts located on each side.</p>

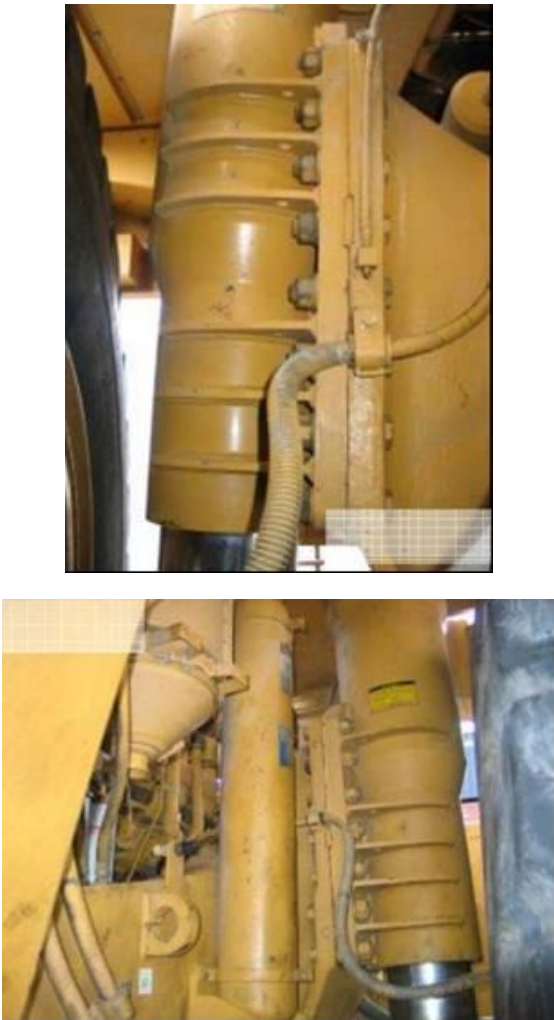
Description	Images
<p>Located just inside each front tyre and rim are two vertical struts. These struts attach to the wishbone, which on the CAT series of dump trucks is a hollow and accessible area that needs thorough flushing to ensure it is clean.</p>

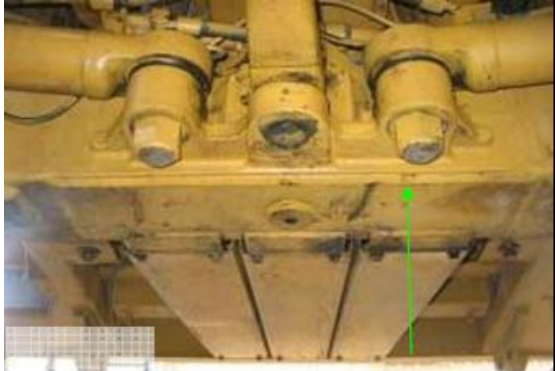
<p>Just right of centre at the rear of the wishbone is a small drainage hole (green arrow). Flushing via the two entrance holes located below either strut will result in water draining from this hole.</p> <p>N.B. It can literally take hours to flush this wishbone clean.</p>

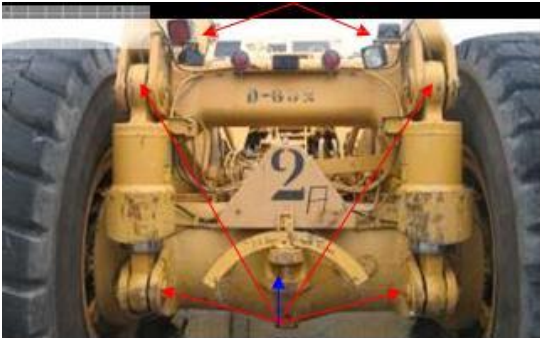
Description	Images
<p>The rear end of the dump truck with the tray removed. Ensure all pivot points have all contaminated grease removed, all light covers checked (red arrows - best to look inside) and the towing pin (blue arrow).</p>

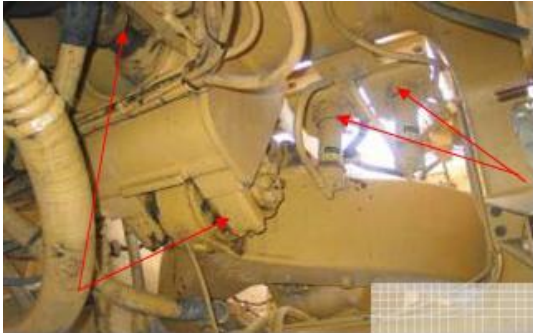
<p>The rear of the dump truck from the underside. This area consists of chassis framework, pivot points and a universal joint (red arrows). All require careful inspection and viewing from several angles.</p>

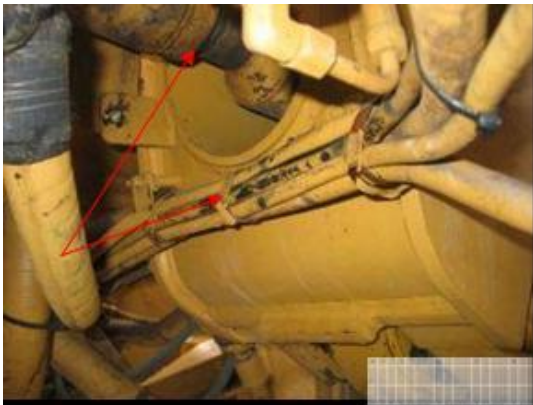
<p>A close up of the underside showing the universal joint and a conglomeration of hydraulic hoses. These hoses require to have the zip-ties or clamps removed to enable cleaning and inspection (red arrows).</p>

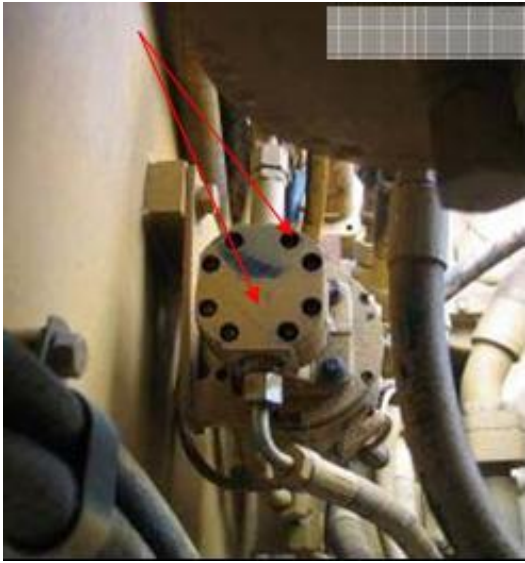
Description	Images
<p>There are numerous structures such as the one highlighted left (red arrows), all requiring inspection from various angles to ensure cleanliness.</p>

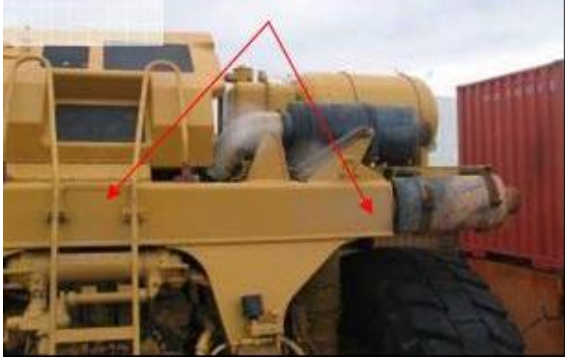
A close-up photograph of a complex mechanical assembly, likely part of a truck's engine or exhaust system. The assembly consists of various pipes, hoses, and metal components. Two red arrows point to specific circular openings or ports on a central component, indicating areas that require inspection for cleanliness.
<p>The red arrows indicate the exhaust pipe housing. On some models a drainage hole can be found either halfway along, or at the end. This housing requires flushing to verify cleanliness. On this model, the area is fully sealed.</p>

An exterior photograph of a yellow truck's exhaust system. The exhaust pipe is visible, extending from the engine area towards the rear. Two red arrows point to the housing of the exhaust pipe, indicating the area that requires inspection for cleanliness. The truck is parked next to a red shipping container.

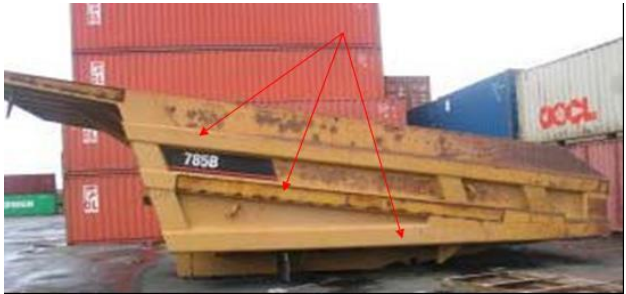
Description	Images
<p>Dump truck trays such as the one illustrated above can be one of the major areas that harbour biosecurity risk material and none may be visible. These trays possess an internal lining or 'skin', which hides a hollow area, capable of harbouring biosecurity risk material. The gussets or ribs along the sides and across the bottom also have the potential to harbour significant amounts of biosecurity risk material (red arrows). Dump trays are prone to damage simply due to the size and weight of the cargo that they carry. If there is any evidence of hairline cracks, splits, new welding or evidence of repair, then all these areas need to be investigated. Trays with suspected biosecurity risk material inside cannot be released until completely verified.</p>

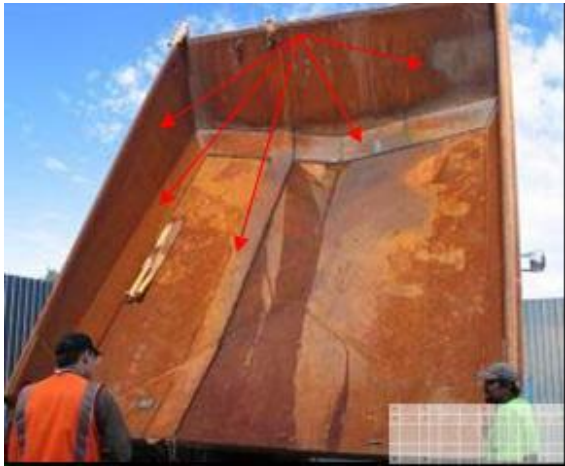
<p>This tray comprises of two segments that are bolted together. Once apart, the ribs along the underside are open and exposed to biosecurity risk material (red arrows).</p>

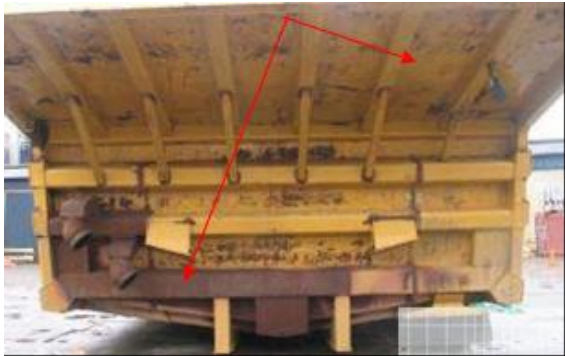
<p>This tray shows evidence of repair and therefore requires investigation of the gussets and ribs (red arrows).</p>

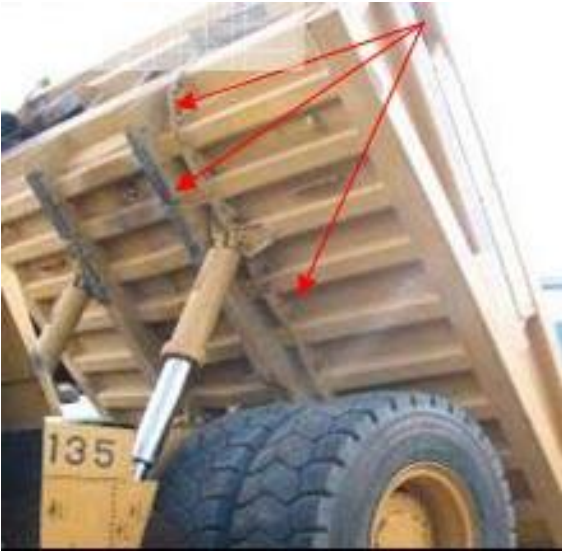
Description	Images
<p>Red arrows indicate where the tray has been bolted together. The black rubber pads on the underside of the tray require thorough flushing to ensure cleanliness.</p>

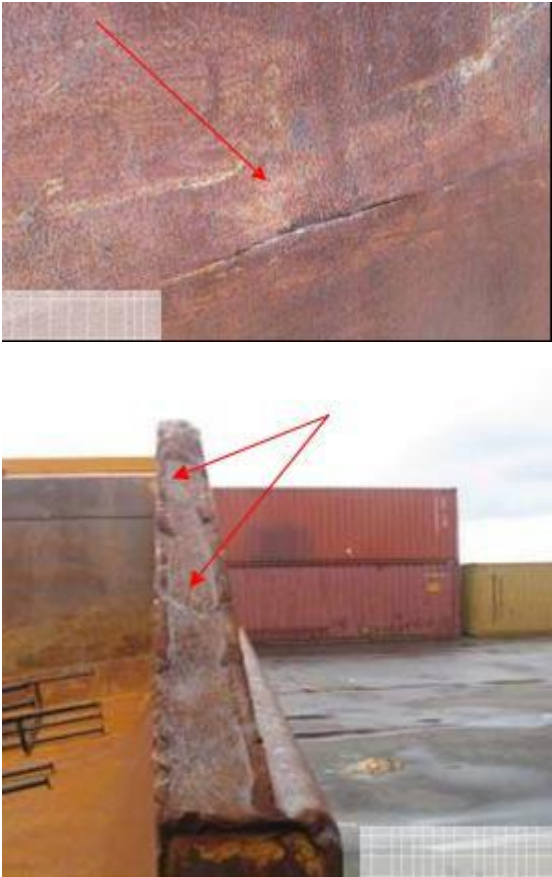
Description	Images
<p>Crack in the 'skin' and damage along the top of the side (red arrows).</p>

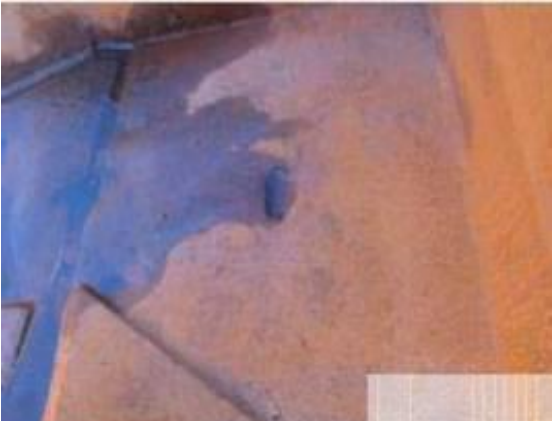
<p>An example of a crack in the tray of a dump truck. If areas like this are found, then they need to be investigated.</p>

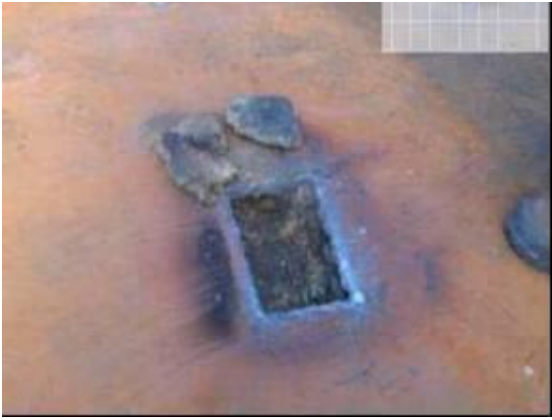
Description	Images
<p>Once this crack was investigated, it revealed biosecurity risk material between the two 'skins'. The department does not direct any cutting, however if any cracks, splits or evidence of repair is evident, then that machine cannot be released until these areas are verified clean. It is the responsibility of the importer to demonstrate that these areas are free of all biosecurity risk material.</p>

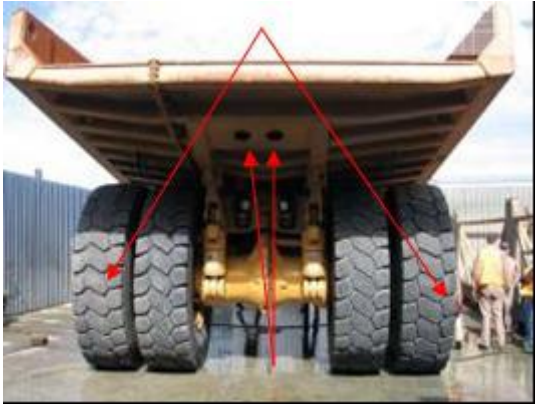
Description	Images
<p>Rear end of a dump truck. The outside dual wheels must be removed to allow a complete inspection. Please ensure that any exhaust channels are free of biosecurity risk material (red arrows).</p>

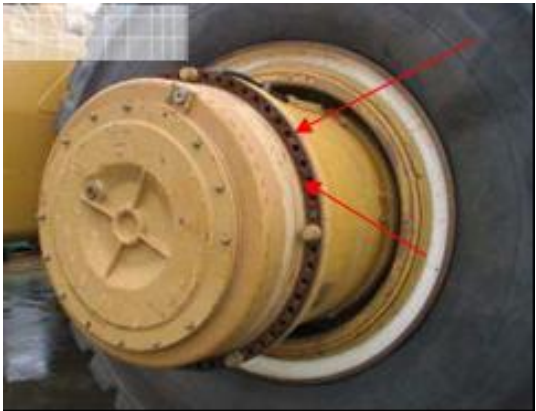
<p>The outside dual wheel removed. On the topside of the rim is a protective plate, which cannot be accessed if the dual wheel is not removed (red arrows). See below.</p>

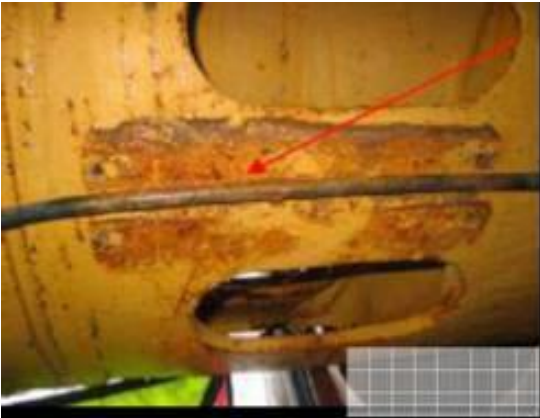
Description	Images
The protective cover on the rim has been removed, revealing biosecurity risk material (red arrow).

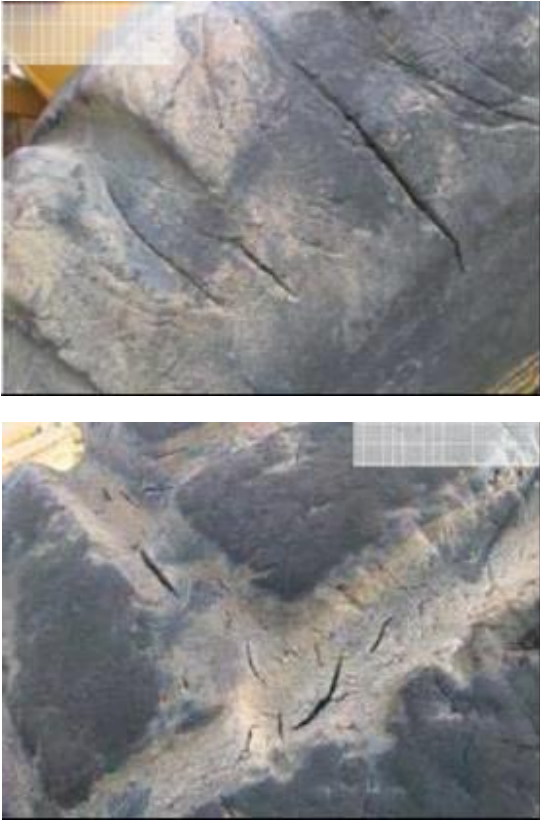
Examples of cracks in tyres that all need to be verified clean.

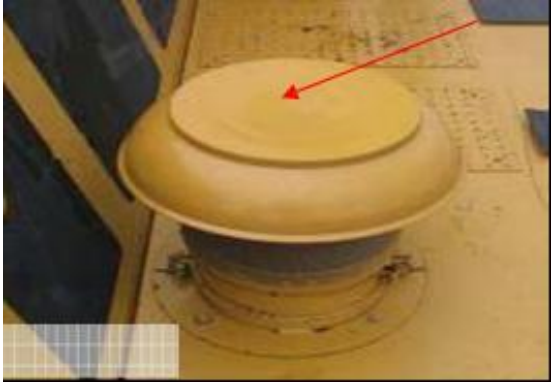
Description	Images
<p>The air-filter pre-cleaner (red arrow). Ensure this housing is removed to enable inspection.</p>

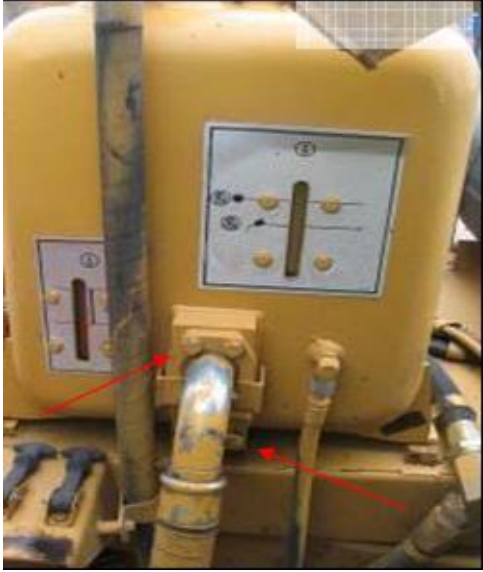
<p>The oil tank situated above the engine is easy to access, however the underside is difficult to inspect and may require the use of a mirror. The coupling also requires inspection (red arrows).</p>

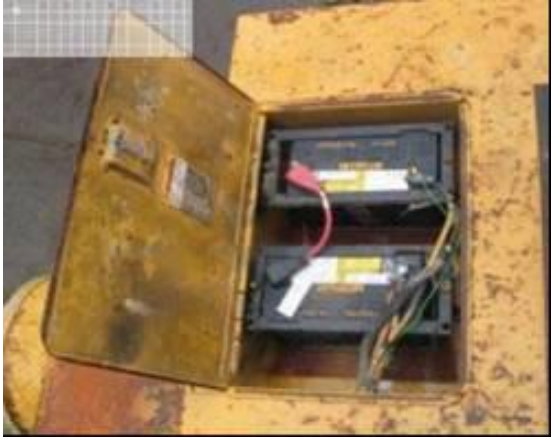
<p>To enable a thorough inspection of the battery box, ensure that the batteries can be lifted and flushed underneath.</p>

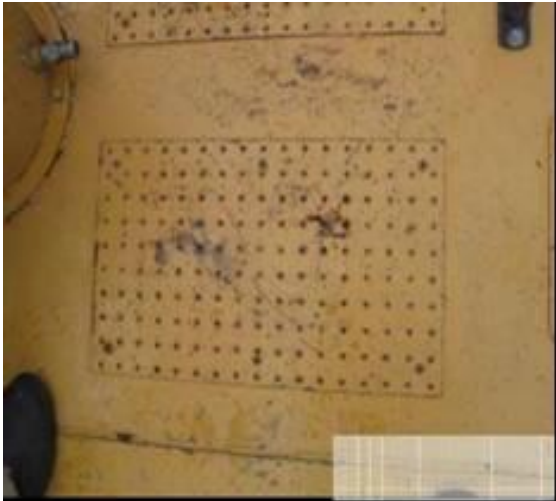
Description	Images
<p>All non-slip checker plate needs to be verified by flushing with high pressure water (some importers have chosen to completely remove).</p>

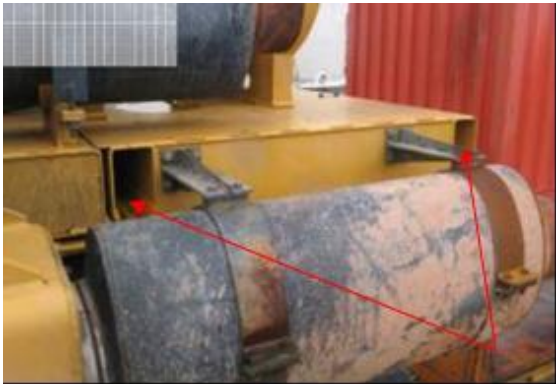
<p>The right hand wheel arch from behind. On some models the box channels are open ended such as the ones illustrated above (red arrows). These require flushing in the presence of the inspecting officer to verify cleanliness.</p>
