Australian Government
Department of Agriculture
and Water Resources

Machinery Cleaning Guide – Excavators

April 2016

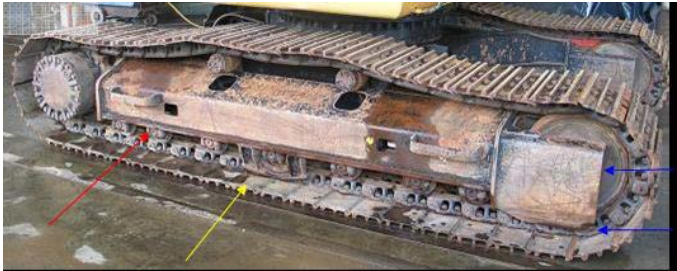
Description	Images
<p>All non-affixed panels, rock guards and motor covers must be dismantled. The yellow arrow indicates a small rock guard, which may not require dismantling. The red arrow indicates the rollers and the blue arrows the hollow channels on the idler wheel frame.</p>

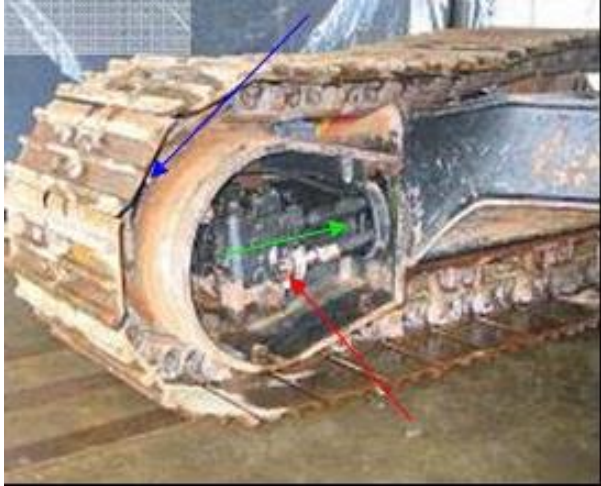
<p>Red arrow indicates that the motor cover has been removed, allowing access to the drive motor. The green arrow indicates the hollow channel, which extends up through the frame into the turret or slew ring. These hollow areas on each side need to be thoroughly flushed to ensure cleanliness. The blue arrow indicates the area at the rear of the motor cover, which can be easily overlooked.</p>

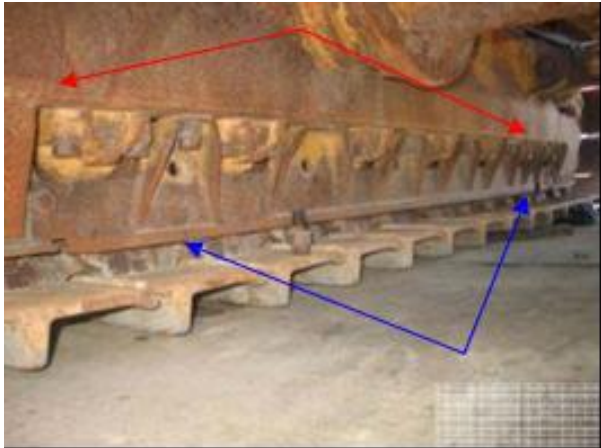
<p>Illustration of rock guards (red arrows) on a track frame. The frame to which these rock guards is attached (blue arrows), is hollow and must be verified clean. To verify this hollow area and around each roller, the rock guards must be dismantled.</p>

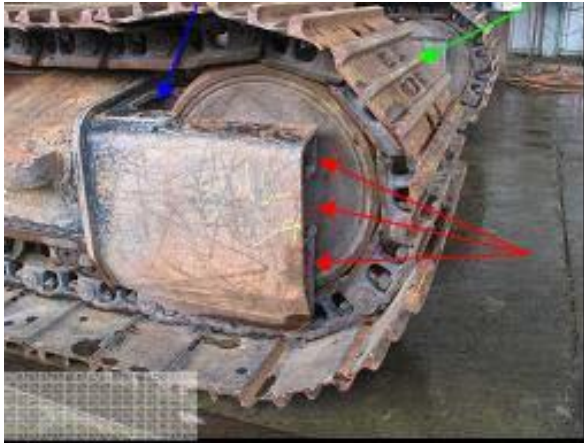
Description	Images
<p>This picture indicates the hollow sections that can be found supporting the idler wheel (red and blue arrows). All these hollow areas require thorough flushing to remove all contaminants. These hollow sections can also be found on the inside of the idler wheel (green arrow).</p>

A close-up photograph of an idler wheel assembly on a tracked vehicle. The image shows a large, cylindrical metal wheel with a central hub and several support arms. Red arrows point to hollow sections between the support arms and the wheel. Blue arrows point to the inner surface of the wheel. A green arrow points to a hollow section on the inside of the wheel.
<p>This picture indicates the outside of the drive motor. The red arrows highlights the rear of the motor cover and the blue arrows highlight each track nut.</p>

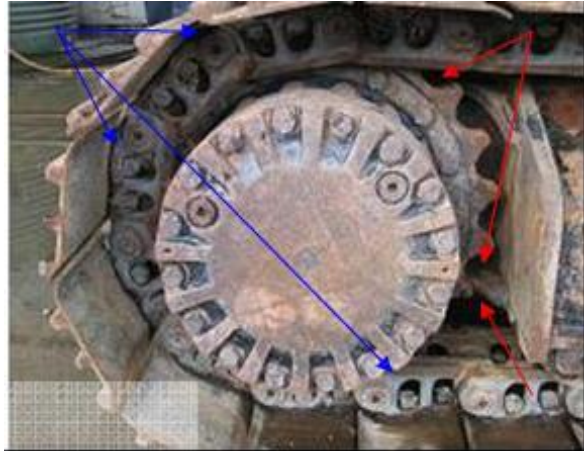
A close-up photograph of a drive motor on a tracked vehicle. The image shows a large, circular metal motor with a central hub and several track nuts. Red arrows point to the rear of the motor cover. Blue arrows point to each track nut.

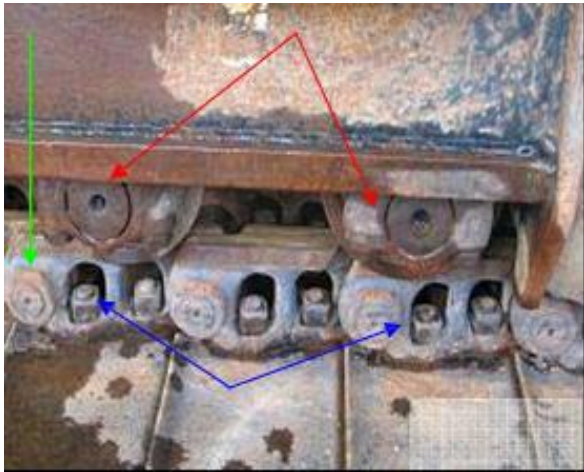
<p>The blue arrows highlights the small gaps either side of each nut where biosecurity risk material (BRM) is commonly found. The red and green arrows highlight small hollow areas where BRM can become compacted.</p>

A close-up photograph of track nuts on a tracked vehicle. The image shows several track nuts arranged in a row. Blue arrows point to the small gaps between the nuts. Red and green arrows point to small hollow areas where biosecurity risk material (BRM) can become compacted.

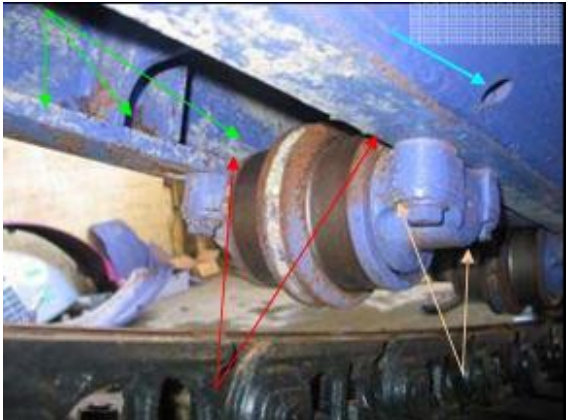
Description	Images
<p>This picture highlights the roller inside the track frame. Note the horizontal ledge inside the frame highlighted by the green arrows. The red arrows highlight the small gap either side of the roller while the aqua arrow shows a drainage hole, sometimes found on the turret of some excavators. The orange arrows highlight the area behind each nut.</p>

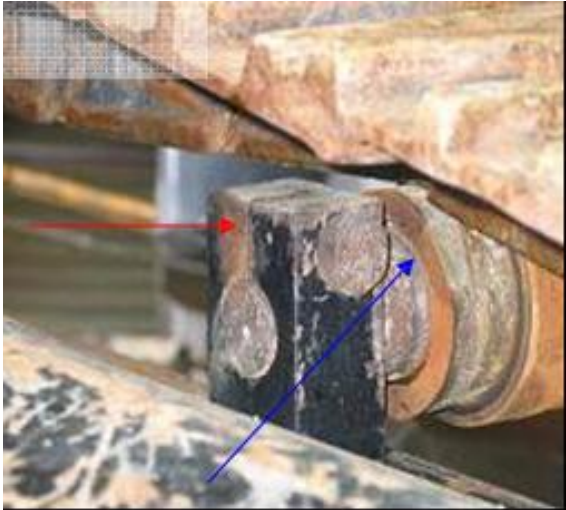
<p>Indicates the top roller above the track frame. The red arrow highlights the small gap at the rear, which must be flushed while the blue highlights the small gap at the rear of the roller.</p>

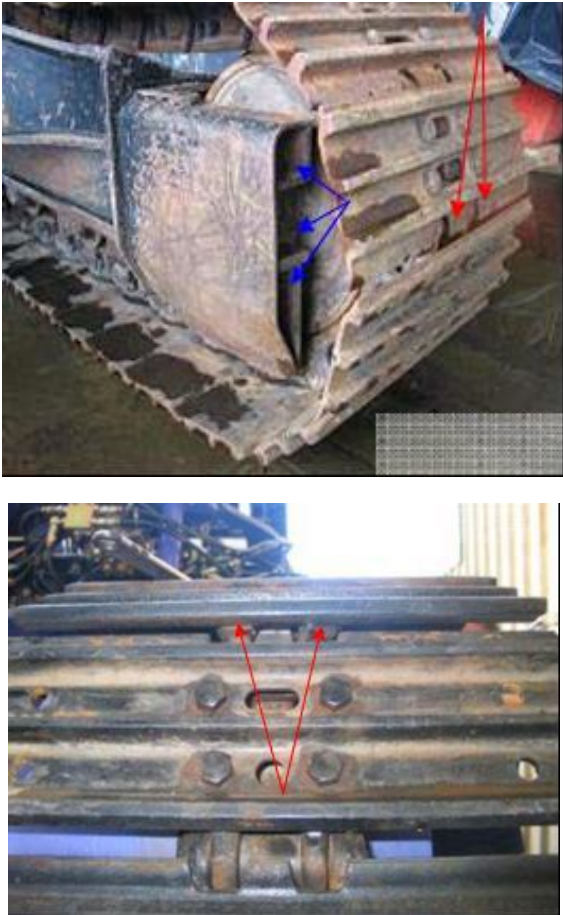
Description	Images
<p>Blue arrows again show the hollow framework that requires thorough cleaning and the red highlights where the track pads connect to the chain. All tracked machines undergo one full revolution to ensure cleanliness. The picture highlights the track pads opening slightly, this area is to be cleaned.</p>

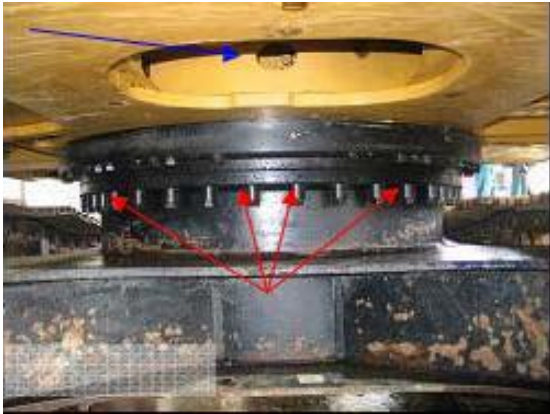
Description	Images
<p>A closer view of each nut/bolt that attaches the body to the turret (red arrows). The blue arrow highlights just one of the plates which has been removed, allowing access to the underside of the engine.</p>

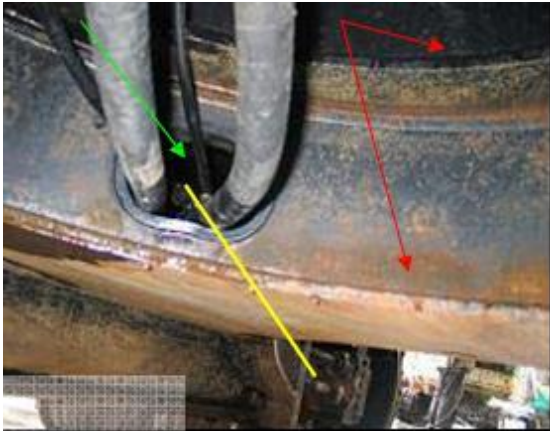
<p>The red arrows highlight the various ledges that can be found inside the turret/slew ring, each ledge requires thorough cleaning. The green arrow points to the hollow channel where the hydraulic hoses run down through the turret housing to the drive motors (yellow line demonstrates the path of the hydraulic hoses). This area must be flushed in the presence of the inspecting officer to verify cleanliness.</p>

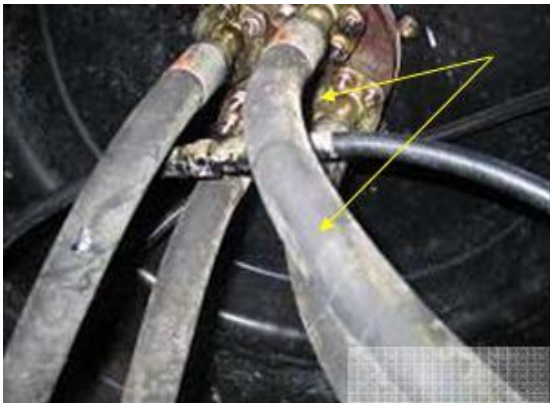
<p>The hydraulic hoses inside the turret/slew ring (yellow arrows). Each hose must be individually cleaned.</p>

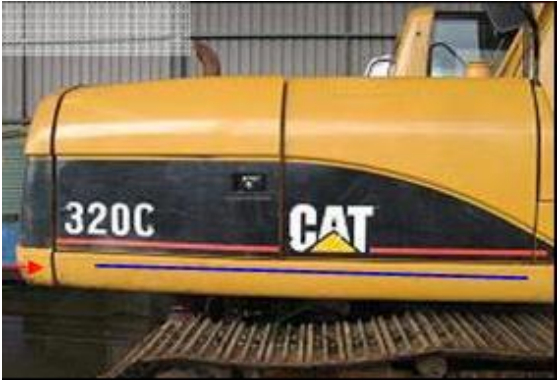
Description	Images
<p>The right hand side of the engine bay. On some models the horizontal blue line highlighted in this picture indicates a hollow channel while the red arrow on the left indicates the entrance to this area. On other models this area is completely sealed. If this channel is open ended, it will require flushing in the presence of the inspecting officer.</p>

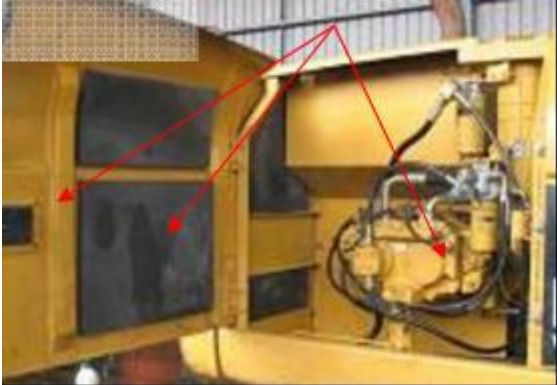
<p>Check all engine doors for hollow support channels. Check for drainage holes or if only spot-welded – will require flushing if not completely sealed. Check all foam insulation and hydraulic hoses (red arrows).</p>

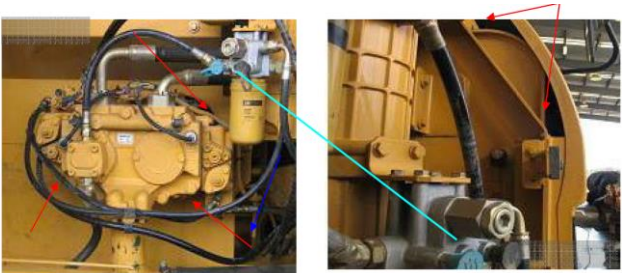
<p>Check all surfaces and hydraulic hoses for cleanliness as indicated by the red arrows. The blue arrow indicates an accumulation of hydraulic hoses, bound together by zip-ties. These hydraulic hoses need to be separated to allow cleaning and inspection.</p>

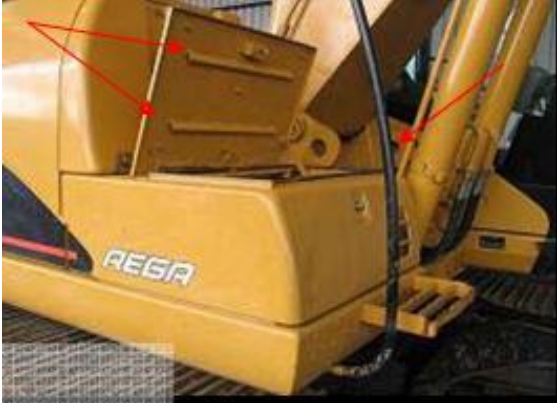
<p>The battery box located just in front of the fuel cell on the RH side of the excavator. Ensure the hollow, open-ended sections in the battery-box cover are flushed. Check handrail for openings at either end – flush if open-ended (red arrow).</p>

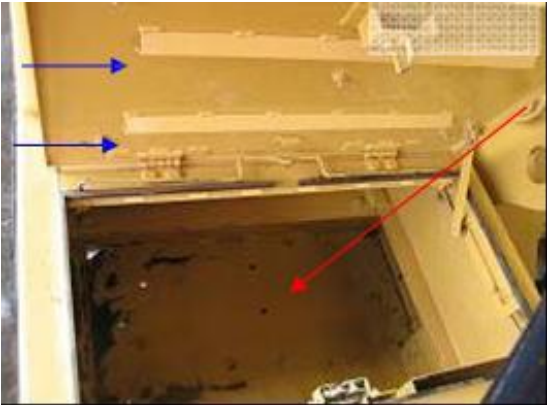
Description	Images
<p>The batteries have been removed (red arrows) allowing for easy cleaning and inspection. The blue arrows again highlight the open-ended channels on the inside of the battery box cover.</p>

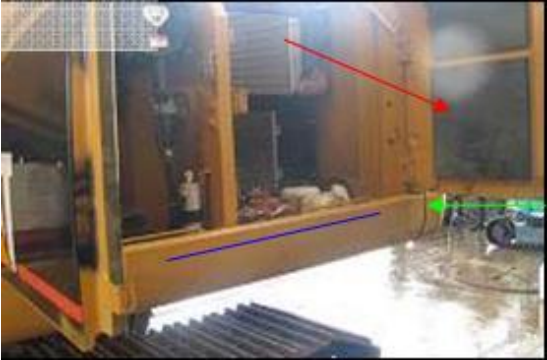
<p>A view of the LH side of the engine bay. Check all insulation foam (red arrow). The blue line again indicates that this section may be a hollow channel while the green arrow highlights the opening to this hollow section. This hollow section is not applicable on all models.</p>

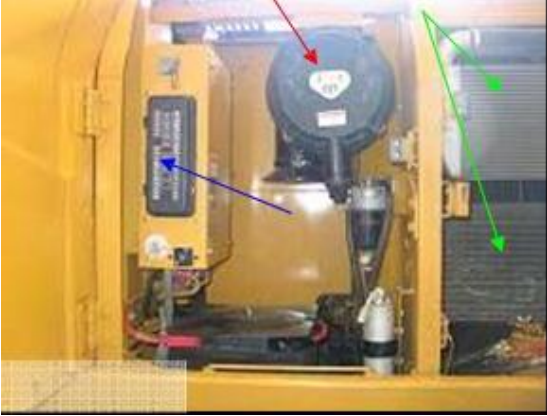
<p>The red arrow highlights the air-filter, which needs to be removed and checked for cleanliness. An air hose is the best way to verify cleanliness. The blue arrow highlights the fuse-box. This area is generally well sealed, however an internal cleanliness check is required. The green arrows highlight the oil coolers. Each must be flushed to ensure cleanliness.</p>

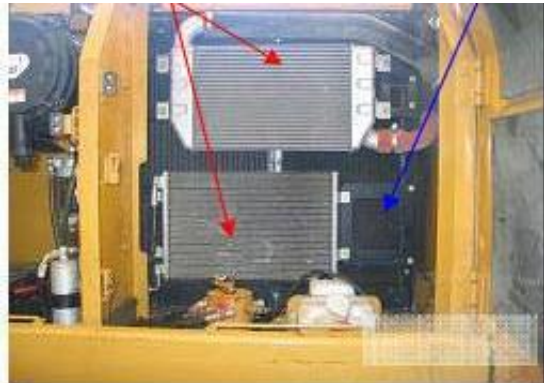
<p>Another view of the oil-coolers (red arrow) and radiator core (blue arrow). All require flushing to verify cleanliness. To allow access to the radiator at the rear, the oil cooling fins may have to be dismantled to allow thorough flushing.</p>

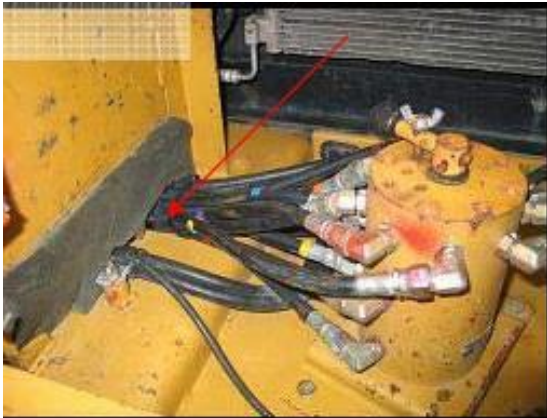
<p>An accumulation of hydraulic hoses bound together with zip-ties (red arrow).</p>

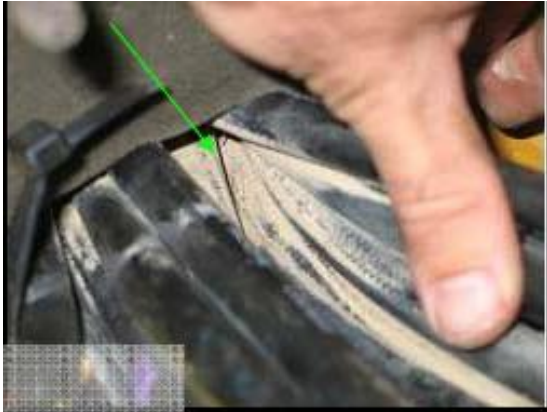
<p>The zip-tie removed, allowing the hoses to be moved and highlighting BRM between the hoses (green arrow).</p>

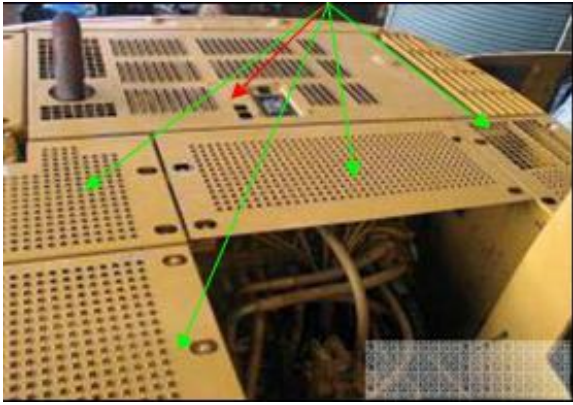
Description	Images
<p>The topside of the engine bay. The red arrow highlights the engine cover that opens, allowing access to the topside of the block. The green arrows highlight the remaining engine covers that are non-affixed and can be dismantled to allow for cleaning and inspection.</p>

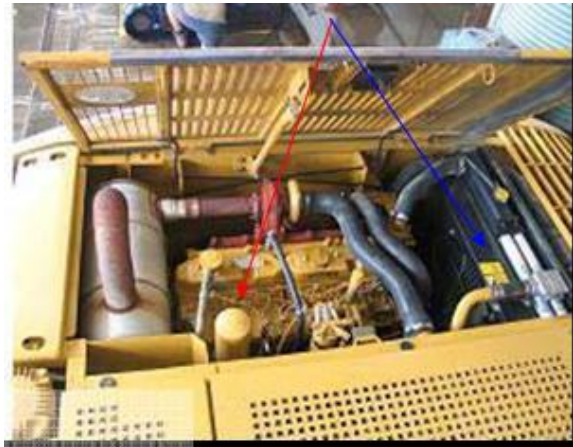
<p>The engine cover open, allowing access to the topside of the engine block (red arrow) and radiator (blue arrow).</p>

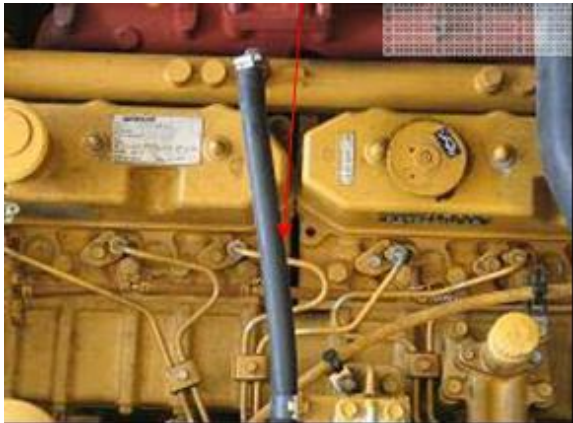
<p>The red arrow highlights a small gap between each tappet cover, which requires thorough cleaning and inspection. Flushing may also be required.</p>

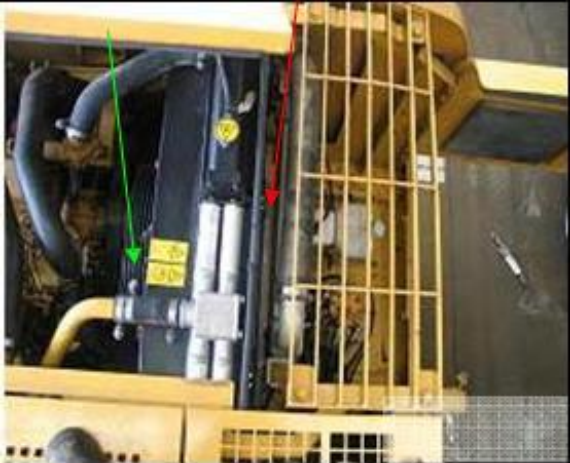
Description	Images
<p>The green arrow highlights the radiator shroud wire grill. This needs to be dismantled to allow access to the inside of the shroud and remove all BRM. The red arrow highlights the small gap between the radiator core and the oil-cooler cores. Check the cores by thorough flushing.</p>

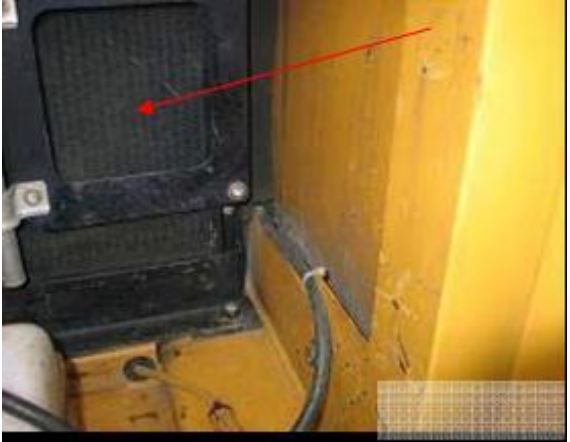
<p>On some models, a mesh grill protects the radiator core. These mesh grills (red arrow) need to be removed as the gauge is small and prevents BRM caught in the radiator fins from being successfully removed.</p>

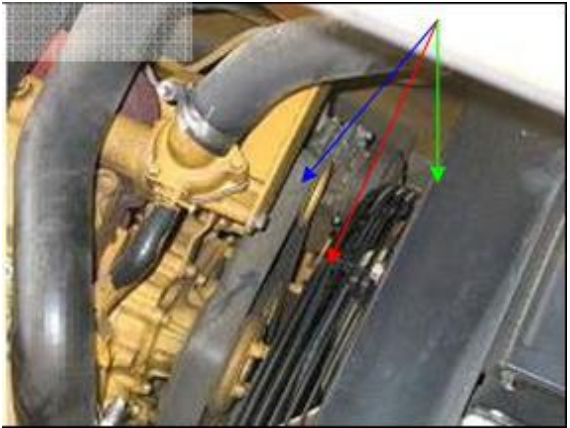
<p>Check the sides of the block, including the harmonic balancers (blue arrow) as BRM can become caught in front of these open ended flywheels. The red arrow indicates the radiator grill, which if still present, prevents access to the bottom of the radiator shroud (green arrow).</p>

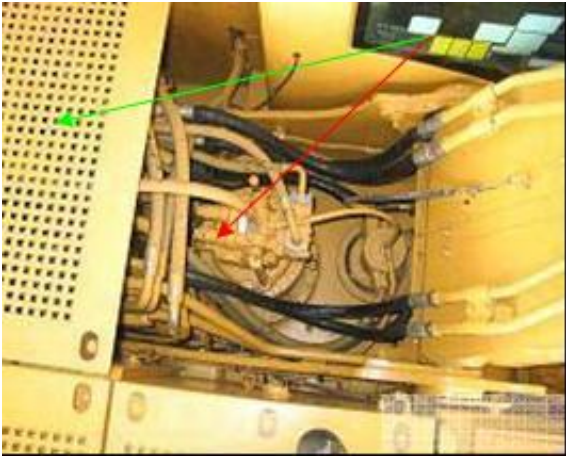
Description	Images
<p>The accumulation of hydraulic hoses (red arrow) situated just behind the boom stick. Sometimes this area may be covered by a non-affixed panel, which will need to be dismantled to allow access. Other non-affixed panels (green arrow) can also be dismantled to facilitate the cleaning and inspection process.</p>

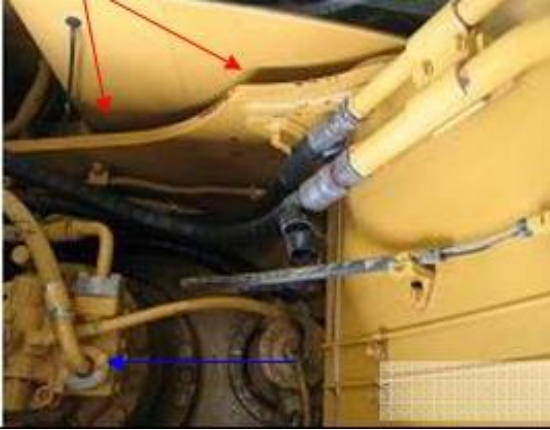
<p>Ensure that the small gap between the cabin wall and the base of the boom stick (red arrows) is cleaned and inspected. BRM can often accumulate inside the small gaps where the hydraulic hoses connect, indicated here by the blue arrow.</p>

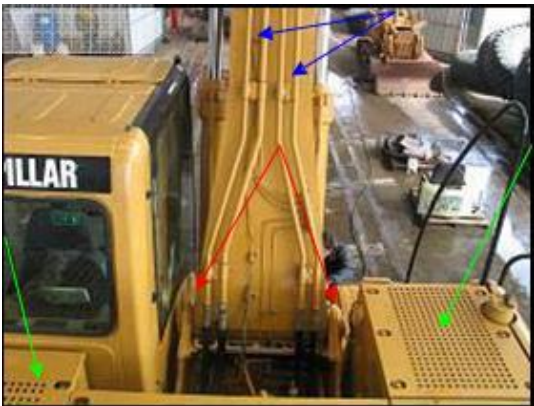
Description	Images
<p>The base of the boom stick and checker-plate above the engine. Ensure all contaminated grease is removed from the pivot-points (red arrows). Flush under all the check-plates as indicated by the green arrows. Check all hydraulic lines and mounting points (blue arrows). The boom can be extended and lowered to address work health and safety concerns (otherwise use scaffolding or cherry picker).</p>

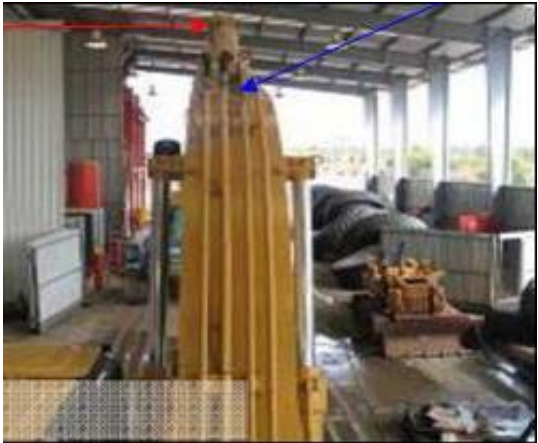
Description	Images
<p>Check along the length of the boom, ensuring all BRM including contaminated grease is removed (red arrow). All hydraulic lines need to be cleaned and inspected (blue arrow).</p>

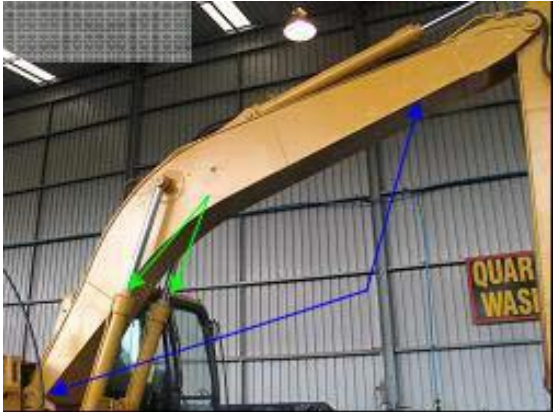
<p>Check along all surfaces, hydraulic rams (green arrows) and for the presence of any drainage holes or openings in the boom stick (blue lines).</p>

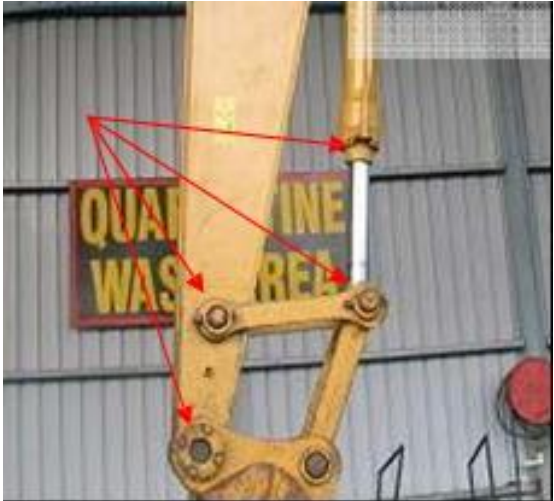
<p>Ensure all rams and pivot points are clean and free of contaminated grease (red arrows).</p>

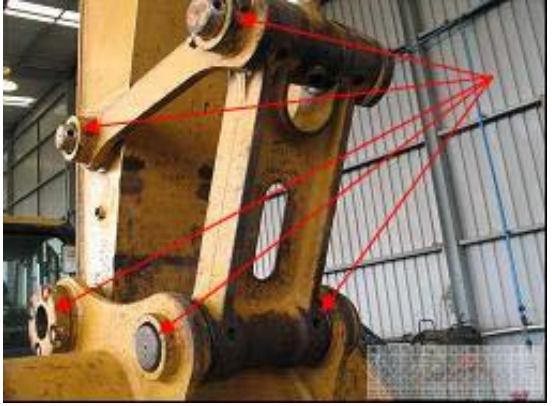
<p>Check all pivot points above the bucket and ensure all contaminated grease is removed (red arrows).</p>

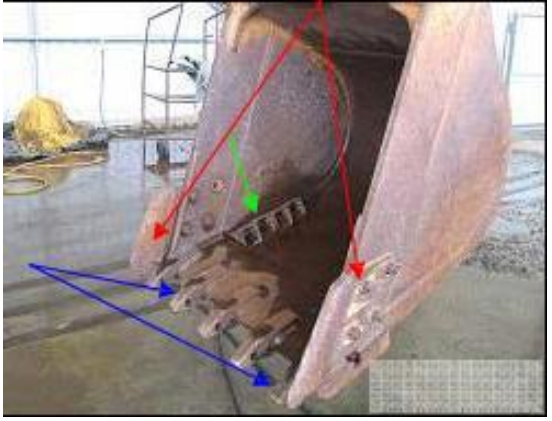
<p>The wear plates (red arrows) either side of the bucket must be either dismantled or at the very least loosened off and flushed behind. All cutting teeth (blue arrows) must be removed and the teeth can be seen here in the bucket (green arrow).</p>

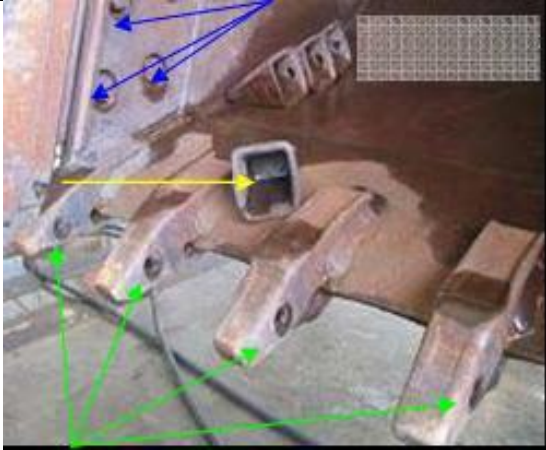
<p>The cutting teeth have been removed, exposing the hole through the centre (green arrows), which cannot be verified while the teeth are still in place. Ensure the countersunk holes (blue arrows) where the wear plates attach are free of all BRM. The yellow arrow shows the inside of the cutting teeth – quick and easy to verify if presented in this manner.</p>

<p>A close-up photograph of the cutting teeth of an excavator bucket. Several blue arrows point to a narrow opening between the teeth. A yellow arrow points to a small rectangular component. Green arrows point to the circular pinholes on the teeth.</p>
<p>A close up of the boots and where the cutting teeth are mounted. Ensure around each pinhole is clean (green arrows). The blue arrows highlight a narrow opening that tends to become compacted with BRM and can be overlooked if the cutting teeth are still attached.</p>

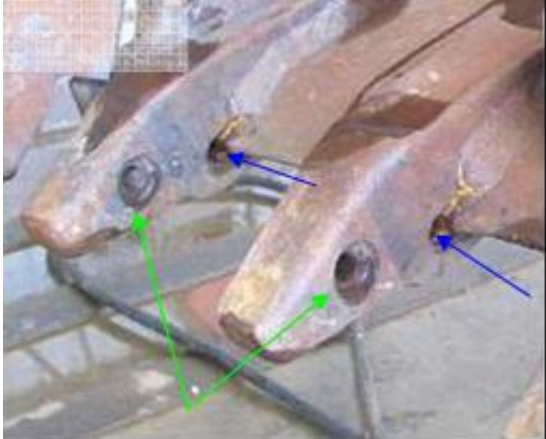
<p>A close-up photograph of the excavator boots. Blue arrows point to a narrow opening between the boots. Green arrows point to the circular pinholes on the boots.</p>
<p>Evidence of a crack/split (blue arrow) in the wear plate on the underside of the bucket. Side wear plates (yellow arrow) need to be either removed or loosened and flushed. Cutting teeth (aqua arrows) must be removed at the time of inspection.</p>

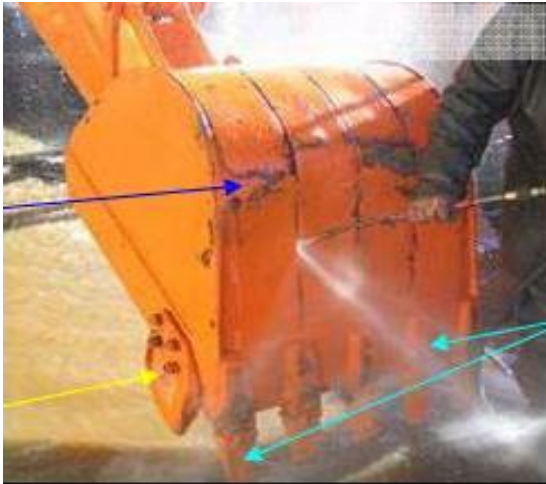
<p>A photograph of an excavator bucket being inspected. A blue arrow points to a crack in the wear plate. A yellow arrow points to a side wear plate. Aqua arrows point to the cutting teeth. A person's leg is visible on the right side of the bucket.</p>

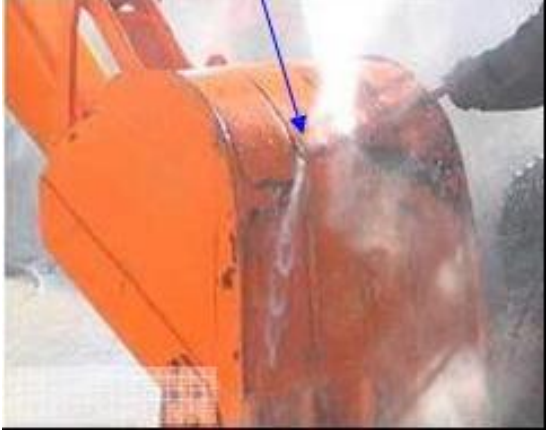
Description	Images
<p>If wear plates are only spot-welded as seen in the examples above, ensure that these are verified. For example; by witnessing high-pressure water being flushed through (blue arrow).</p>

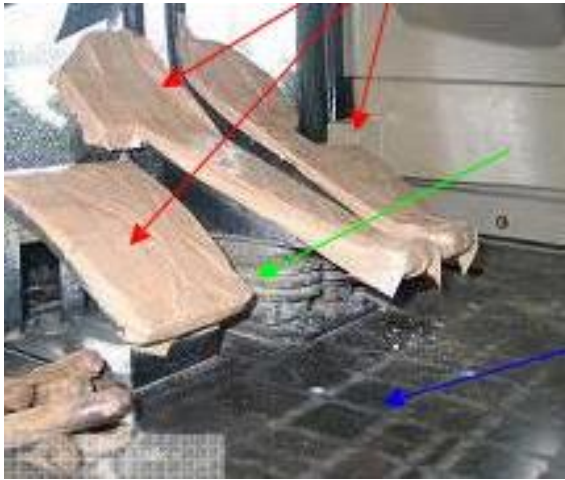
A photograph of the interior of an excavator cab. The view is from the driver's perspective. There are several air vents on the dashboard and side panels. A blue arrow points to a storage compartment on the right side of the dashboard. Two red arrows point to air vents on the dashboard and the right side panel.
<p>If rubber or plastic foot pedal covers (red arrows) are in place, remove and clean. Rubber shrouds below pedals (green arrow) must also be verified clean inside. Under the floor mat must be clean (blue arrow).</p>

A close-up photograph of the foot pedals in an excavator cab. There are two pedals with rubber or plastic covers. Red arrows point to the covers. A green arrow points to the rubber shroud below the pedals. A blue arrow points to the floor mat area under the pedals.

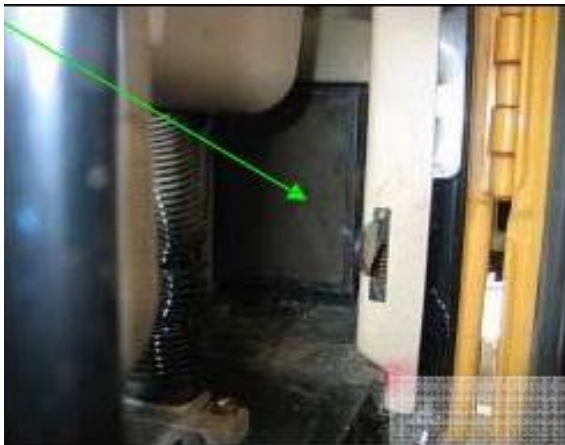
<p>Located behind the seat in some models is the air-conditioning filter (green arrow). The filter must be removed, the filter and surrounding area cleaned and verified.</p>

A photograph showing the air-conditioning filter located behind the seat in an excavator cab. A green arrow points to the filter, which is a cylindrical, pleated component.

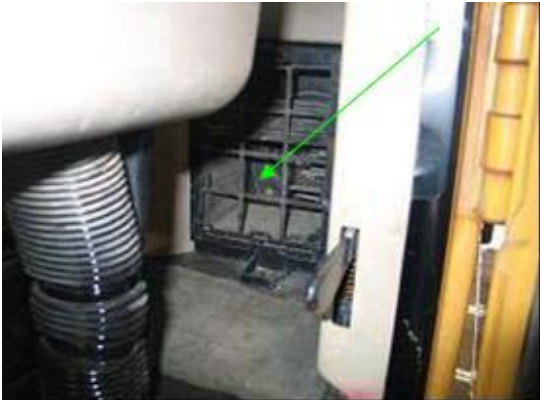
Description	Images
<p>The filter has been removed (green arrow), revealing BRM inside which must be removed.</p>

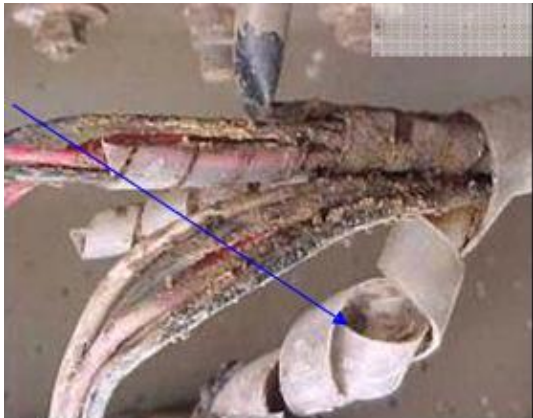
Description	Images
<p>Ensure that all looming (blue arrow) around hydraulic hoses and lines is free of all BRM. Flushing these areas with the looming still in place rarely removes all BRM as can be seen in this illustration.</p>

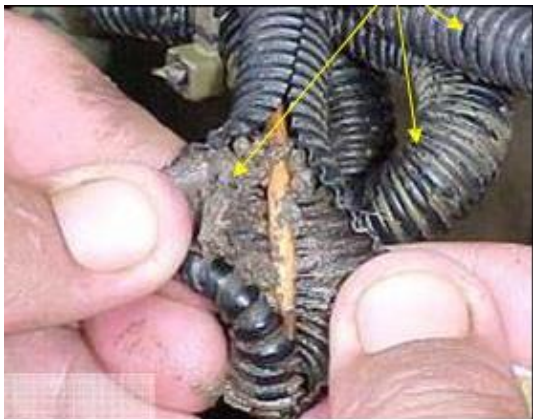
<p>All wiring harnesses (yellow arrows) must be thoroughly inspected for internal BRM as seen in this image.</p>

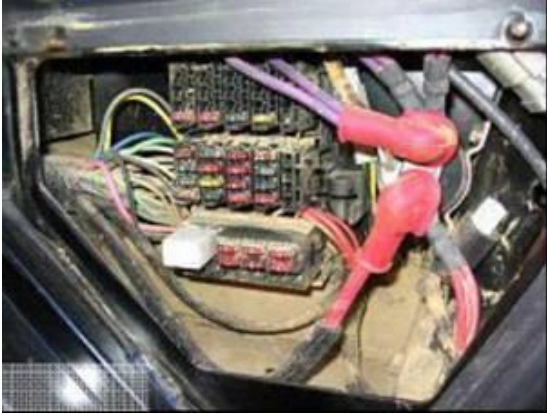
Description	Images
BRM inside the fuse box must be removed.

A photograph showing the interior of a fuse box. The box is open, revealing a complex arrangement of electrical components. In the center, there is a fuse block with several fuses. To the right, there are two prominent red components, possibly relays or solenoids, connected to thick red wires. Various other colored wires (yellow, green, blue, purple) are visible, some bundled together. The interior of the box is somewhat cluttered and appears to be part of a larger mechanical assembly.
