Australian Government
Department of Agriculture
and Water Resources

Machinery Cleaning Guide - Hitachi DX-40

Biosecurity

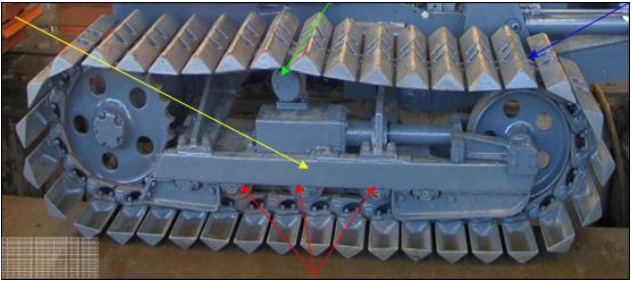
Description	Images
<p>The track frame and swamp tracks as seen on many small dozers. This track frame can be accessed for cleaning and inspection from both the topside and bottom. Each individual roller (red arrows), carrier roller (green arrow) and swamp tracks (blue arrow) must be thoroughly cleaned and inspected. The yellow arrow highlights the hollow track channel that must be flushed in the presence of the inspecting officer to verify internal cleanliness.</p>

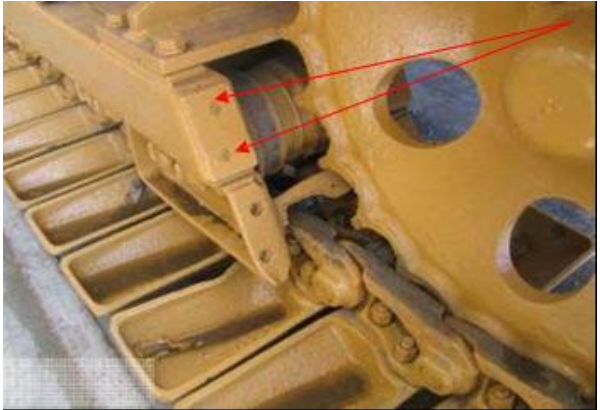
<p>The hollow track frame highlighted previously, may have drainage holes (red arrows) at the end or along the bottom – see next illustration. Pieces of cork have been placed in these holes, however they still require flushing.</p>

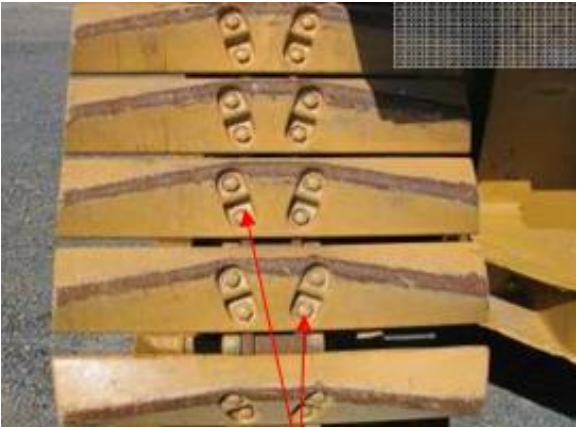
<p>Another way to access the hollow track frame is via the bolt holes (blue arrow) after the rock guards have been removed. Small recesses (green arrow) also require inspection. Flush around the perimeter of the roller (yellow arrow) to verify cleanliness.</p>

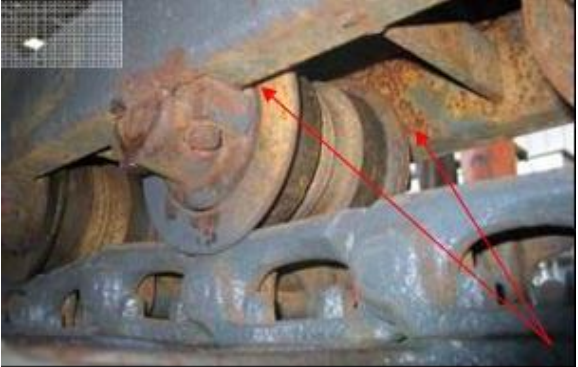
Description	Images
<p>Around the bolt heads (red arrows) of each track pad must be thoroughly cleaned and inspected. The tracks must undergo one full revolution at the time of inspection to verify all track pads are free of biosecurity risk material (BRM).</p>

A close-up photograph of several yellow track pads stacked vertically. Two red arrows point to the bolt heads on the pads, indicating the areas that need to be cleaned and inspected for biosecurity risk material.
<p>All internal surfaces of the track frame must be cleaned and inspected. The small gap between the roller and the frame (red arrows) requires thorough attention.</p>

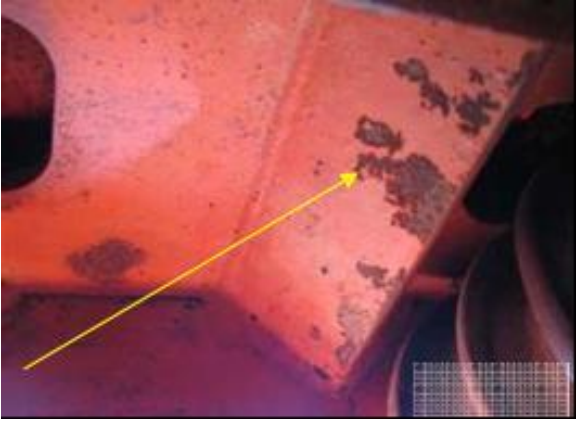
A close-up photograph of the internal structure of a track frame, showing a roller and the frame. Two red arrows point to the small gaps between the roller and the frame, indicating areas that require thorough cleaning and inspection.
<p>Inside some track frames, V-shaped channels like the one illustrated may be present (yellow arrow). These may be sealed units however they must be verified clean if open from the topside or only spot welded in place.</p>

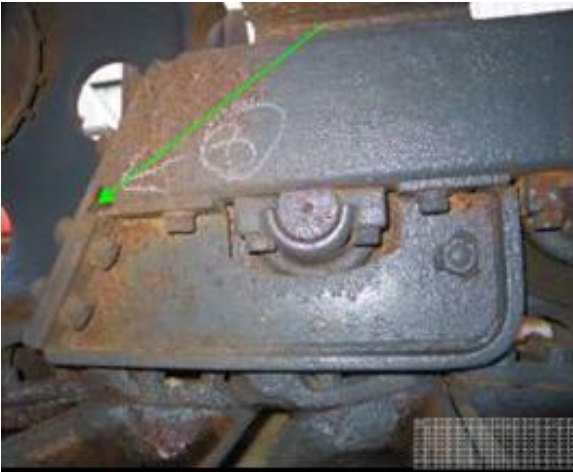
A close-up photograph of a V-shaped channel in a track frame. A yellow arrow points to the channel, indicating that it must be verified clean if open from the topside or only spot welded in place.

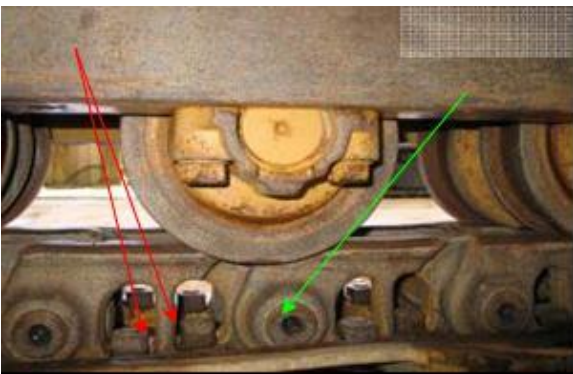
Description	Images
<p>On some models, the drainage hole for the hollow track frame rail may be on the inside edge as highlighted by the green arrow.</p>

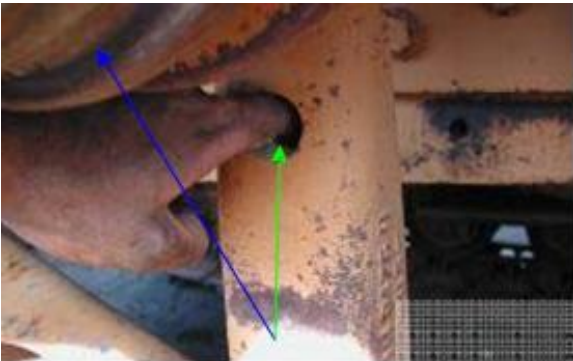
<p>All ledges inside the track frame must be clean and verified free of all BRM.</p>

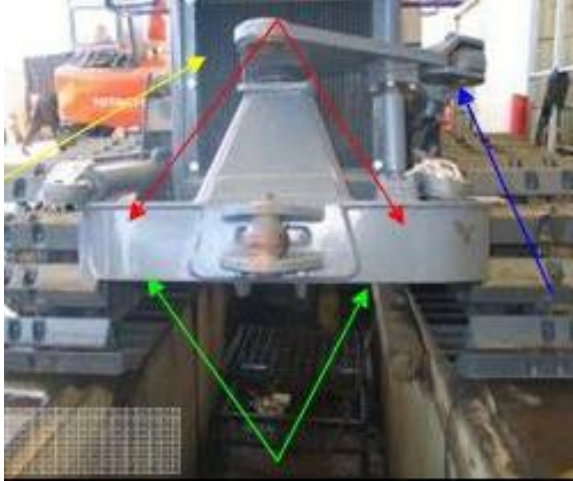
<p>The vertical support for the carrier roller (blue arrow) may be hollow and full of BRM as illustrated (green arrow). All contaminants must be removed and the interior verified at the time of inspection.</p>

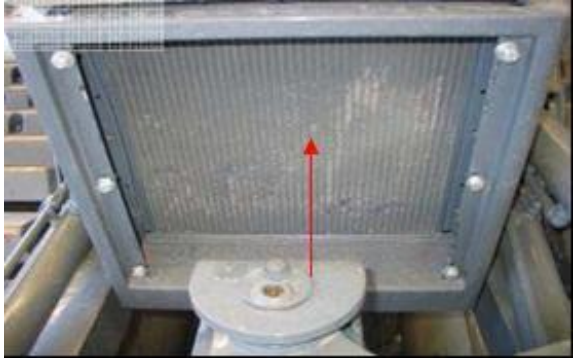
Description	Images
<p>The dozer blade push arms (red arrows) may have drainage holes (green arrows) on the underside. Flush to verify cleanliness if present. If sealed, check to verify that all surfaces are free of cracks, splits or evidence of repair. All contaminated grease must be removed from all pivot points (blue arrow). The grill must be removed (yellow arrow) to allow access to the radiator core.</p>

<p>A photograph showing the front view of the engine bay. Red arrows point to the dozer blade push arms. Green arrows point to drainage holes on the underside of the push arms. A blue arrow points to a pivot point. A yellow arrow points to the grill. A blue arrow points to the radiator core.</p>
<p>The front of the radiator core. The radiator fins must be flushed to verify cleanliness (red arrow).</p>

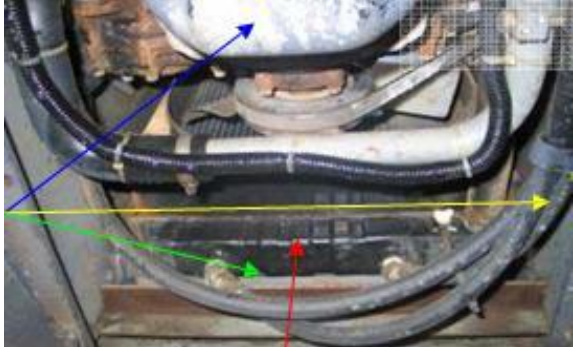
<p>A close-up photograph of the radiator core. A red arrow points to the radiator fins.</p>

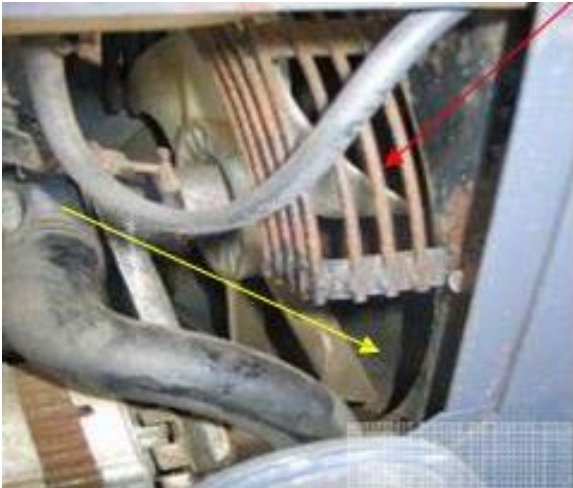
<p>The belly plate has been removed, allowing cleaning and inspection access to the underside of the radiator (red arrow). All ledges (green arrow), hoses (yellow arrow) and the underside surface of the sump (blue arrow) must be cleaned and free of all BRM.</p>

<p>A photograph showing the underside of the engine bay. A red arrow points to the underside of the radiator. A green arrow points to a ledge. A yellow arrow points to hoses. A blue arrow points to the underside surface of the sump.</p>

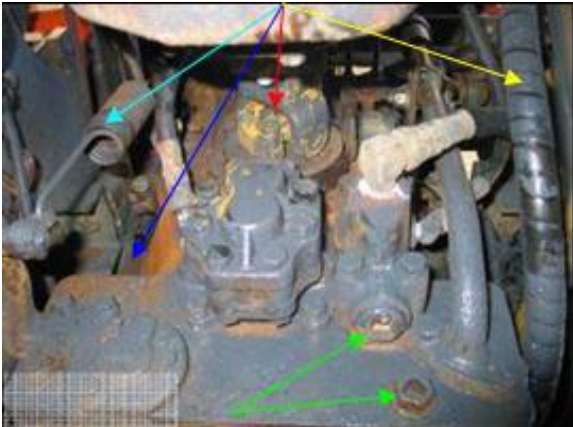
<p>The underside of the engine block and sump (red arrow). All surfaces must be free of all BRM, including dirty grease. The inside of all wiring harnesses (green arrow) and harmonic balancer (blue arrow) must be verified clean.</p>

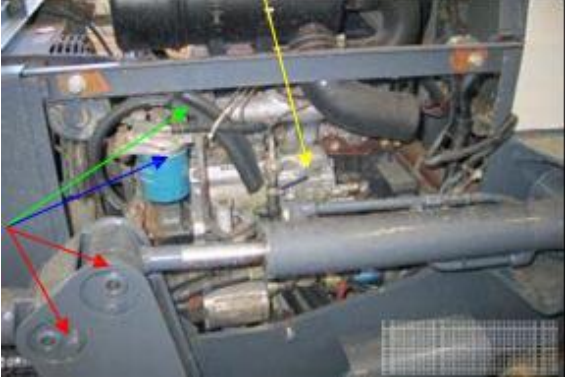
Description	Images
<p>The right hand side of the block. The engine cover and side panels have been removed to allow access for cleaning and inspection (yellow arrow). The hydraulic rams and pivot points (red arrows) must have all contaminated grease removed. Remove the air filter (green arrow) and verify cleanliness. All surfaces of the block are to be thoroughly cleaned and inspected.</p>

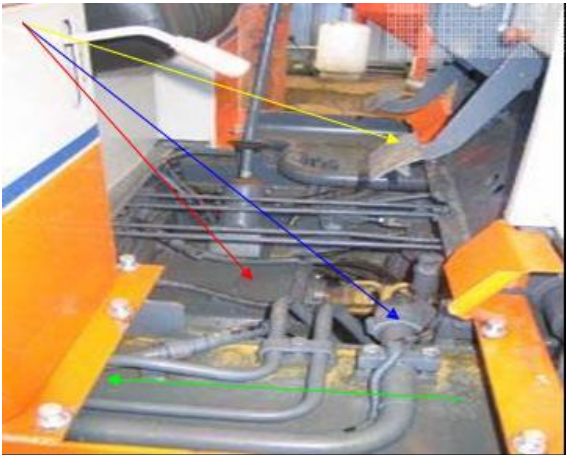
Description	Images
<p>A side view of the cabin highlighting fuel cell (red arrow), seat (blue arrow), floor pan (green arrow) and instrument panel (purple arrow). Access to the internal of the joystick control panel (aqua arrow) and instrument panel is required for cleaning and inspection.</p>

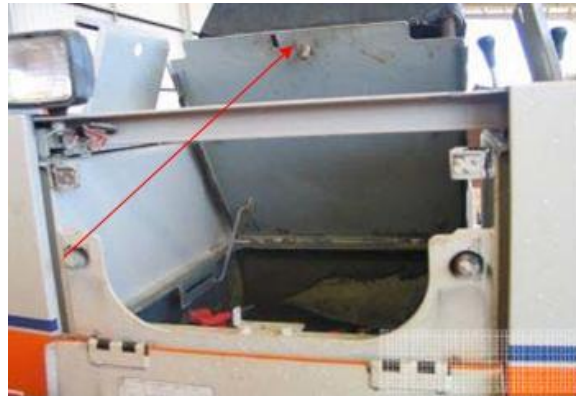
<p>The floor pan has been removed to allow access to the topside of the gearbox (red arrow) and hydraulics (blue arrow). These hydraulic lines extend under the fuel cell (green arrow) and this area requires thorough cleaning and inspection. The rubber foot pedal covers (yellow arrow) have been removed for cleaning.</p>

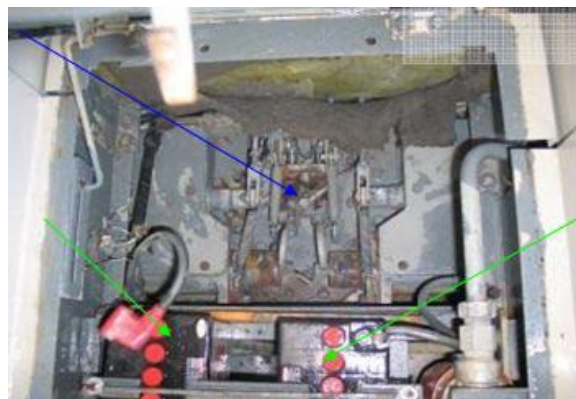
The rear flap on the dozer opens and the seat lifts forward (red arrow) to provide cleaning and inspection access to the battery box. Ensure that the underside of the seat is clean.
