Australian Government
Department of Agriculture
and Water Resources

Machinery Cleaning Guide - Medium Sized Dozers

Tracks, rock guards, track pads and rollers

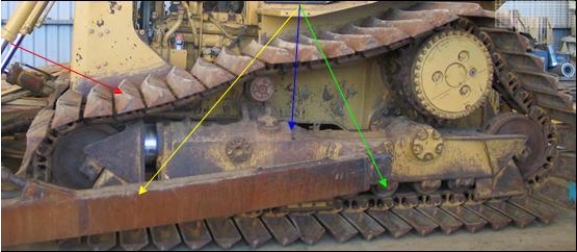
Description	Images
<p>The track pads (swamp tracks – red arrow) on a small model dozer. The track frame (blue arrow), push arms (yellow arrow) and rollers (green arrow) will all be highlighted in the following illustrations. To allow a complete inspection, all tracked machinery must undergo one full revolution to verify all track pads and countersunk holes in the rollers and idler wheels.</p>

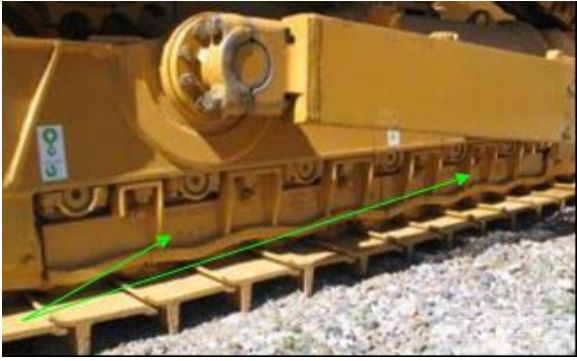
<p>To enable thorough cleaning and inspection, all rock or stone guards (green arrows) which are commonly found on smaller model dozers, must be removed.</p>

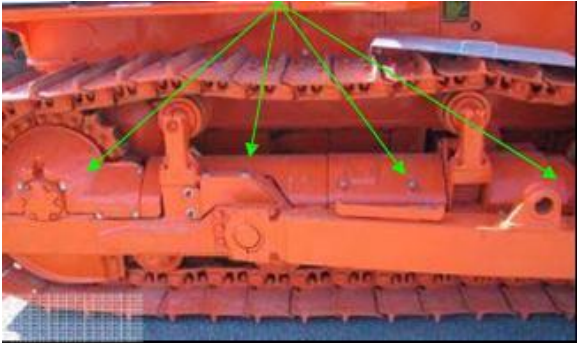
<p>On other small models the topside of the track frame may have numerous non-affixed panels (green arrows) which all must be removed for cleaning and inspection.</p>

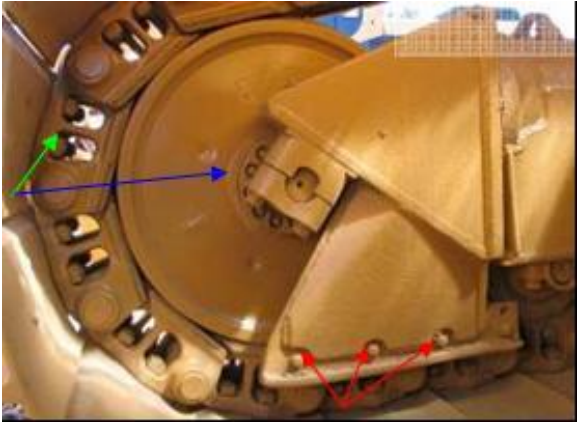
<p>The idler wheel on the track frame. The protective plate on the bottom of the track is hollow and will require flushing via the openings (red arrows) to verify cleanliness. All countersunk bolts (blue arrow) on the idler wheel require verification. Each nut (green arrow) holding the trackpads must be verified.</p>

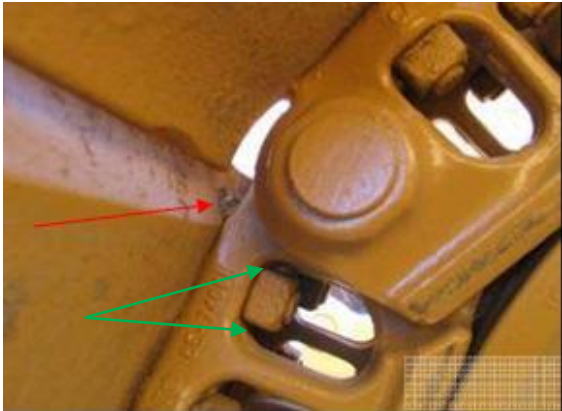
Description	Images
<p>The green arrows highlight the small gap either side of the nut, while the red arrow highlights the rear of the outside nuts. The red arrow highlights where the track pads attach to the chain. See next illustration.</p>

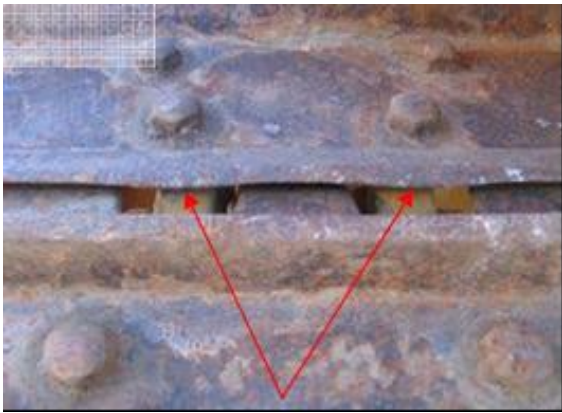
<p>When the tracks are rolled, the track pads will open when they pass around the idler wheel, opening the pads so the area highlighted by the red arrows can be cleaned and inspected.</p>

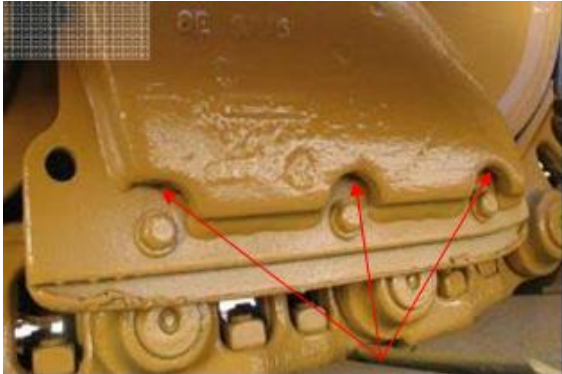
<p>The protective cover at the end of the track frame, which is hollow. Flushing via the access points (red arrows) will verify internal cleanliness.</p>

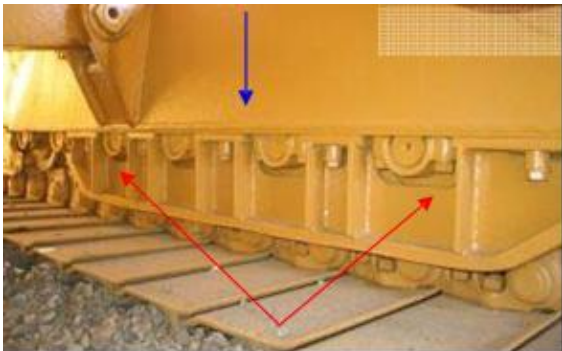
<p>The rock or stone guards (red arrows) in place on a small dozer. These must be removed to allow cleaning and inspection access to the inside of the track frame, but also to allow the hollow track frame (blue arrow) to be flushed, once the bolts have been removed. See next illustration.</p>

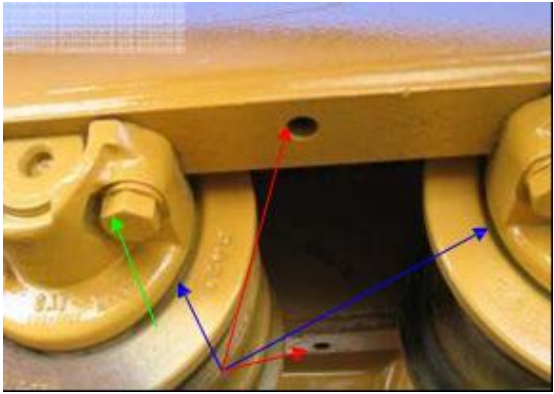
Description	Images
<p>Once the rock or stone guards have been removed, the hole (red arrows) vacated by the bolts allows an access point to the hollow frame for flushing. The rock guards from both sides of the track frame must be removed. Check around each roller nut (green arrow) and flush around the small recess around each individual roller (blue arrows).</p>

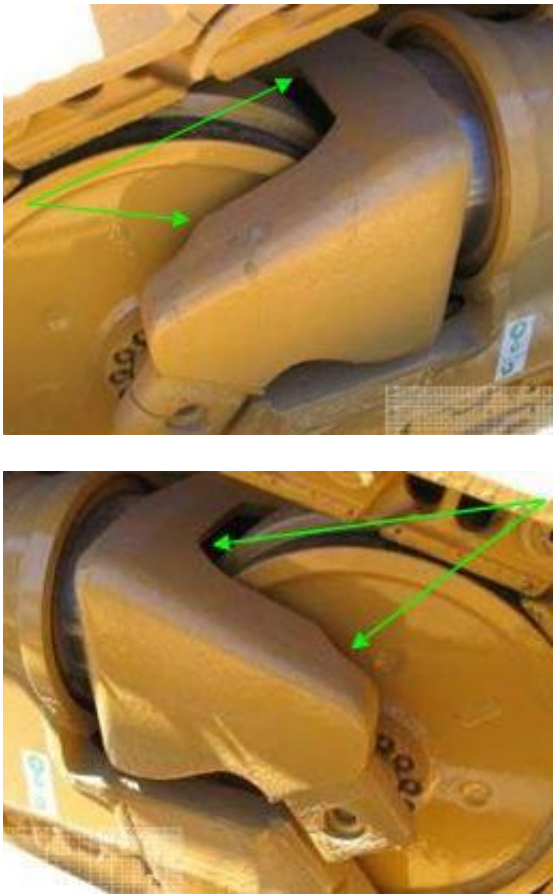
<p>These illustrations highlight the adjuster ram and the rear idler wheel. There are usually ledges inside the frame (green arrows) that must be thoroughly cleaned and inspected.</p>

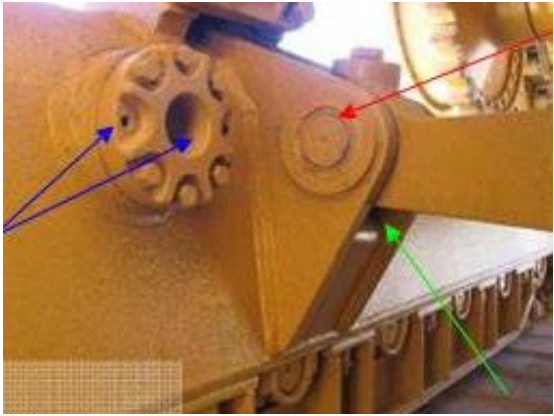
Description	Images
<p>The sway bar pivot point (red arrow) must be free of all contaminated grease. The green arrow highlights the bottom access point for cleaning and inspection, while the blue arrows highlight a number of countersunk holes that must be clean and free of all biosecurity risk material.</p>

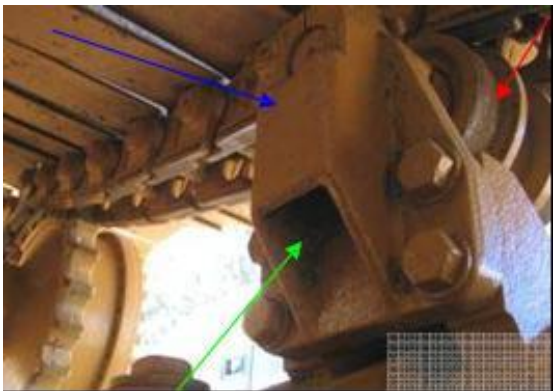
<p>A close-up photograph of a yellow metal pivot point. A red arrow points to a circular feature on the right. A green arrow points to a recessed area at the bottom. Two blue arrows point to countersunk holes on the left side.</p>
<p>The carrier roller (red arrow) support arm. In this illustration the support arm is open ended (green arrow) and on other models the opening may be topside or at the rear (blue arrow).</p>

<p>A close-up photograph of a carrier roller support arm. A red arrow points to a roller at the top right. A green arrow points to an open end of the support arm. A blue arrow points to a hole on the left side.</p>

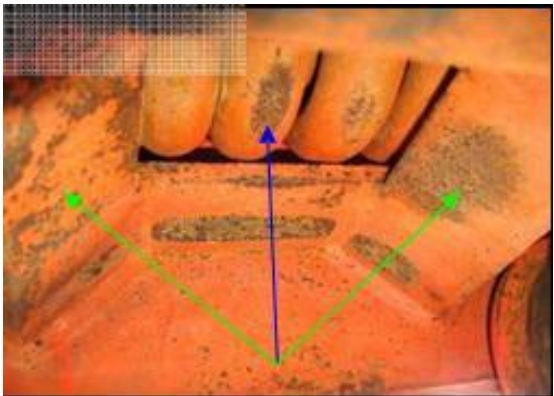
<p>Inside some small dozer track frames, small v-shaped gussets may be found. These v-shaped gussets may be sealed units, however verification if open or spot-welded is required. The blue arrow highlights the track adjuster spring that, due to limited access requires flushing to verify cleanliness.</p>

<p>A close-up photograph of track adjuster springs. A blue arrow points to a spring in the center. Two green arrows point to v-shaped gussets on either side.</p>
<p>The inside of the drive wheel on the dozer. Flush small recess highlighted by the green arrows to verify. The cogs have several small recesses around the perimeter where they join (blue arrows).</p>

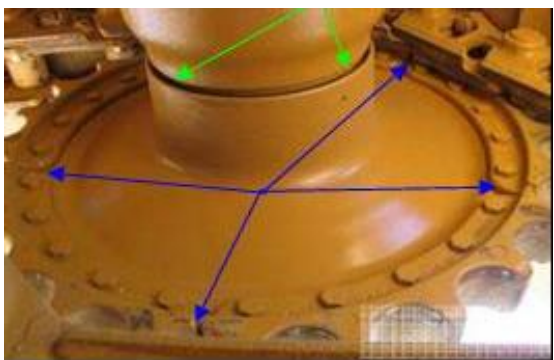
<p>A close-up photograph of the inside of a drive wheel. Two green arrows point to small recesses on the top surface. Four blue arrows point to recesses around the perimeter of the cog teeth.</p>

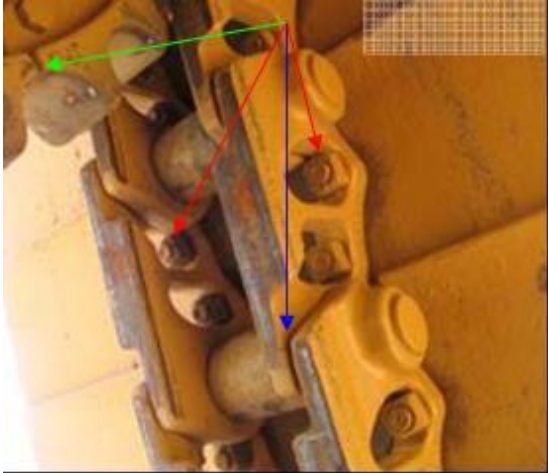
Description	Images
<p>Another view of the track chain, highlighting the track pad nuts (red arrows), the small recess in the drive wheel (green arrow) and the gaps between the track chains (blue arrow). All must be thoroughly cleaned and inspected. In some cases flushing will be required.</p>

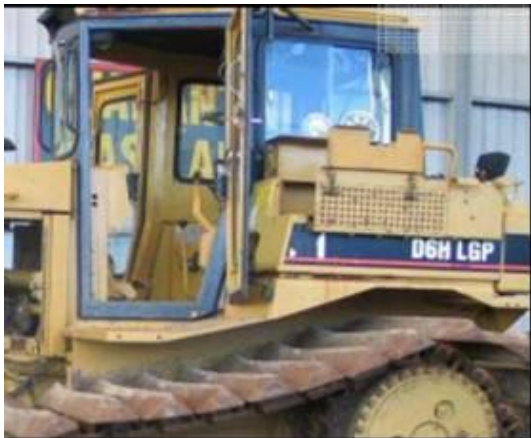
Description	Images
<p>A typical dozer cabin as seen on the D6 model. All cabins require dismantling and thorough cleaning and inspection.</p>

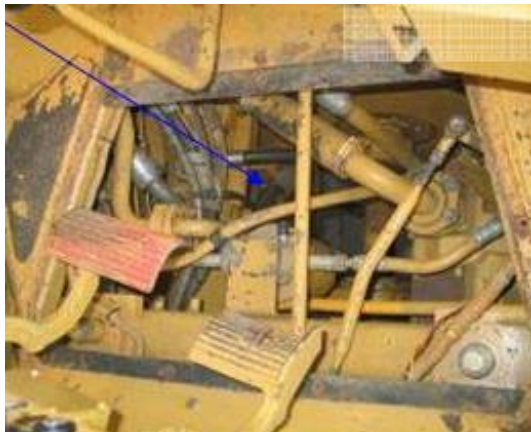
<p>The floorpan immediately below the foot pedals has been removed, allowing access to the top of the transmission, bell housing, rear of the engine block and the base of the roll over protection system (ROPS). All will be highlighted in the following illustrations.</p>

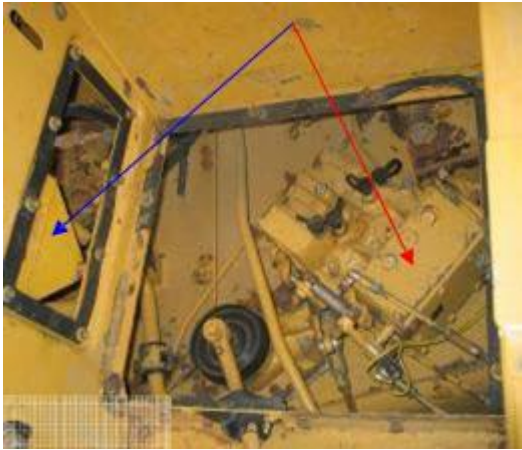
Description	Images
<p>The seat and floor panel below have also been removed allowing access to the topside of the differential and steering box (red arrow). The non-affixed panel on the side of the joystick control (blue arrow) has been removed for internal cleaning and inspection.</p>

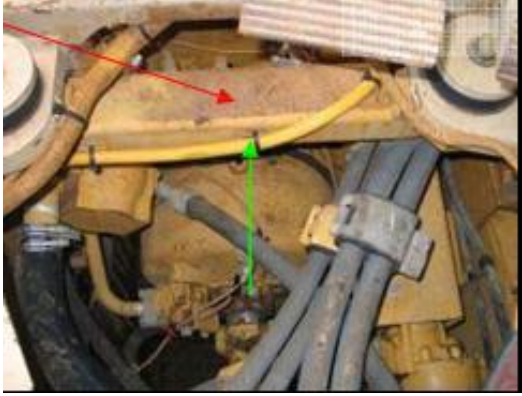
<p>Under the floorpan of most Cat dozers, a box channel (red arrow) will be found directly below the instrument panel. On the larger dozers, these are open-ended, however on the smaller models, these have a drainage hole on the underside, in the middle (green arrow). See next illustration.</p>

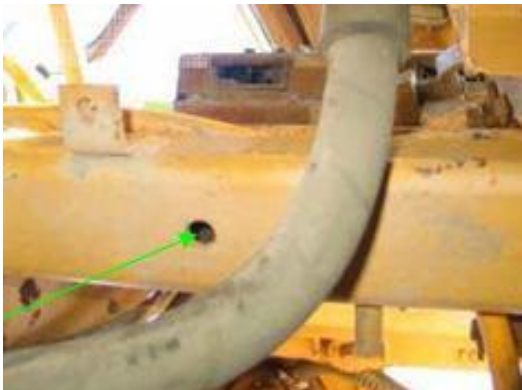
<p>The underside of the box channel below the instrument panel. This area must be flushed via the small drainage hole (green arrow) in the presence of the inspecting officer to verify internal cleanliness.</p>

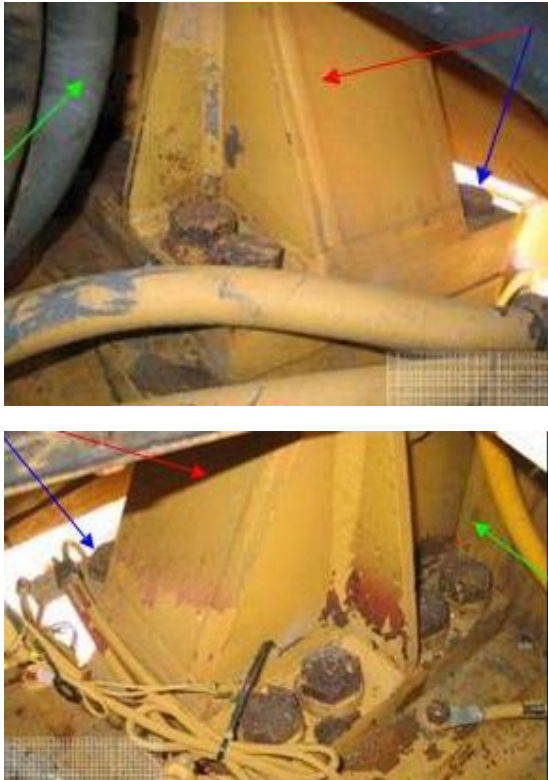
Description	Images
<p>The red arrows highlight the base of the roll over protection systems (ROPS). These ROPS do not sit flush against the sidewall of the dozer and the small recess must be flushed to verify cleanliness. The bolt heads (blue arrows) at the rear of the ROPS also require cleaning and inspection. The green arrow highlights where contamination lodges behind the hydraulic hoses.</p>

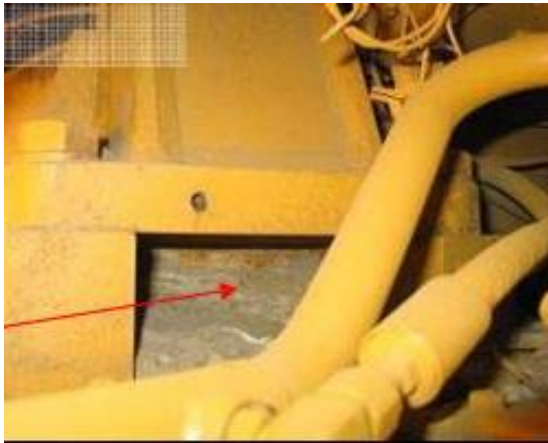
<p>Some ROPS have large recesses underneath and can be full of biosecurity risk material as highlighted by the red arrow.</p>

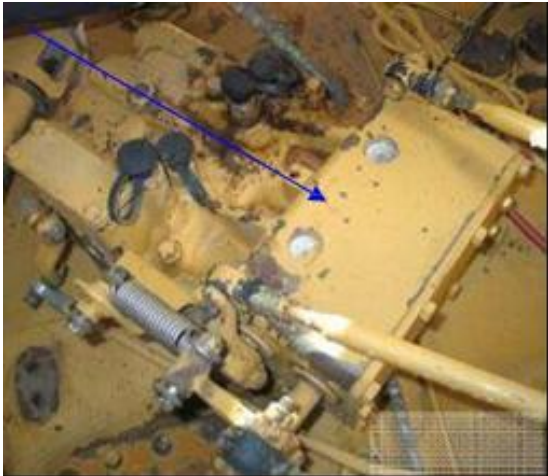
Description	Images
<p>The topside of the steering box (blue arrow) as seen under the seat. This requires careful cleaning and inspection due to the undulating surface, both topside and bottom. Also see next illustration.</p>

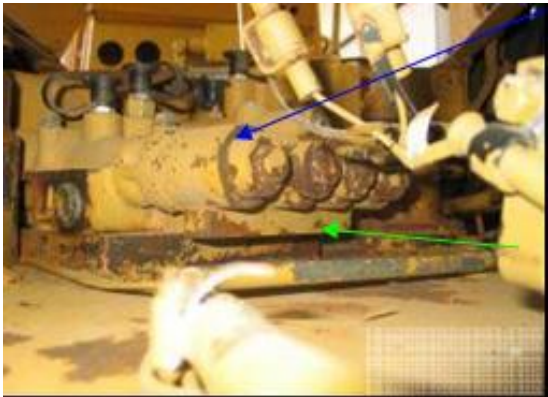
<p>A rear view of the steering box. This steering box (blue arrow) has an undulating surface and must be thoroughly cleaned and inspected. There is a recess behind steering box (green arrow)</p>

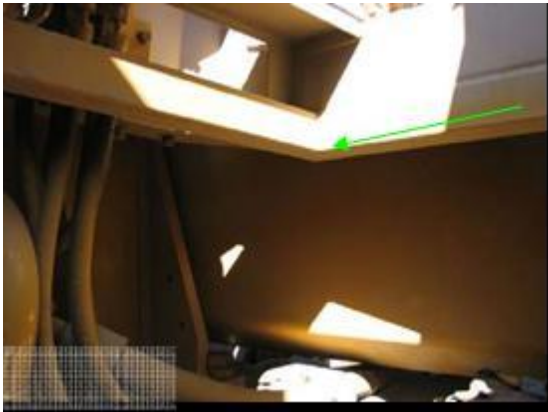
<p>Check all framework under the cabin floor. On some models this has open ends (green arrow), which will require flushing to verify cleanliness.</p>

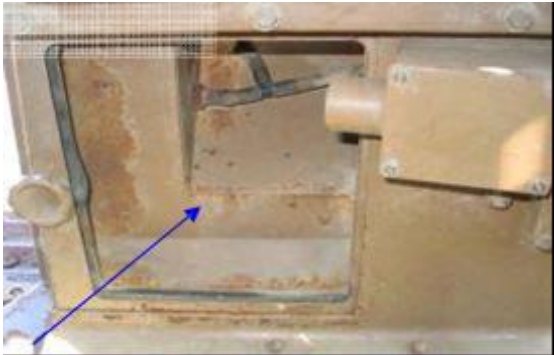
Description	Images
<p>The air-conditioning vent under the instrument panel has been removed for cleaning and inspection.</p>

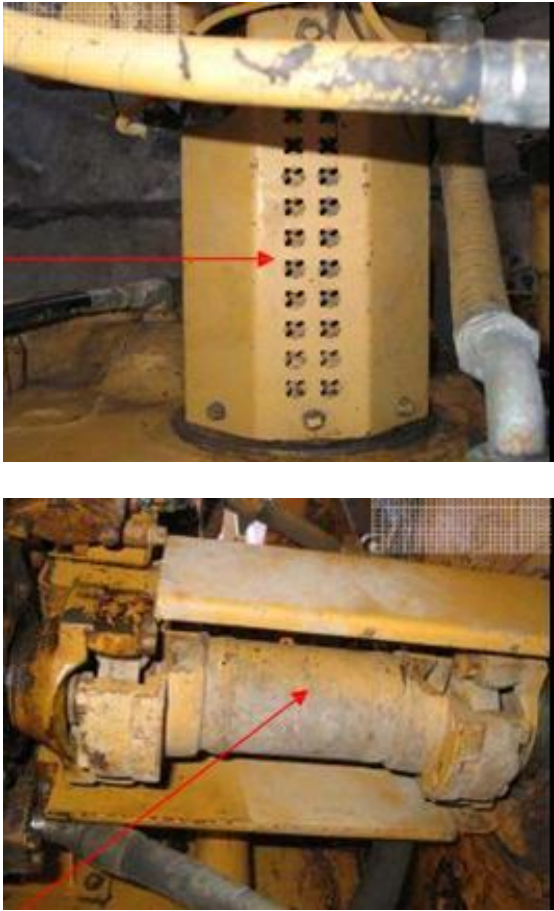
<p>The protective plate around the universal joint under the floorpan must be removed to facilitate the cleaning and inspection process. The second illustration shows the bottom half of the protective cover removed, allowing access to the universal joint.</p>

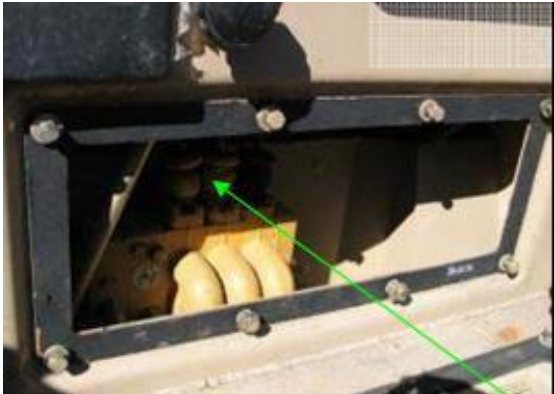
Description	Images
<p>The internal view of the right hand joystick control panel. Removing this panel allows cleaning and inspection access to the ledges and hydraulic hoses found inside and requires verification.</p>

A photograph showing the internal view of the right-hand joystick control panel. The panel is removed, revealing a complex arrangement of hydraulic hoses, metal brackets, and structural components. A green arrow points to a specific area within the internal structure, likely indicating a point of interest for cleaning or inspection.
<p>The left hand joystick control panel. Like the right hand panel, internal cleaning and verification will be required.</p>

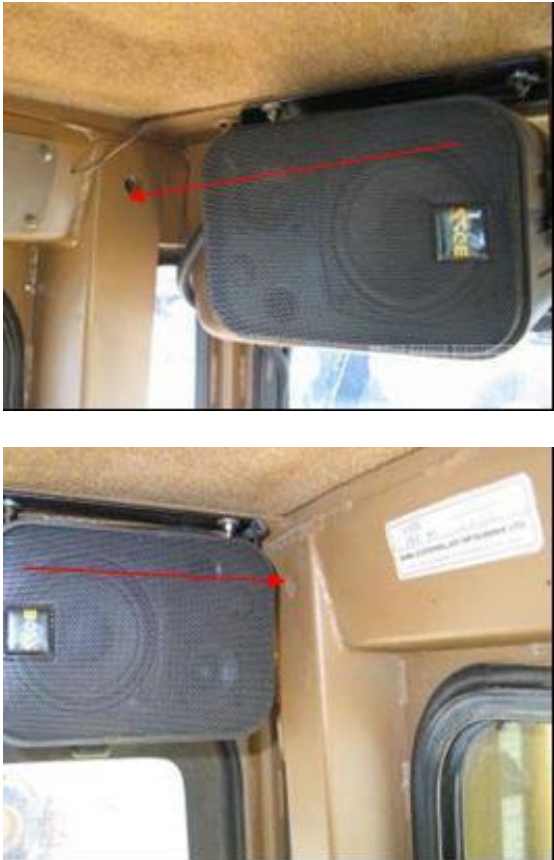
Description	Images
<p>Check all internal cabin framework for small holes like the one illustrated. If present, flush to verify cleanliness.</p>

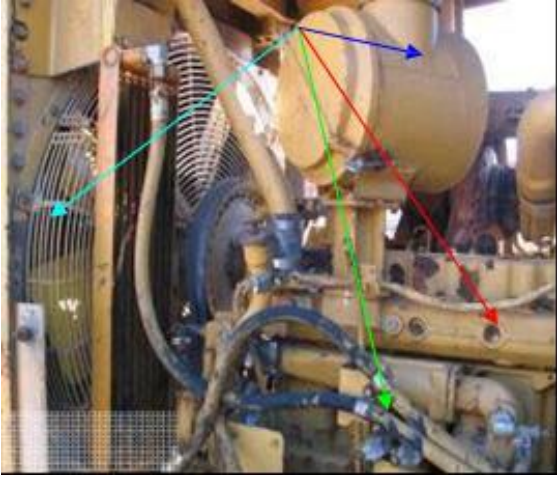
Description	Images
<p>The left hand side of the engine block. This illustration highlights the air-filter (blue arrow), the block (red arrow), hydraulic hoses (green arrow) and the radiator (aqua arrow). All must be thoroughly cleaned and inspected. The internal radiator grill (aqua arrow) must be removed for internal access to the radiator shroud.</p>

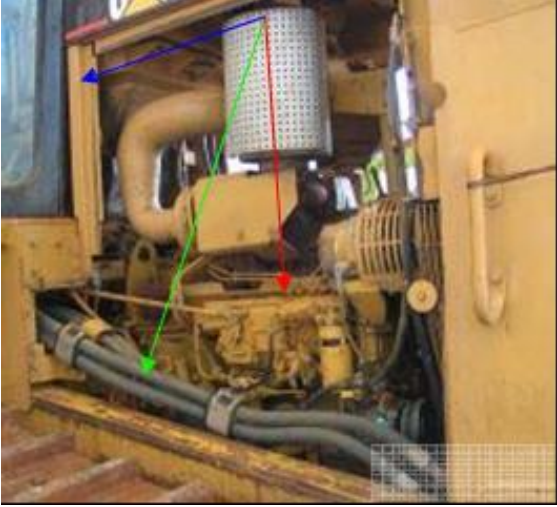
<p>The right hand side of the block also highlighting the side of the block (red arrow), hydraulic hoses (green arrow) and part of the engine housing (blue arrow) which must be checked for hollow or open-ended channels.</p>

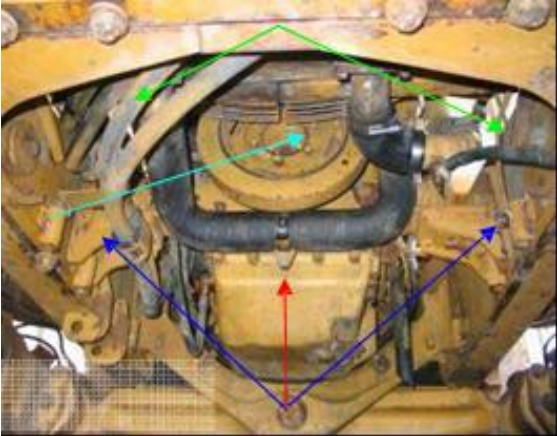
<p>The underside of the block of a medium sized dozer. The belly plates have been removed, allowing cleaning access to the sump (red arrow), engine mounts (blue arrows), hydraulic hoses (green arrows) and harmonic balancer (aqua arrow).</p>

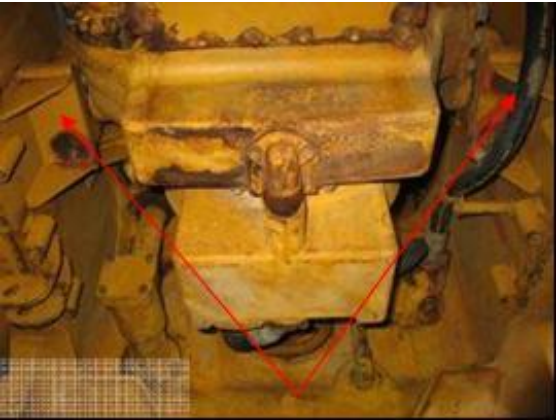
Description	Images
<p>The rear of the engine block and bell housing. All surfaces, including rear engine mounts (red arrows) require thorough cleaning and inspection.</p>

A photograph showing the rear of an engine block and bell housing. The engine is yellow and shows signs of wear and rust. Two red arrows point to the rear engine mounts on either side of the block.
<p>The topside of the block as seen from below the floorpan. From this angle, the rear end of the block can be accessed for cleaning and inspection.</p>

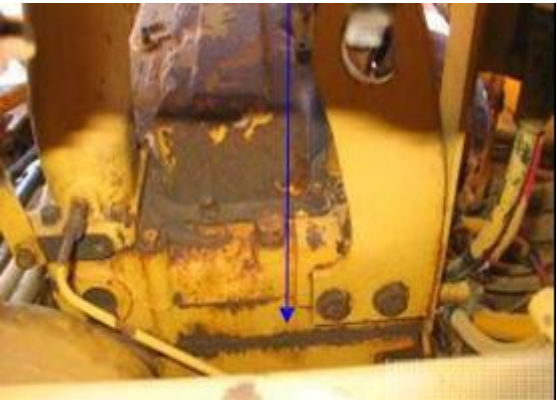
A photograph showing the topside of the engine block from a low angle, looking up from below the floorpan. A blue arrow points to the rear end of the block, indicating the area for cleaning and inspection.
<p>Another view of the topside of the block. All contaminated grease must be removed from this area.</p>

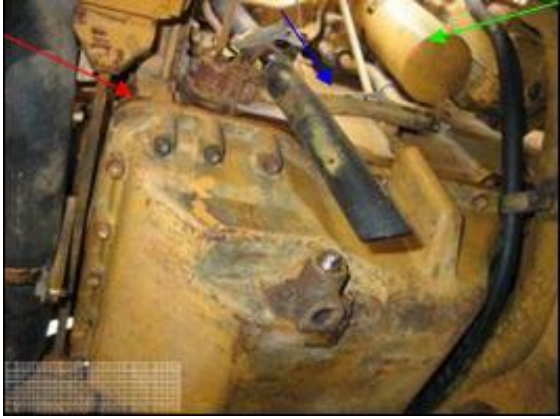
Description	Images
<p>The right hand side of the block, highlighting the lip around the sump (red arrow), and the oil filter (green arrow). All areas must be thoroughly cleaned.</p>

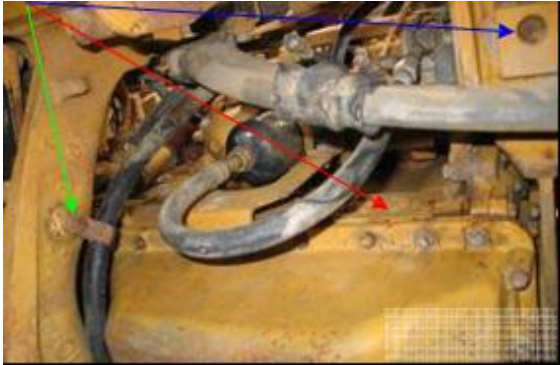
<p>The left hand side of the block, highlighting the topside of the sway bar (green arrow), the lip around the sump (red arrow) and the underside of the engine mount (blue arrow).</p>

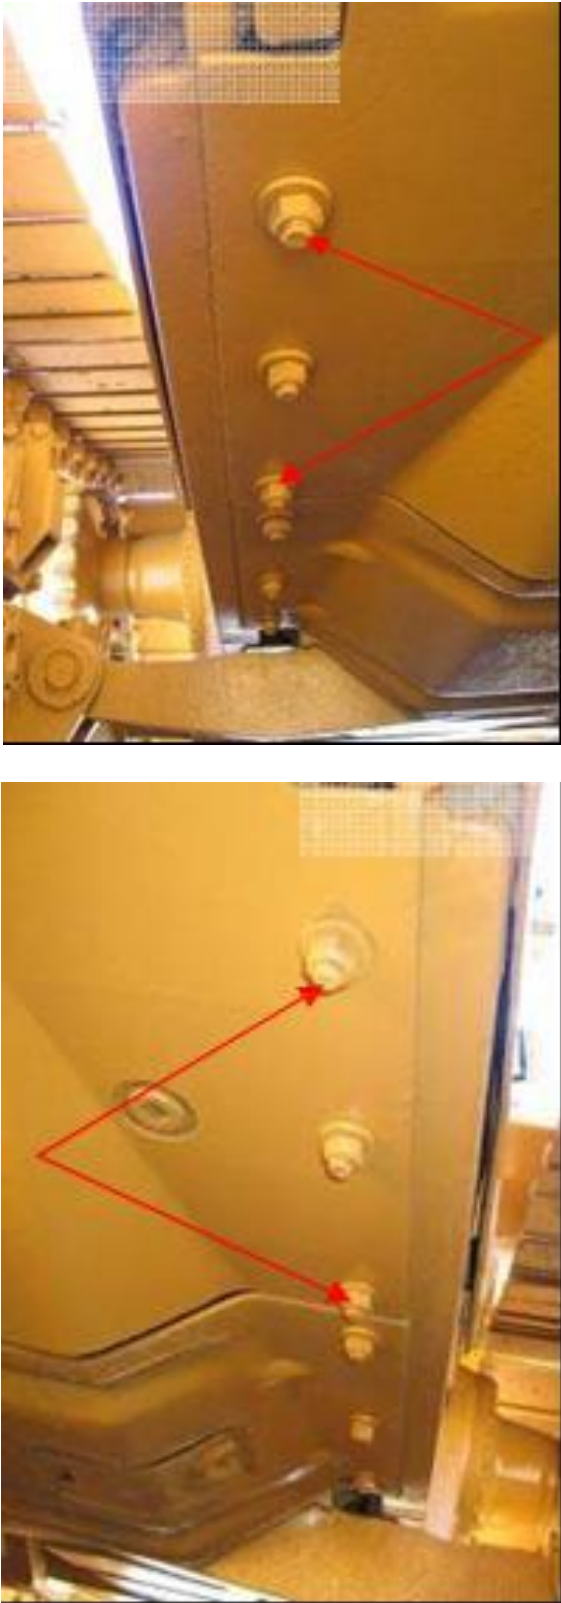
Description	Images
<p>Once the belly plate bolts (red arrows) have been removed, these may provide access holes to the hollow chassis rails (These chassis rails are sealed on all small models).</p>

<p>The images show the underside of a dozer chassis. The top image shows a row of bolts along a metal rail, with two red arrows pointing to specific bolts. The bottom image shows a similar view from a different angle, also with two red arrows pointing to bolts. The bolts are located on a metal plate (belly plate) that covers hollow chassis rails.</p>

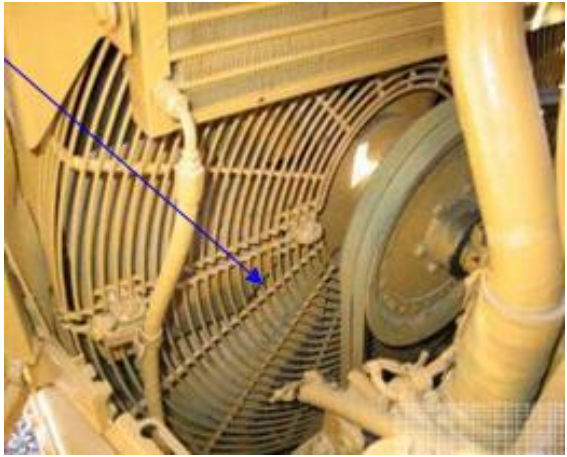
Description	Images
<p>The internal radiator grill (blue arrow) which must be removed to allow cleaning and inspection access to the radiator shroud.</p>

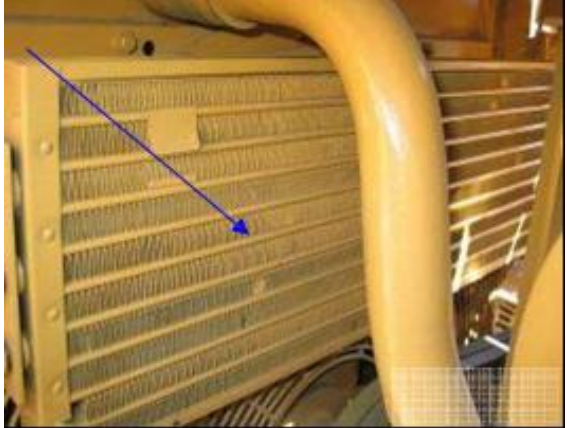
<p>The oil cooler (blue arrow) located behind the radiator. To verify cleanliness, this and the radiator core must be flushed in the presence of the inspecting officer.</p>

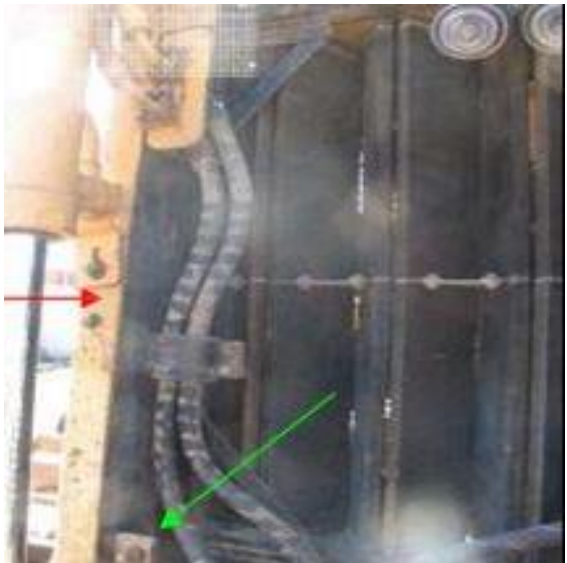
<p>Check the vertical frame either side of the radiator (red arrow) for drainage holes at the top or bottom. On some models these have small openings on the inside rear (green arrow) and if present, these channels will require flushing to verify cleanliness.</p>

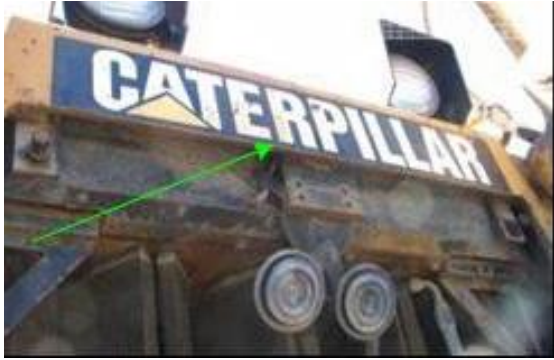
Description	Images
<p>Check along the topside of the radiator for any ledges or channels that will require cleaning and inspection. Flush the radiator fins to verify cleanliness.</p>

A close-up photograph of the top of a Caterpillar radiator. The word "CATERPILLAR" is printed in white on a blue background. A green arrow points to a ledge or channel on the metal surface below the radiator fins.
<p>On some models there may be an open-ended cavity (green arrow) below the radiator grill that may require flushing to verify cleanliness.</p>

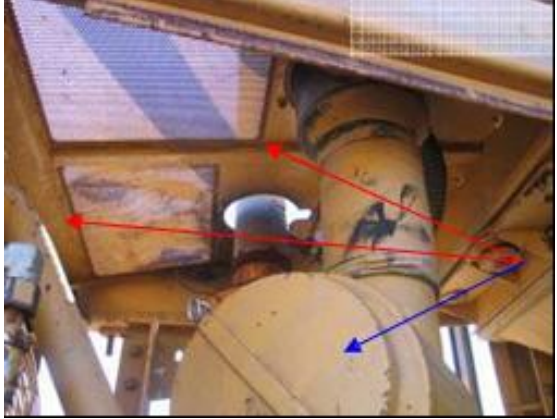
Description	Images
<p>Check all internal engine housing support framework (red arrow) for hollow, open-ended or spot welded channels. Flush to verify internal cleanliness if present.</p> <p>Remove the air-filter (blue arrow) and verify clean.</p>

A photograph showing the internal engine housing support framework of a dozer. Red arrows point to various structural components, including a large cylindrical support and surrounding beams. A blue arrow points to a circular opening, likely the air filter location.
<p>Check all engine cover doors for hollow, open-ended or spot welded channels (red arrows). Flush to verify internal cleanliness if present.</p>

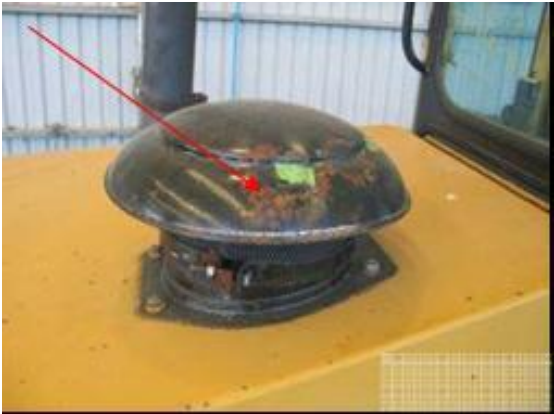
Description	Images
<p>Remove the dust collector cover (red arrow) and verify internal cleanliness.</p>

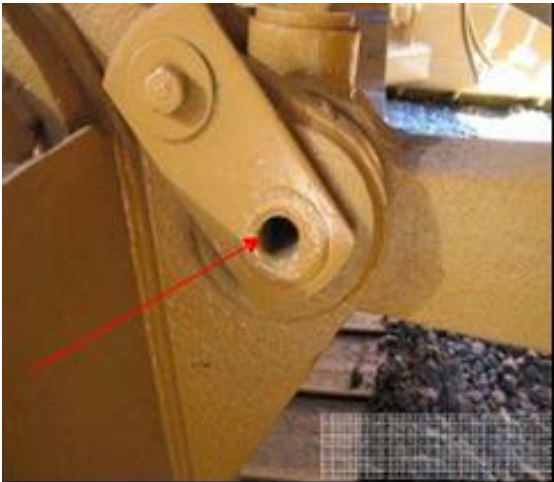
<p>The sway bar joints attachment point to the track frame. Check all recesses (red arrow) and ensure all contaminated grease is removed.</p>

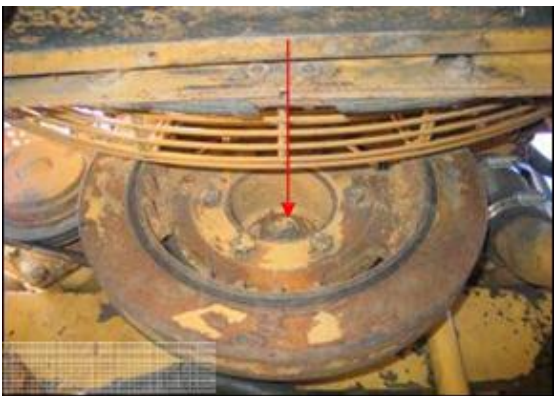
<p>The front view of the harmonic balancer (red arrow) at the front of the engine block. Like many harmonic balancers, they are concave and can harbour significant amounts of biosecurity risk material and must be verified clean inside.</p>

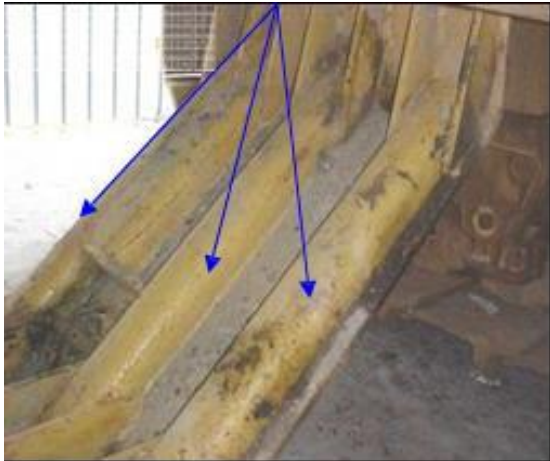
Description	Images
<p>The inside of a typical belly plate. Check along each of the gussets (blue arrows) as on some models these are open-ended and require flushing in the presence of the inspecting officer in order to verify cleanliness.</p>

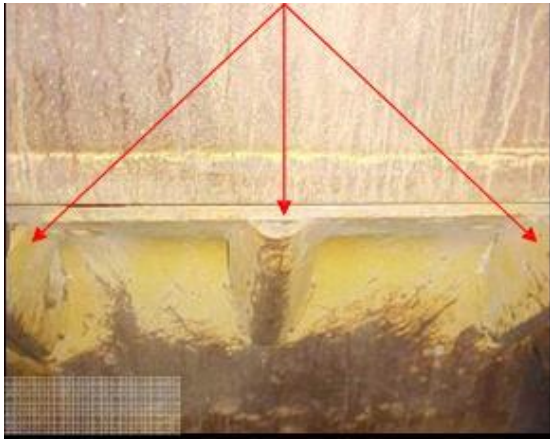
<p>On some belly plates, gussets can be found on the outside of the belly plate, as highlighted by the red arrows. These need to be flushed to verify clean.</p>

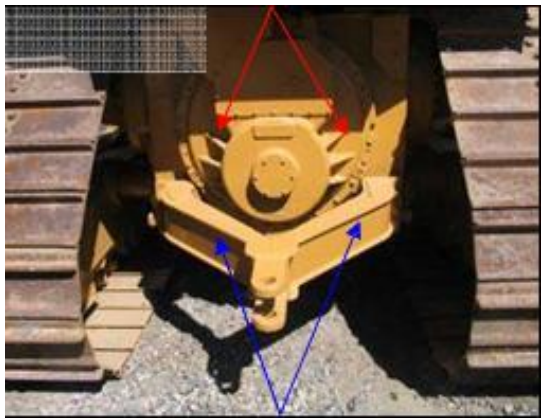
Description	Images
<p>The rear of the small dozer (red arrows) and drawbar (blue arrows). Check all surfaces of the drawbar for drainage holes, for cracks, splits or evidence of repair.</p>

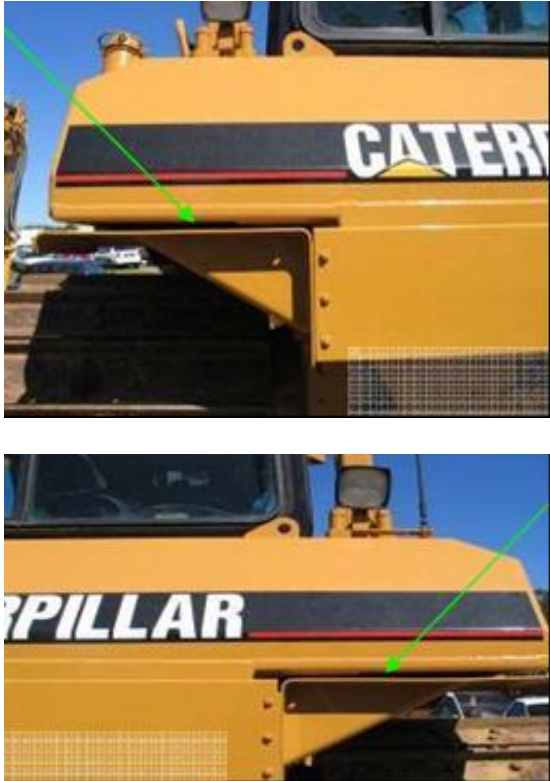
Two photographs showing the fuel cell area on a yellow dozer. The top photo shows a Caterpillar dozer with a green arrow pointing to the back of the fuel cell. The bottom photo shows a Komatsu dozer with a green arrow pointing to the underside of the fuel cell.
<p>The oil tank outside the right door of the cabin. All surfaces must be thoroughly cleaned and inspected.</p>

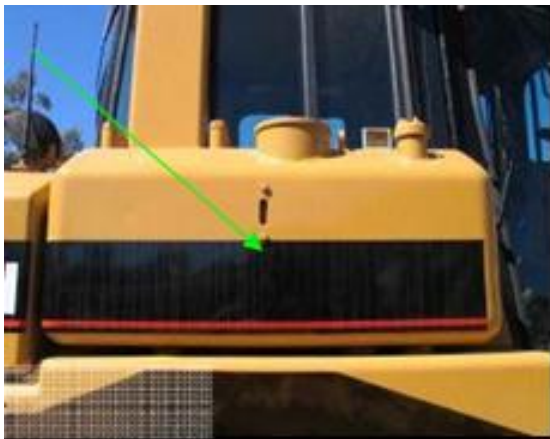
A close-up photograph of the oil tank on a dozer. The tank is yellow and has a black stripe. A green arrow points to the surface of the tank.

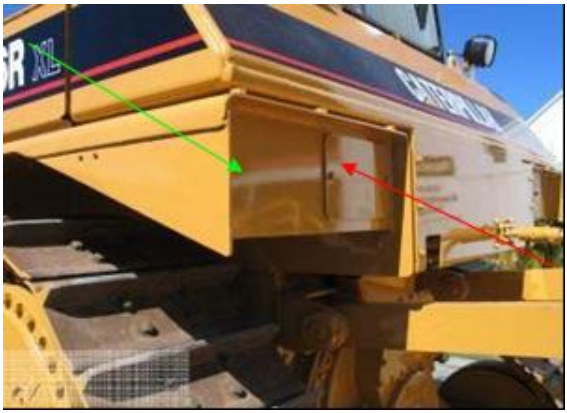
<p>The area highlighted by the green arrow is hollow and can be accessed by removing the non-affixed panel (red arrow) for cleaning and inspection.</p>

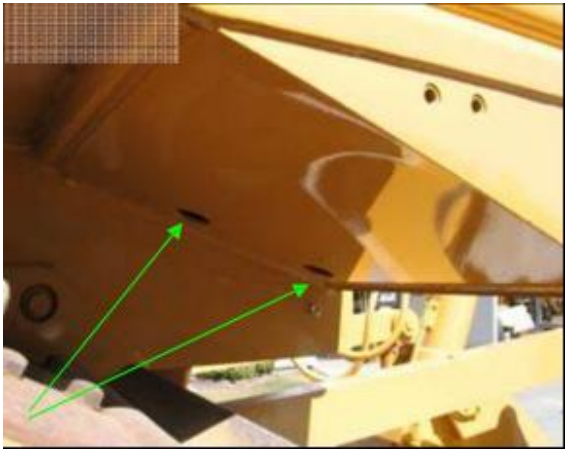
<p>The area illustrated in the previous picture may also have drainage holes on the underside as highlighted by the green arrows.</p>

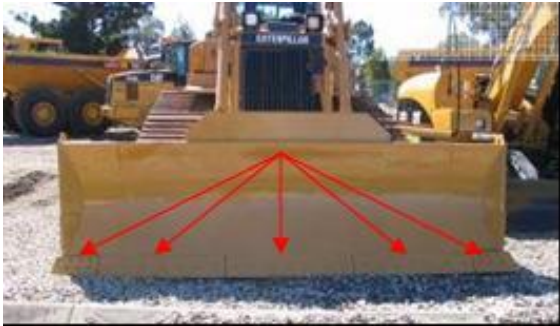
Description	Images
<p>A typical blade on a dozer. All cutting teeth (red arrows) must be loosened and flushed to verify cleanliness. Check all surfaces for cracks, splits or evidence of repair to any surfaces. If detected, these will require investigation to verify internal cleanliness.</p>

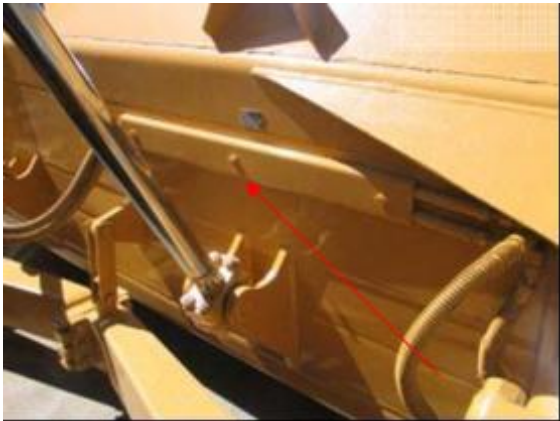
<p>On the rear of some blades, gussets or protective plates may cover hydraulic hoses. These must be removed for cleaning and verification.</p>

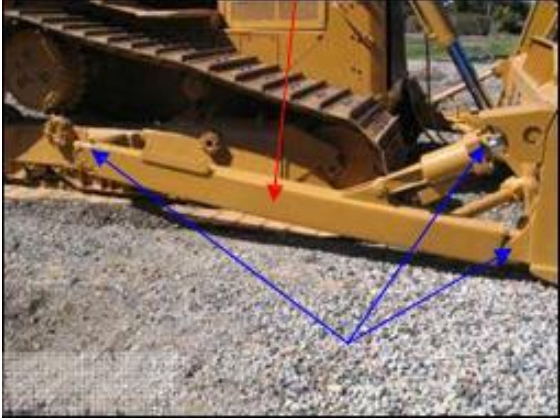
Description	Images
<p>The push arms (red arrow) on a dozer. These are generally sealed units, but need to be checked for any cracks, splits or evidence of repair. Ensure all contaminated grease is removed from pivot points (blue arrows).</p>

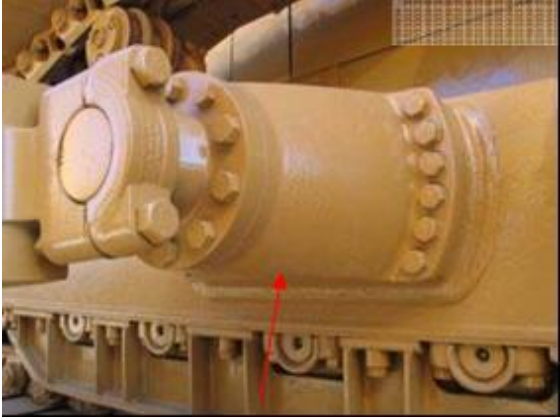
<p>Illustrates where the push arms attach to the track frames. These units are hollow and may have drainage holes on the underside (red arrow), which will require flushing, if present to verify internal cleanliness.</p>

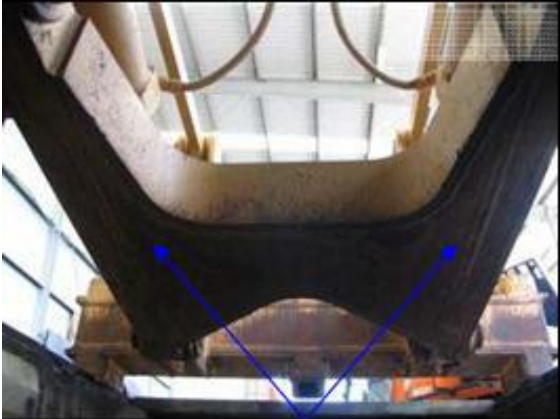
Description	Images
<p>The underside of a typical ripper cradle. On this illustration, there are no drainage holes, but if present, these must be flushed to verify internal cleanliness. Check all surfaces for any cracks, splits or evidence of repair.</p>

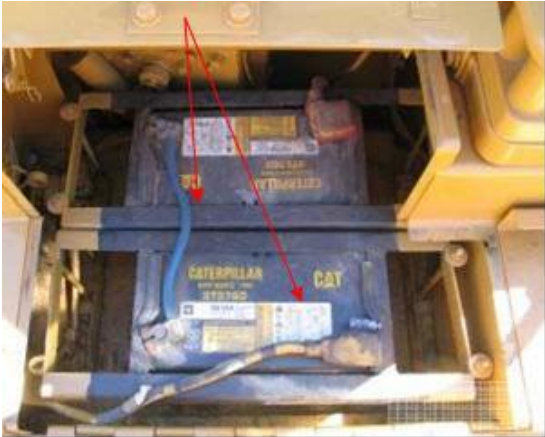
Description	Images
<p>All batteries must be loosened from the tie down points for cleaning and underside inspection.</p>

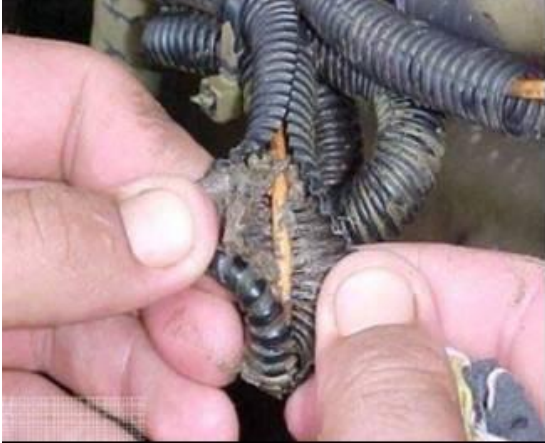
<p>All wiring harnesses are to be carefully cleaned and inspected.</p>
