Australian Government  
Department of Agriculture  
and Water Resources

# Machinery Cleaning Guide - Scrapers

**Biosecurity**

April 2016

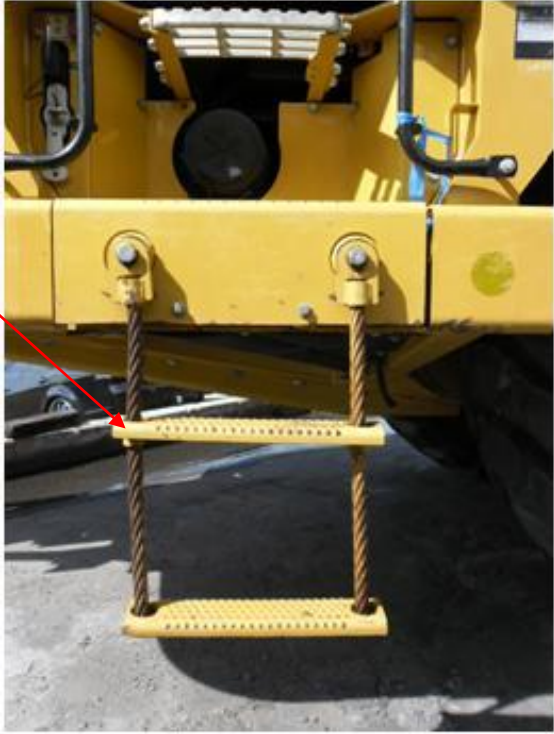
Description	Images
<p>Check the ladder to the cabin, particularly under the steps. On this model the ladder (red arrow) is made from wire bundles, which must be free of all biosecurity risk material (BRM).</p>

<p>A close-up photograph of a yellow ladder on a machine. The ladder consists of two vertical wire bundles connected by a horizontal yellow step. A red arrow points to the wire bundles.</p>
<p>The front end, highlighting the non-affixed panels removed from in front of the cabin, exposing the air-conditioning unit for inspection (red arrow). In newer models as photographed, removing these panels allows access to the first set of batteries located at the front of the machine as well as flush points located in the front bumper rail (blue arrow).</p>

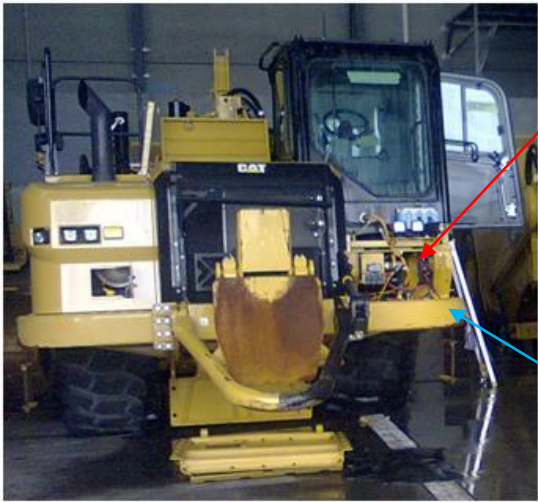
<p>A photograph of the front of a yellow machine. A red arrow points to the air-conditioning unit, and a blue arrow points to the bumper rail.</p>

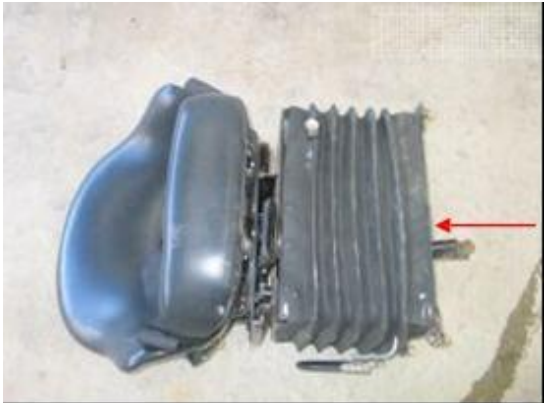
<p>Once the seat has been removed, the internal of the rubber shroud (red arrow) can be easily cleaned and inspected.</p>

<p>A close-up photograph of a grey rubber shroud. A red arrow points to the internal surface of the shroud.</p>

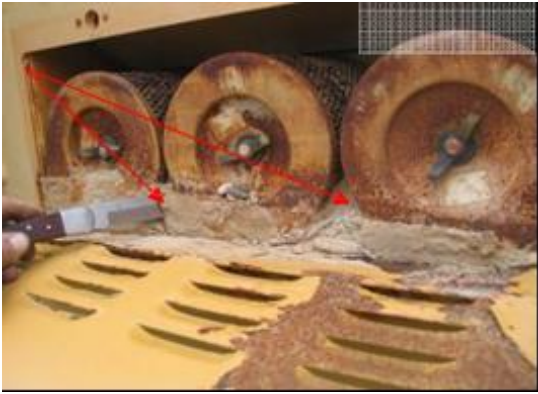
Description	Images
<p>Air-filters in front of the cabin(red arrow). This illustration highlights the amount of BRM that can be found in this area.</p>

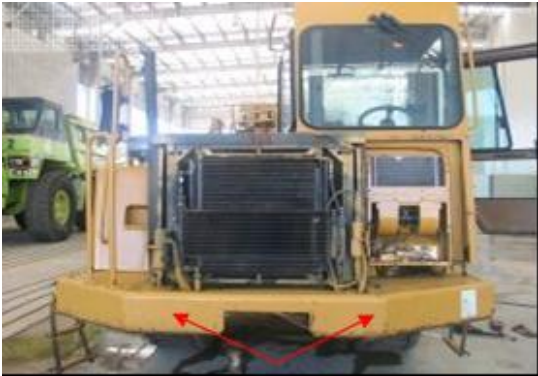
Description	Images
<p>Illustrates the amount of dismantling (a number of non-affixed panels) required to make the engine and front end accessible for cleaning and inspection. The front drawbar (red arrows) is usually hollow, which will be highlighted later.</p>

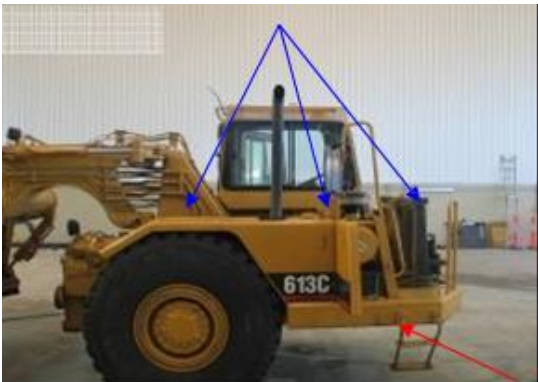
<p>All non-affixed engine covers (blue arrow) have been removed, allowing access for cleaning and inspection. The red arrow is highlighting the hollow drawbar.</p>

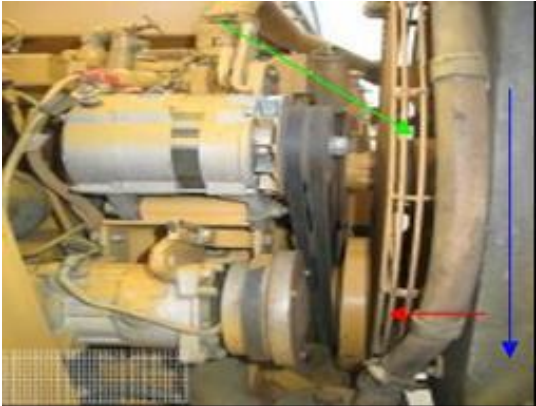
Description	Images
<p>The front of the block and the harmonic balance (flywheels). These can be concave and harbour BRM inside (red arrow). The internal radiator grill (green arrow) must be removed, allowing cleaning and inspection access inside the radiator shroud (blue arrow). Check all external surfaces of the block, including oil filters, starter motors and between tappet covers.</p>

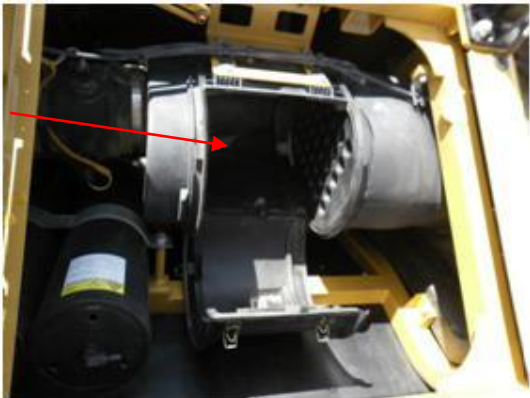
<p>The air-filter is to be removed from the housing (red arrow) and verified clean (usually performed with pressurized air).</p>

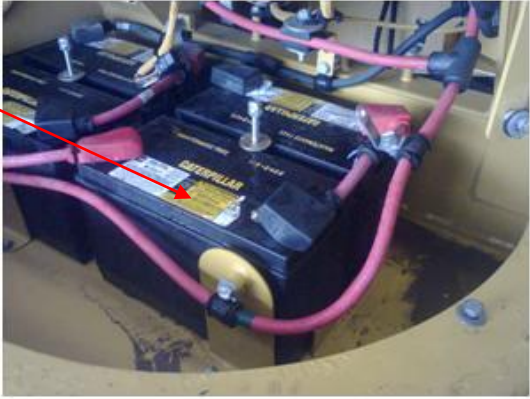
<p>The batteries (red arrow) are to be loosened from the tie-down points and inspected underneath. In newer scrapers the batteries are located under the front of the cab, removing the cover to allow access also allows access to the hollow sections of the front draw bar.</p>

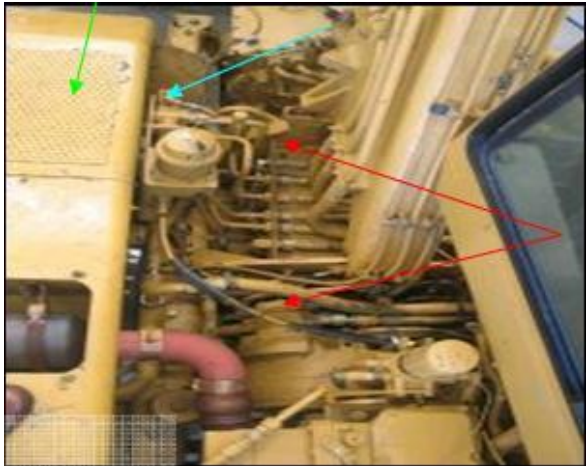
Description	Images
<p>The rear of the block, below the gooseneck. This area is also characterised by numerous hydraulic and electrical hoses and cables (red arrows), all requiring thorough cleaning and inspection. All checker plates (green arrow) are to be flushed to verify cleanliness. Flushing to verify areas that cannot be seen or felt will be required. The aqua arrow highlights the access point to the hollow chassis rail that is highlighted next.</p>

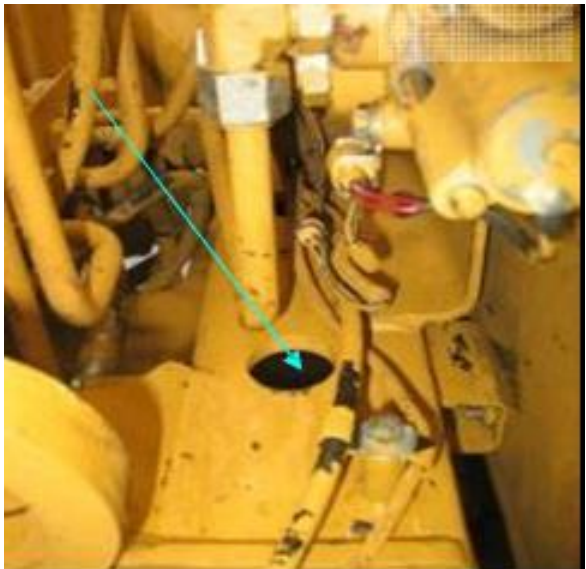
<p>The two chassis rails either side of the engine block are hollow (aqua arrow). On most models there will be access points or drainage holes. The one illustrated in this picture is located on the topside of the chassis rail, towards the rear.</p>

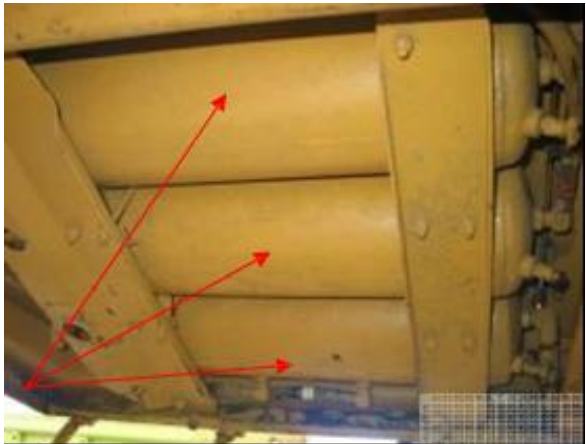
<p>The air tanks that can be located under the front end (red arrows). The topside of these can be difficult to access and may require dismantling for cleaning and inspection.</p>

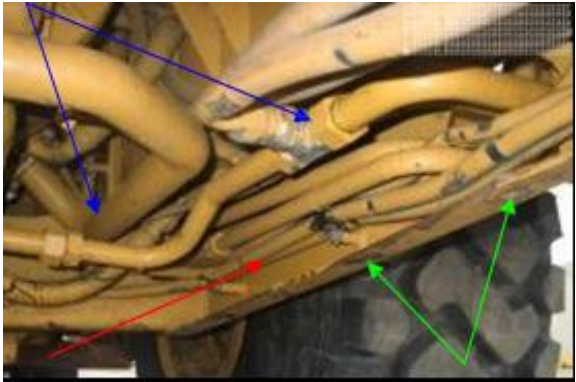
Description	Images
<p>The underside of the front end and hollow chassis rail (red arrow). The belly plates have been removed, allowing access for flushing both channels via the vacant belly plate bolt-holes (green arrows). All hydraulic hoses require thorough cleaning and inspection (blue arrows - especially the non-visible surfaces).</p>

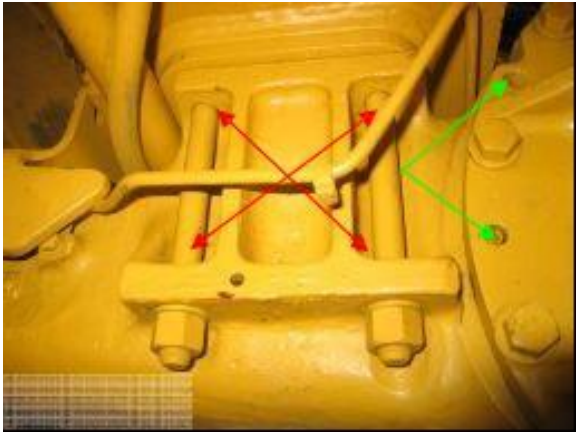
<p>Each axle on either side of the differential has supports (red arrows) for the housing above. Each of these areas requires thorough cleaning and inspection. Check all countersunk recesses (green arrows).</p>

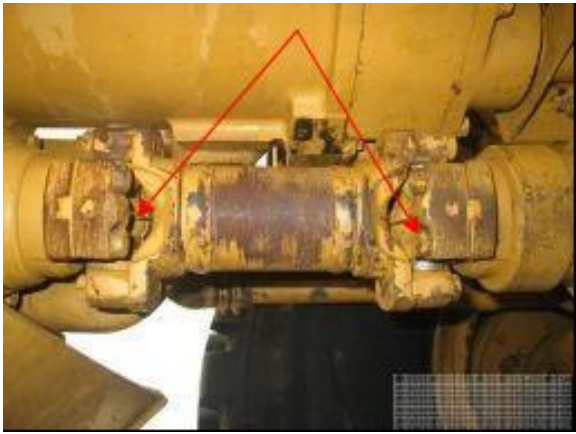
<p>All universal joints must be free of contaminated grease.</p>

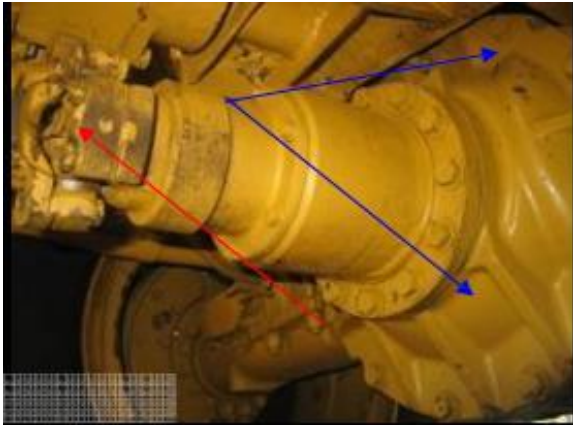
Description	Images
<p>All universal joints must be free of contaminated grease (red arrow). The bell housing (blue arrow) has many nooks, ledges, countersunk holes and hydraulic hoses, all of which require careful cleaning and inspection.</p>

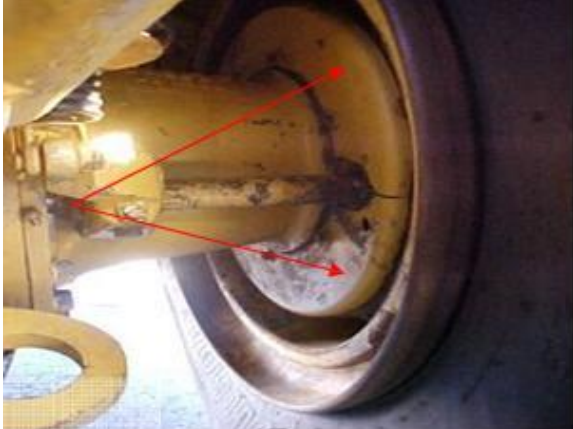
<p>All non-affixed internal wheel rims (red arrows) must be removed for cleaning and inspection.</p>

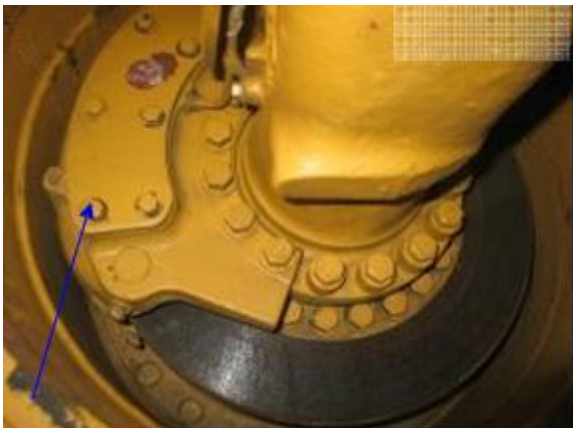
<p>Thoroughly inspect all internal wheel rim surfaces. A mirror is recommended to inspect the backside of the brake drum (blue arrow).</p>

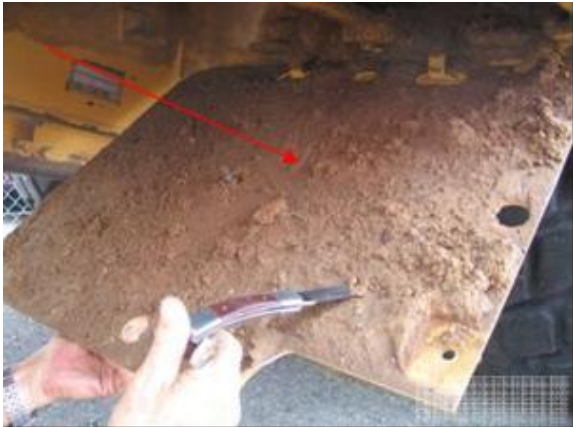
Description	Images
<p>A non-affixed panel removed from under the cabin floor (red arrow). This illustration highlights the amount of BRM that can be found in these areas.</p>

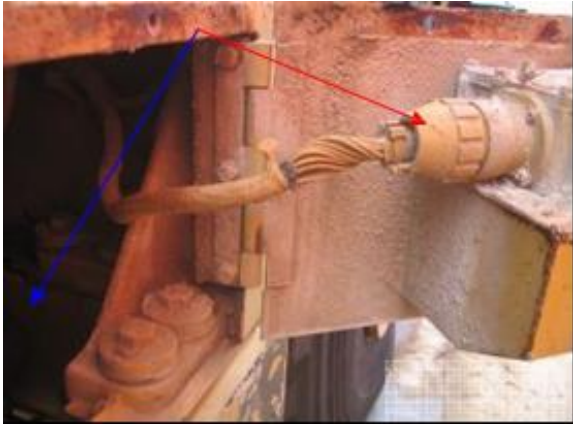
<p>A small door below the cabin, which also provides access to the BRM seen in the last illustration (red and blue arrow).</p>

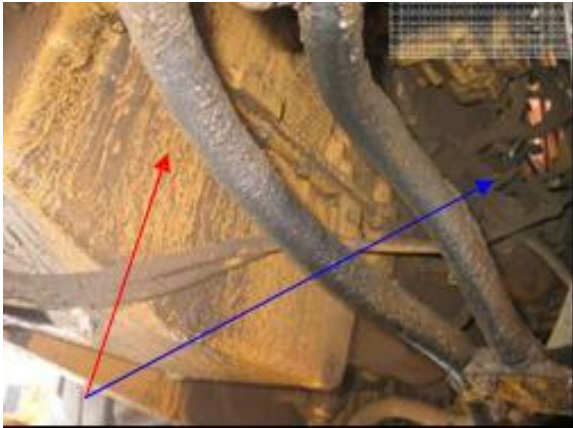
<p>The side of the sump (red arrow), which can only be accessed once all belly plates have been removed. Note the amount of BRM (blue arrow) that can be seen in the surrounding area. This whole area must be thoroughly cleaned and inspected.</p>

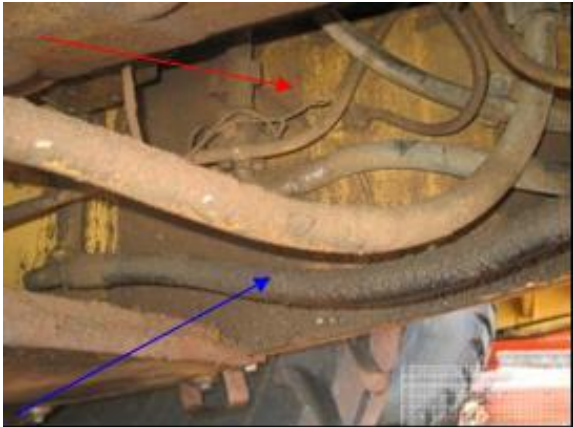
Description	Images
<p>The inside chassis rails (red arrow), visible once the belly plates have been removed. All hydraulic hoses (blue arrow) must be thoroughly cleaned and inspected.</p>

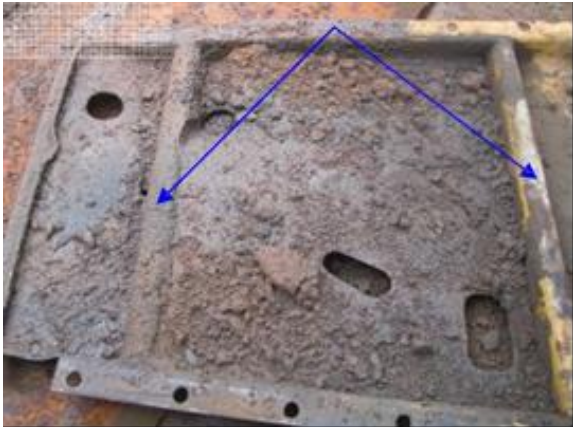
Description	Images
<p>Belly plates must be removed and thoroughly cleaned. Check for openings along the framework (blue arrows). If open, these will require flushing to verify cleanliness.</p>

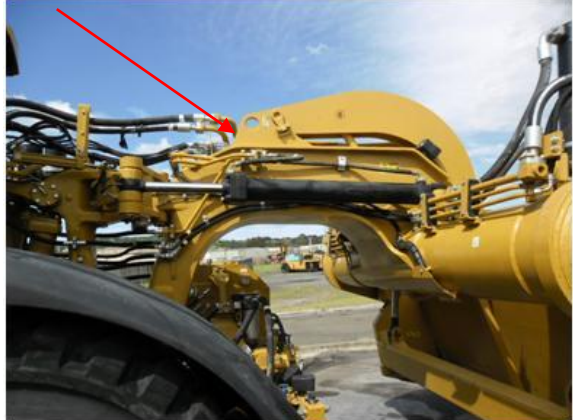
Description	Images
<p>The gooseneck found on all scrapers. Check all surfaces of the gooseneck for any openings or drainage holes. On some models the opening may be topside (red arrow). All hydraulic hoses and lines must be thoroughly cleaned and inspected. Remove all contaminated grease from pivot points and rams.</p>

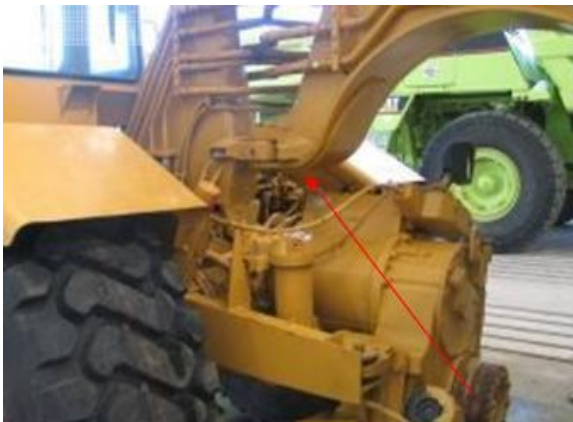
<p>Check all surfaces of the gooseneck for any openings or drainage holes. On some models the opening may be at the bottom (red arrow).</p>

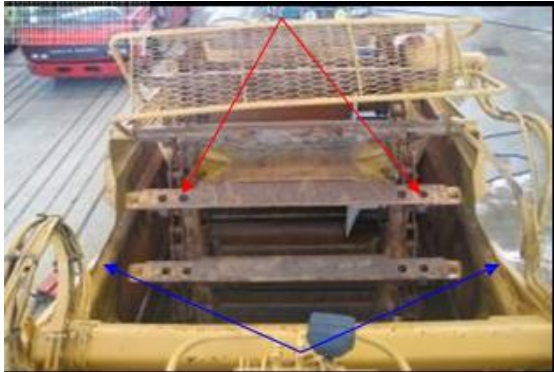
Description	Images
<p>The elevator as seen from the gooseneck. This area consists of a series of blades (red arrows) on a chain, used to push the load to the rear of the bowl. The blue arrows highlight the side of the bowl, which will be highlighted later.</p>

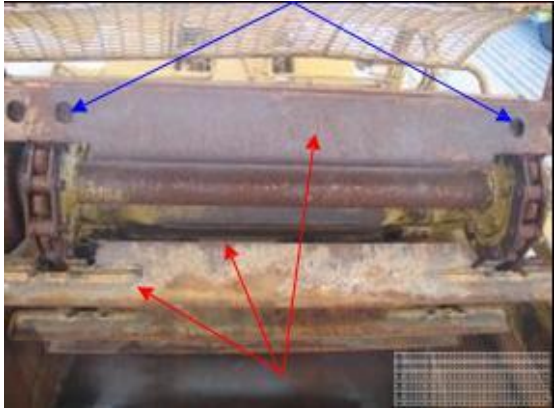
<p>A photograph showing the elevator mechanism from a perspective looking down from the gooseneck. Several horizontal blades are visible, mounted on a chain. Red arrows point to the blades, and blue arrows point to the sides of the bowl structure.</p>
<p>The elevator blades (red arrows) are hollow and need to be flushed via the entrance holes (blue arrows) to verify cleanliness.</p>

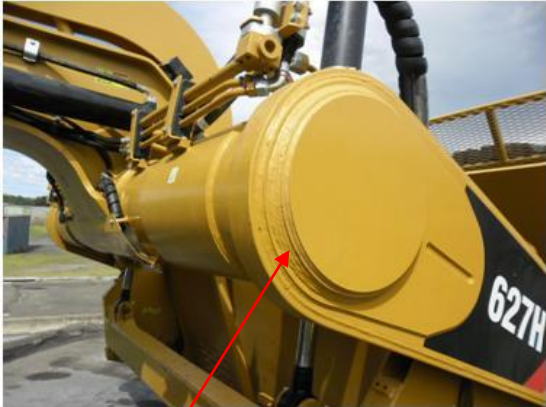
Description	Images
<p>An illustration of the cylinder, located just behind the gooseneck (red arrow). This area is hollow and can harbour significant amounts of BRM. Generally a sealed unit as illustrated however check for cracks, splits or evidence of repair. On this model the ends are completely welded, sealing the unit, but on other models this plate may only be spot-welded. If only spot-welded, flush inside to verify cleanliness.</p>

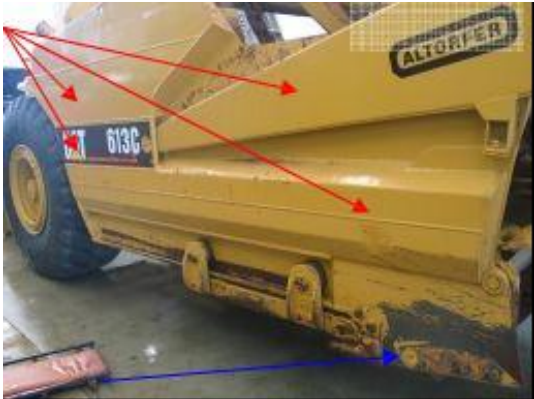
Description	Images
<p>An illustration of the side of a typical scraper bowl. The sides, rear and underside of most scraper bowls are hollow structures and can potentially harbour hundreds of litres of BRM. The red arrows highlight that there may be separate compartments and the blue arrow shows where the wear plates have been removed.</p>

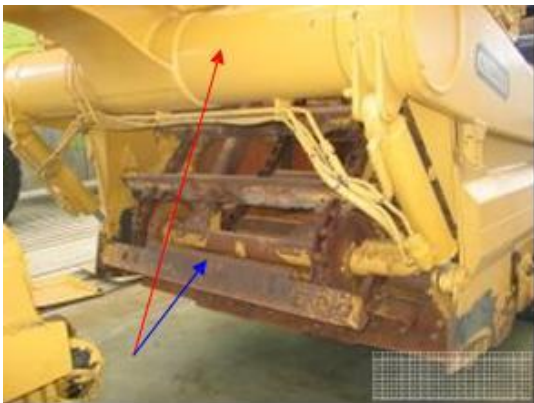
<p>The front of the scraper bowl (blue arrow), also showing the elevator and cylinder (red arrow).</p>

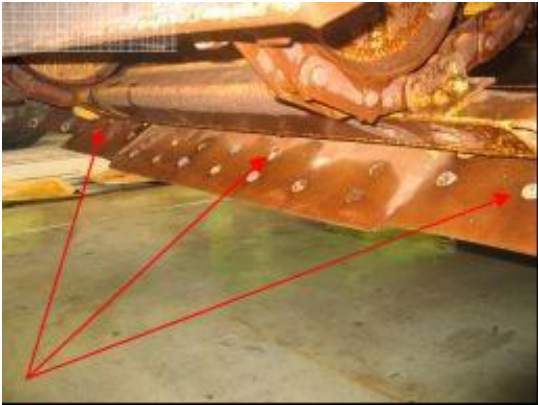
Description	Images
<p>All cutting teeth (red arrows) along the front of the bowl are to be loosened and flushed behind to verify cleanliness.</p>

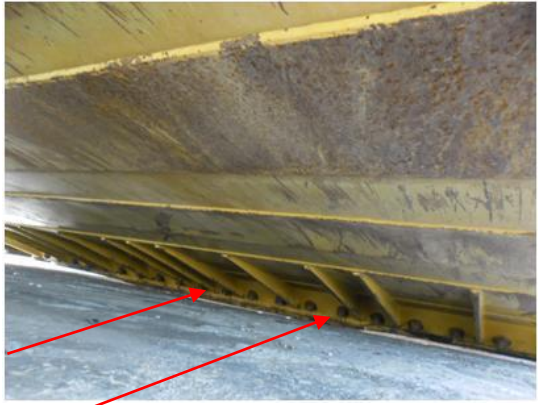
<p>The underside of the cutting teeth. Ensure around each bolt head (red arrows) is clean as well as looking for any cracks, splits or evidence of repair on the underside. The bowl will have to be supported by chocks at the time of inspection.</p>

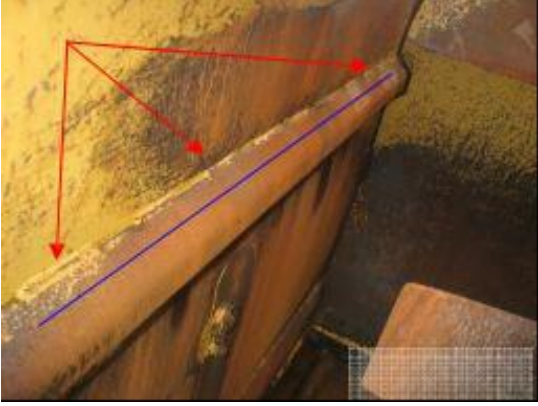
<p>The internal wall of the scraper bowl may have protective plates, covering the hydraulic hoses as they run from front to back. This area is hollow and may only be spot welded (as highlighted by the red arrows), or open-ended and will require flushing to verify cleanliness. The blue line indicates the hollow channel.</p>

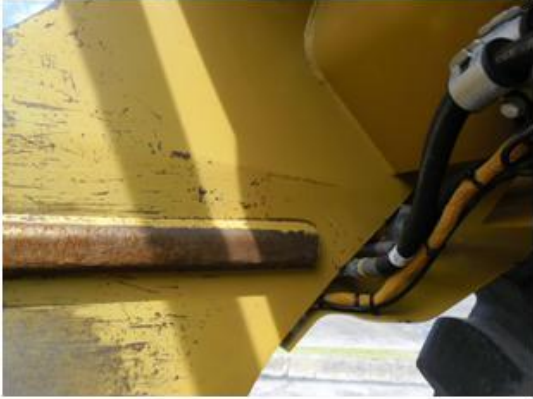
Description	Images
<p>Another example of a protective plate, covering the hydraulic hoses.</p>

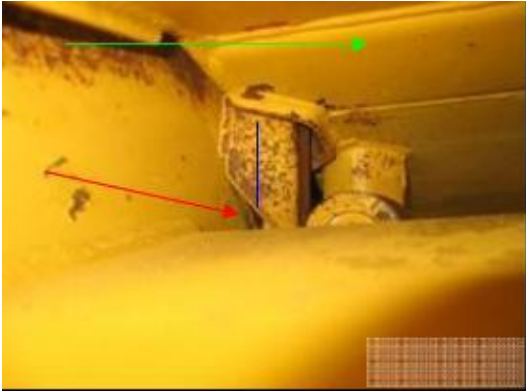
<p>The ends of the protective covers, which were highlighted in the last few illustrations. In this picture the open-end (red arrow) can be seen behind the rear of the bowl (green arrow) and this channel (blue line) will require flushing to verify cleanliness.</p>

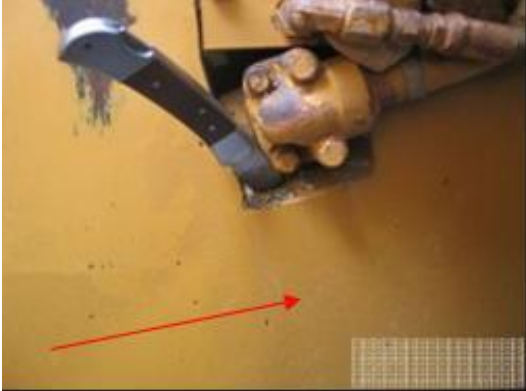
<p>This illustration highlights the exit of the hydraulic hoses from the inside of the bowl, just behind the rear. This is a natural opening on some models, allowing hundreds of litres of BRM to enter the sides. The knife is supported by the amount of BRM inside (the red arrow highlights the area full of BRM).</p>

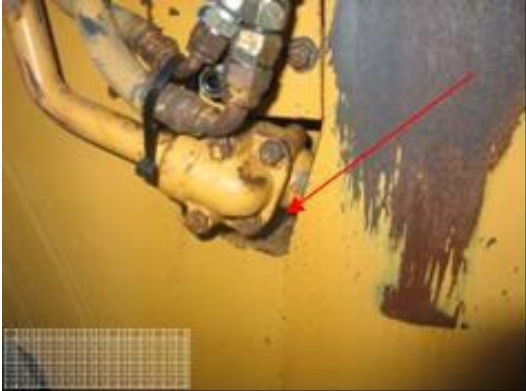
<p>On some models these natural openings can be found on each side of the bowl, behind the rear face. This side is also full of contaminants (red arrow).</p>

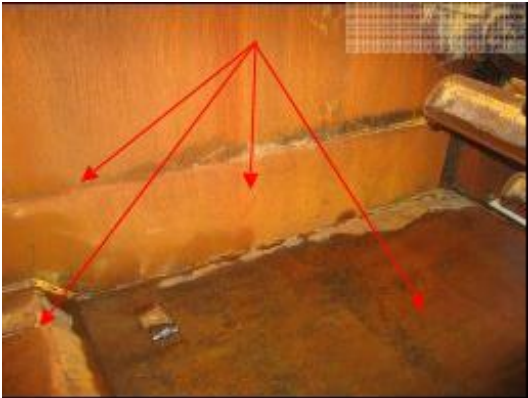
Description	Images
<p>The inside face of a typical scraper bowl. Check all surfaces carefully for any cracks, splits or evidence of repair. If detected, these areas will need to be investigated to be verified clean (red arrows).</p>

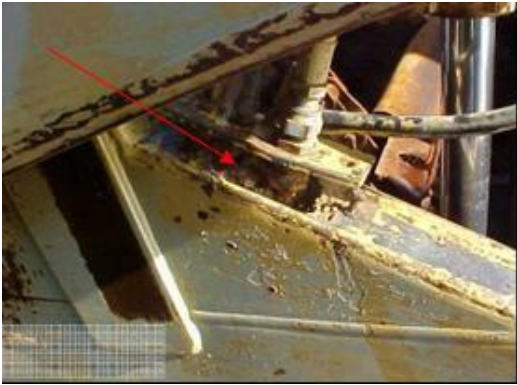
<p>This illustrates the hydraulic lines entering the sides of the bowl at the front end. Several bolts have been removed, allowing access for inspection. This area has been illustrated to show that these sides can be full of BRM.</p>

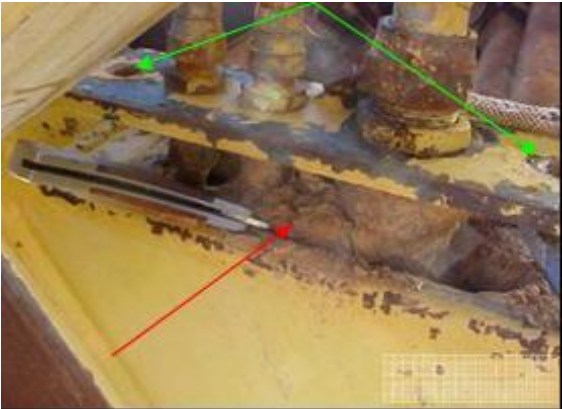
<p>A close view of where the hydraulics enter the side of the bowl. Once again, several bolts (green arrows) have been removed to allow for cleaning and inspection. This area has been illustrated to show that these sides can be full of BRM (red arrows).</p>

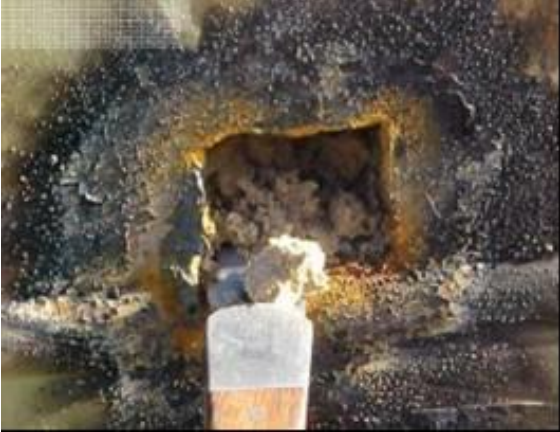
<p>Another illustration to highlight an area where repairs were detected. The area was examined and the inside of the bowl was contaminated.</p>

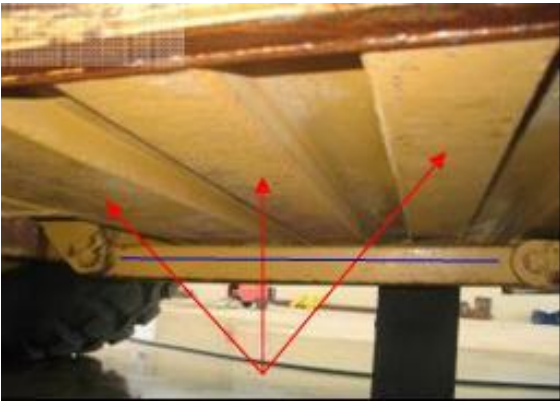
<p>The underside of the scraper bowl, showing individual gussets that can each harbour BRM (red arrows). Check all surfaces for cracks, splits or evidence of repair. The beam highlighted by the blue line may also be hollow and require flushing.</p>

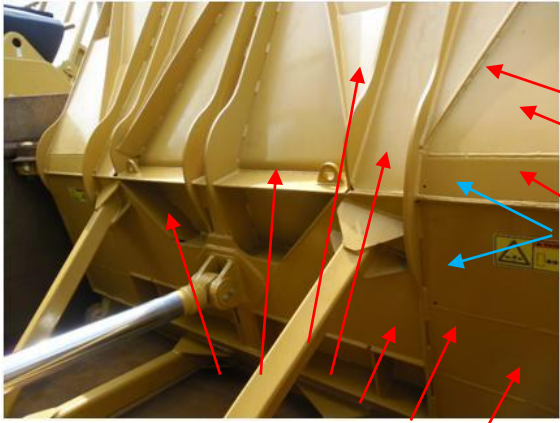
<p>More modern models have a number of hollow sections in the back of the ejector of the scraper bowl (red arrows). Some of these areas have flush holes that are easily accessible. Whilst other compartments are spot welded. Care should be taken to inspect for damage and that access has been granted to all hollow (blue arrows)</p>

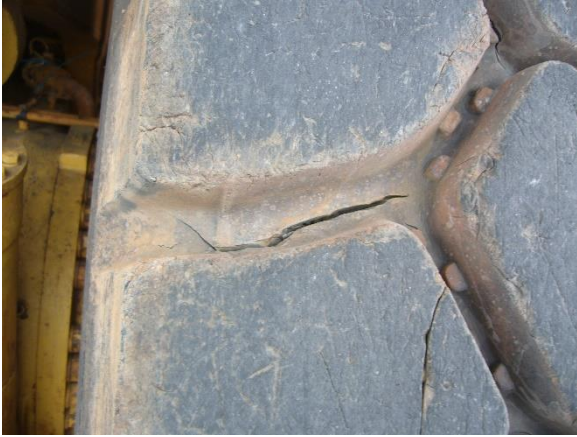
Description	Images
<p>All cracks and splits in tyres must be verified to ensure that all are free of BRM.</p>

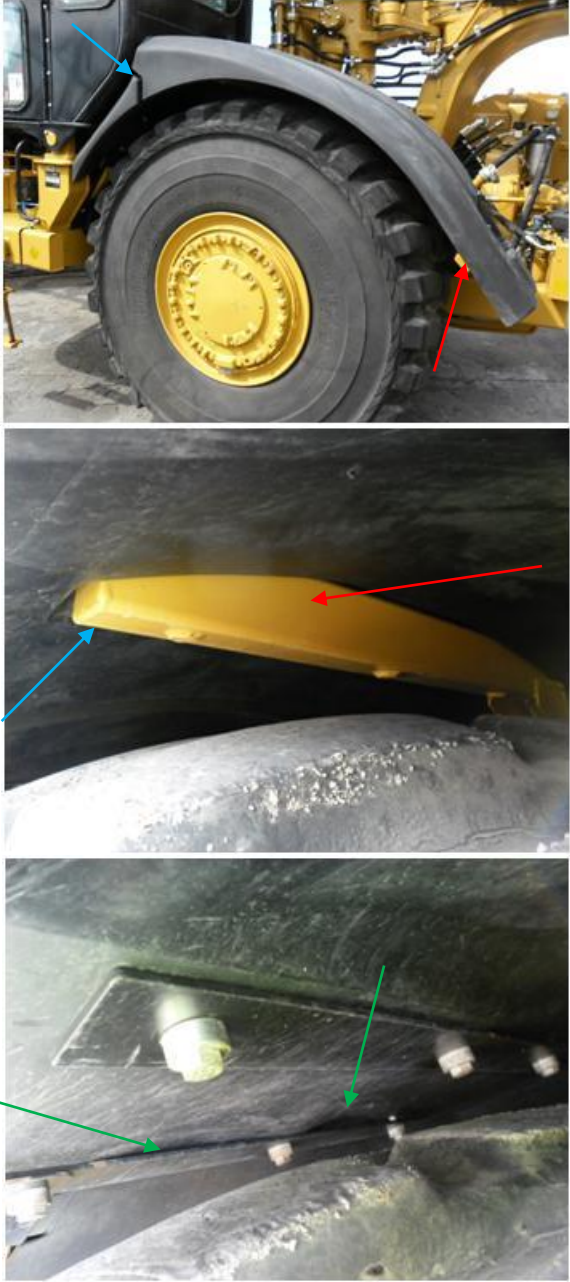
Description	Images
<p>Newer models now have plastic wheel guards over the front wheels. These guards are held in place with hollow metal support rails (red arrow). The plastic guards should be loosened off to allow access between the plastic and metal supports where BRM is easily caught up as the plastic is warped and damaged (green arrows). Also bends are formed in the plastic from manufacture where the supports are housed allowing little to no access for cleaning (blue arrow). Care should be taken to ensure the plastic guards are not damaged or breached, allowing risk material to build up inside.</p>

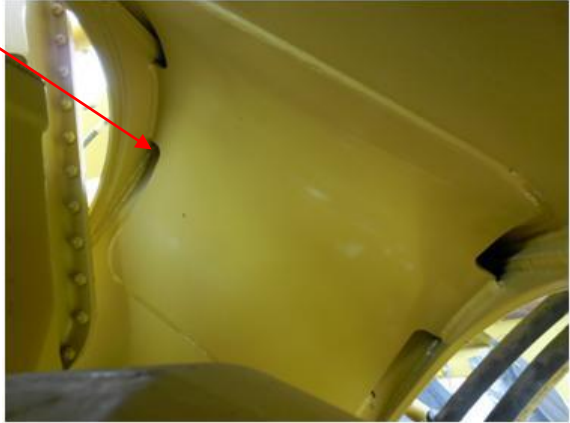
<p>The metal guards over the rear wheels of the newer models have a hollow section inside the guard which can harbor large amounts of BRM (red arrow).</p>

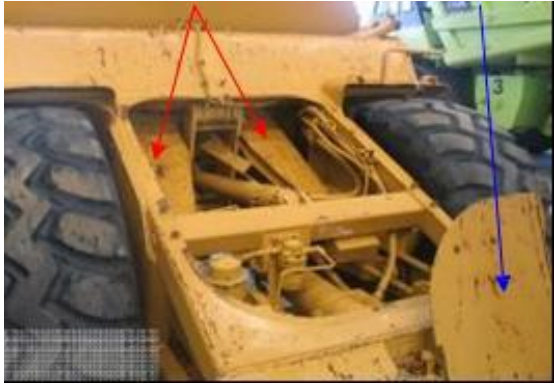
Description	Images
<p>The rear end of the scraper with all non-affixed panels removed, allowing access for cleaning and inspection. The red arrows highlight the rails under the rear, which will be seen later (red arrow).</p>

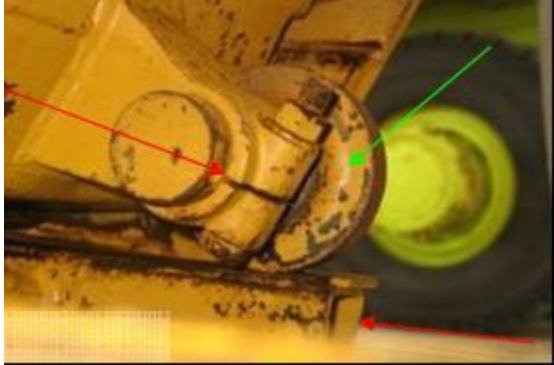
<p>At the back of the bowl and under the rear, check the small bowl pulley wheels (green arrow) and flush small recesses (red arrow).</p>

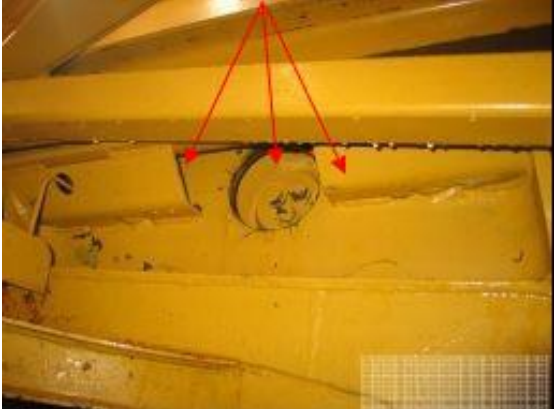
<p>Hollow cavities (red arrows) such as these are common under the rear of scrapers. All must be accessible at inspection.</p>

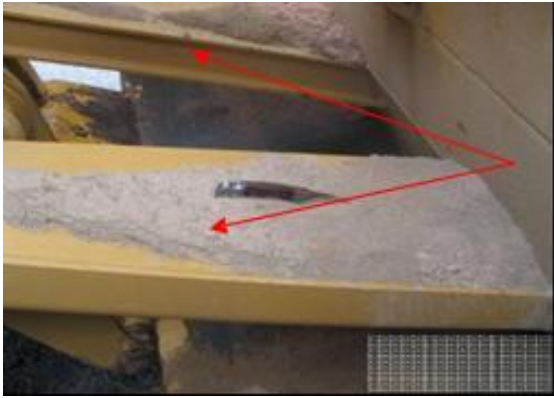
Description	Images
<p>The rails (red arrows) as seen under the rear of the scraper, behind the bowl. These areas can hold significant amounts of BRM.</p>

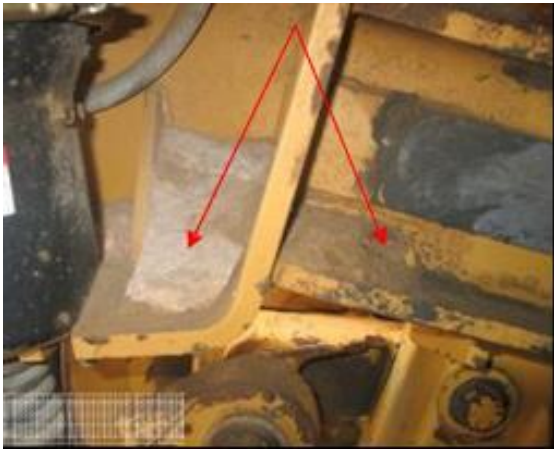
<p>An example of the different nooks and ledges that can be found under the rear of the scraper, harbouring BRM.</p>

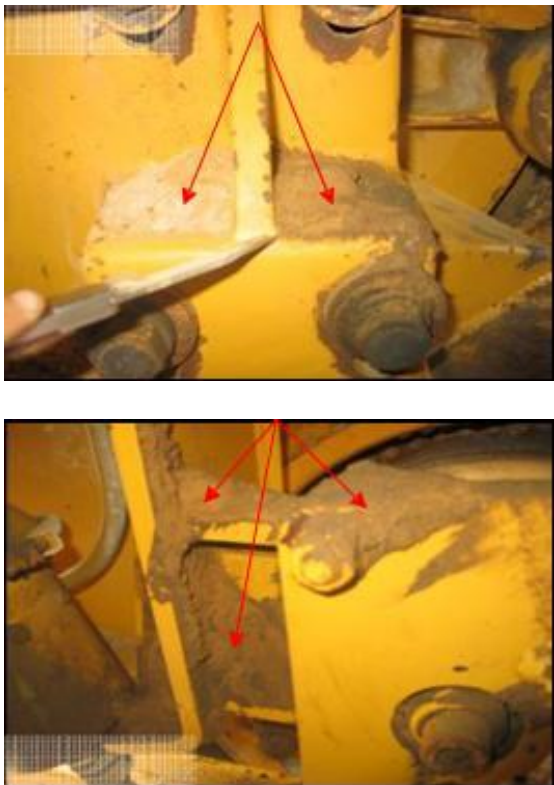
<p>More examples of the different nooks and ledges that can be found under the rear of the scraper, harbouring BRM.</p>

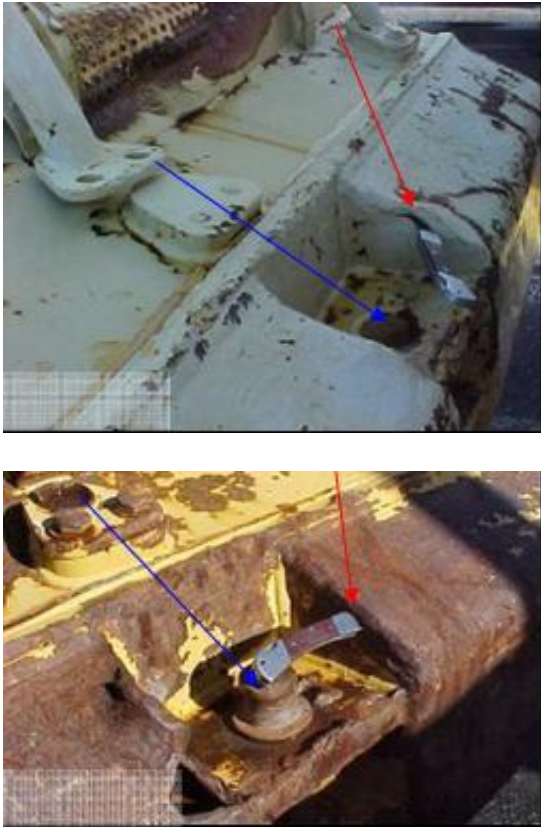
Description	Images
<p>Examples of the rear drawbars on scrapers. In each, a crack in the drawbar (red arrows) can be seen, which will require further investigation in order to verify the internal cleanliness. Remove the pins (blue arrows), as sometimes the access point to these areas maybe via this entrance (or drainage holes below).</p>

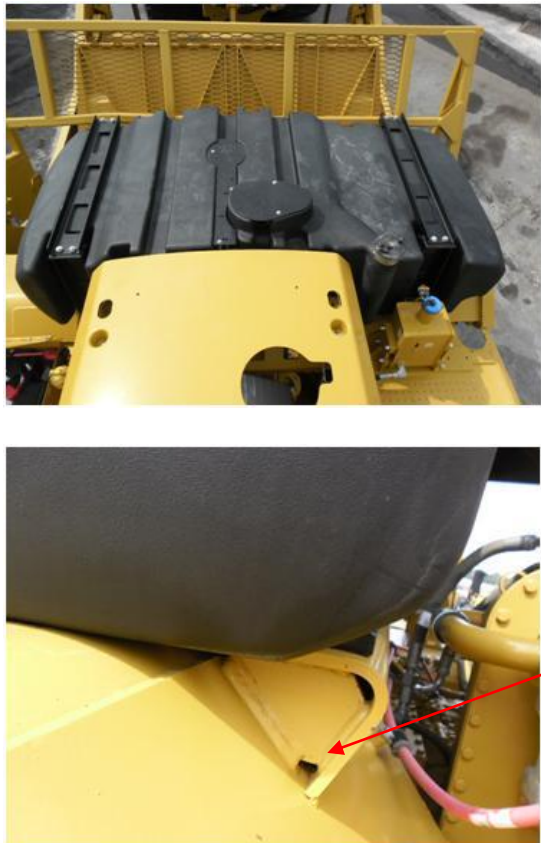
<p>Modern models now have a plastic fuel tank mounted to the rear of the scraper. Care is required to verify no risk material has lodged under the fuel tank as the fuel tank has been moulded to fit in place access is difficult. The fuel tank also sits on hollow sections that require flushing (red arrow).</p>
