Australian Government
Department of Agriculture
and Water Resources

Machinery Cleaning Guide - Wheel Loader

April 2016

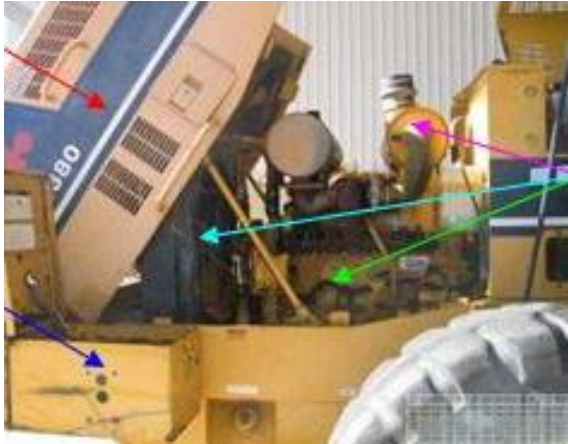
Description	Images
<p>A wheel loader where the engine cover pivots rearwards. Areas of significance that will be highlighted for cleaning and inspection purposes are the engine cover (red arrow), battery box (blue arrow), engine block (green arrow), radiator (aqua arrow) and the air-filter (purple arrow).</p>

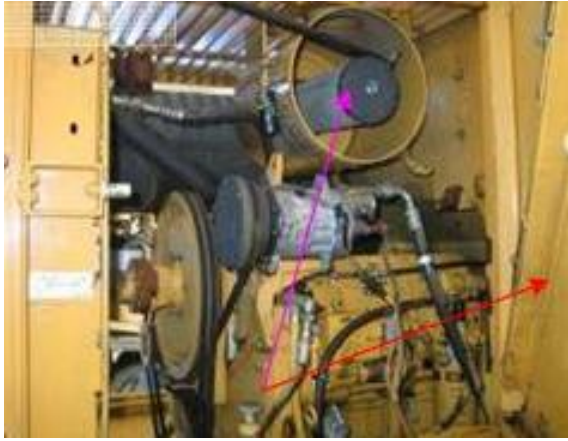
<p>This picture illustrates the side of the engine block and the air-filter housing, which has had the outer filter removed (purple arrow). On this particular model the engine cover is accessed, by opening hinged doors (red arrow).</p>

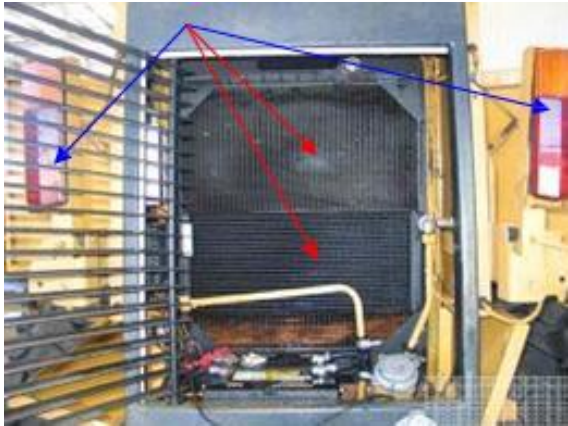
<p>Illustrates the rear of the wheel loader and the radiator grill open, exposing the oil cooler and radiator fins (red arrows), which need to be flushed in the presence of the inspecting officer in order to verify cleanliness. Check all internal surfaces of the light covers (blue arrows).</p>

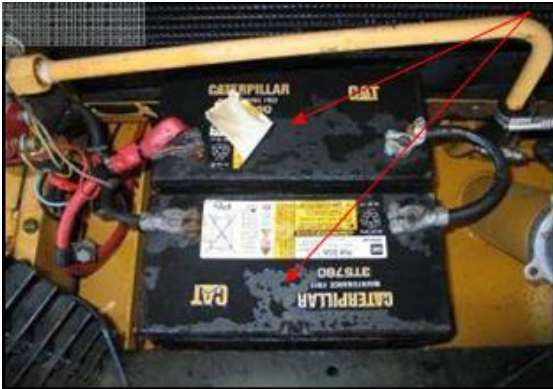
Description	Images
<p>On this model the batteries are located behind the radiator. Each battery (red arrows) must be loosened from the tie-down points and the underside and housing inspected.</p>

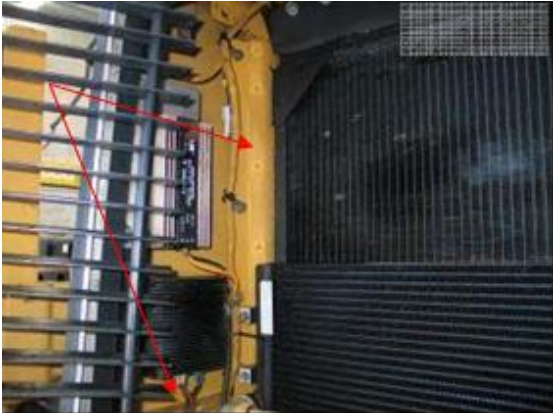
<p>This picture illustrates the left hand side of the engine cover near the radiator. Check for any hollow channels as indicated by the red arrows. If hollow and open-ended, they will require flushing to verify cleanliness.</p>

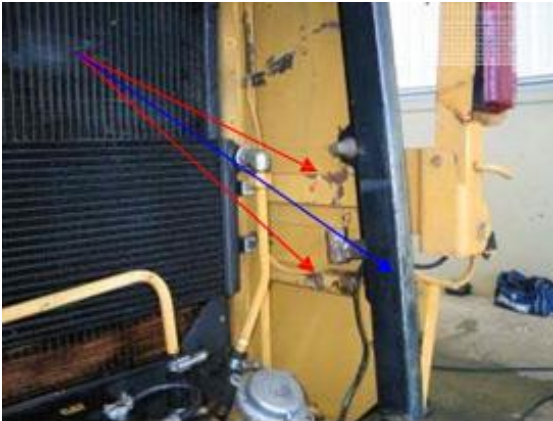
<p>This picture illustrates the right hand side of the engine cover near the radiator. The two red arrows highlight open-ended channels that will require flushing to verify cleanliness. Check the outside framework (blue arrow) for open ends or drainage holes. If present, flush to verify clean.</p>

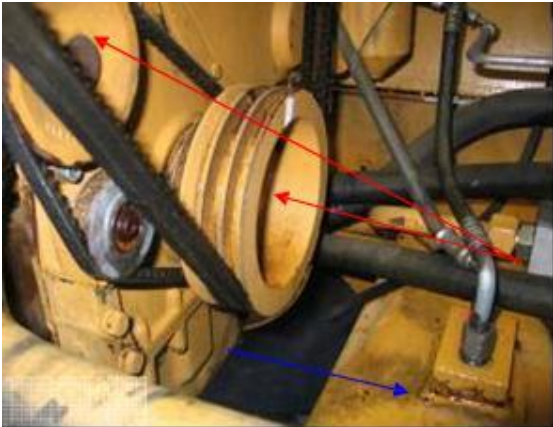
Description	Images
<p>At the rear of the engine block are the harmonic balancers or flywheels (red arrows). These are generally concave and can harbour a significant amount of biosecurity risk material. While inspecting these, check the topside of the fuel cell (blue arrow).</p>

A close-up photograph of the rear of an engine block. Two red arrows point to the concave harmonic balancers (flywheels). A blue arrow points to the topside of the fuel cell.
<p>The radiator grill has been removed, allowing inspection access into the bottom of the shroud.</p>

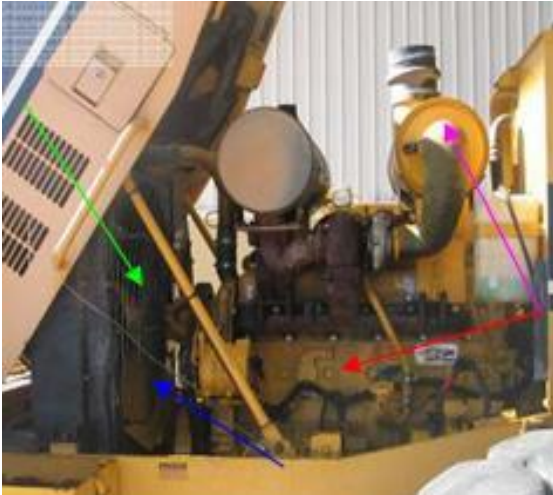
A wide-angle photograph of the engine block and radiator. A blue arrow points to the internal radiator grill. A green arrow points to the harmonic balancers (flywheels). A purple arrow points to the air-filter. A red arrow points to the side of the engine block.

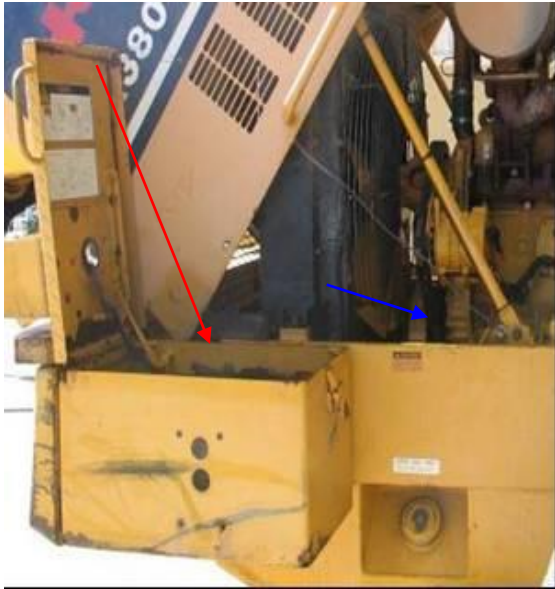
Description	Images
<p>On most models the batteries are located in boxes (red arrows) on either side of the chassis. The batteries need to be loosened from the tie-down points and checked underneath. Battery box entrance holes into the hollow chassis rail (blue arrow). These chassis rails, on the larger models are hollow and can be accessed via small holes in the side of the battery box (where the battery cables go) or once the belly plates have been dropped, flush the open holes where the bolts have been removed.</p>

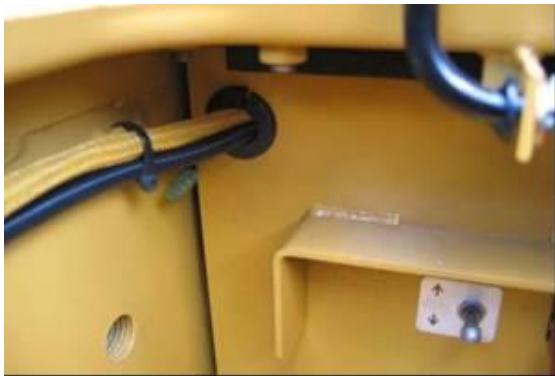
<p>This illustration shows the small hole that can sometimes be found in the battery box – the cables go through this hole, into the hollow chassis rail.</p>

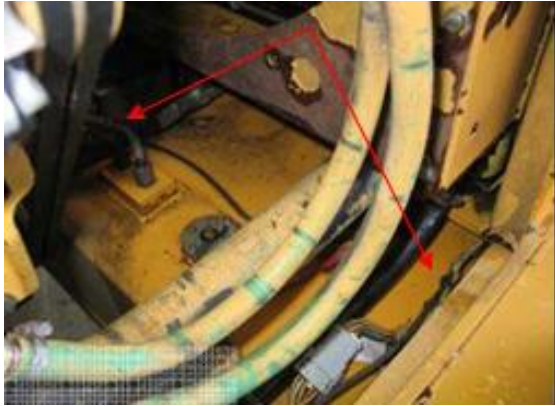
<p>The topside of the fuel cell, under the radiator. Generally there are small gaps either side of the fuel cell (red arrows), inside the chassis rail. This small recess will be further highlighted in the next series of pictures.</p>

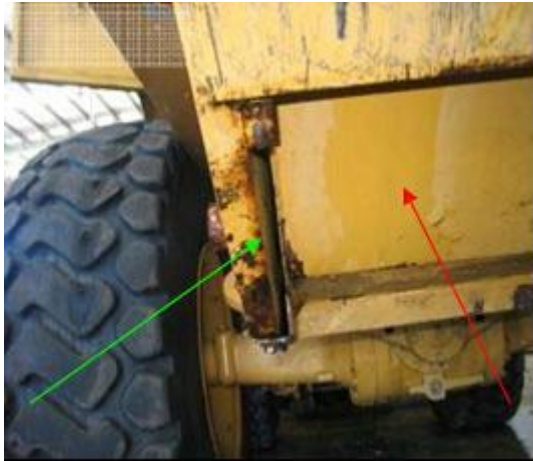
Description	Images
<p>The underside of the fuel cell (red arrow) from the rear. The rear belly plate has been removed, allowing access to the small recess (green arrow) between the fuel cell and the left hand side of the wheel loader.</p>

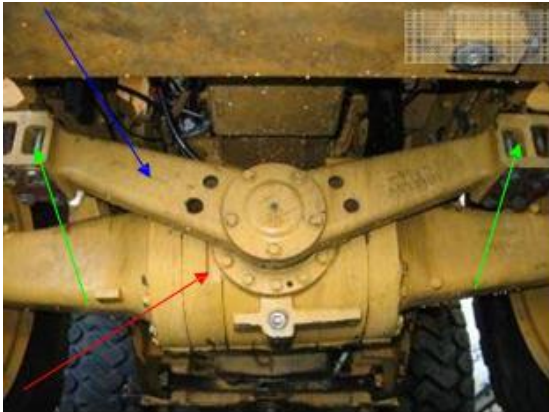
<p>Rear view of the diff (red arrow) and sway bar (blue arrow). Note the holes in the sway bar, indicating a hollow structure that will require flushing. Ensure that all recesses where sway bar attaches to the chassis (green arrows) are clean.</p>

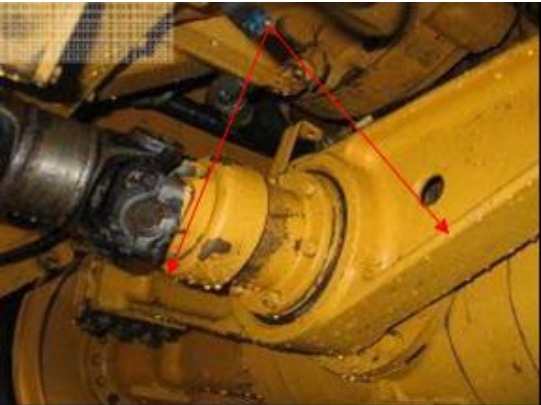
Description	Images
<p>Another example of a sway bar, not hollow like the last example, but does have horizontal ledges (red arrows), both back and front that can harbour biosecurity risk material.</p>

A close-up photograph of a yellow metal sway bar assembly. Two red arrows point to horizontal ledges on the bar, one pointing to a ledge on the back side and one pointing to a ledge on the front side. The assembly is connected to a larger yellow component.
<p>The small recess between the fuel cell and chassis rail (red arrow). This illustration also highlights the countersunk belly plate bolt holes (blue arrow) – flushing points for hollow chassis rails.</p>

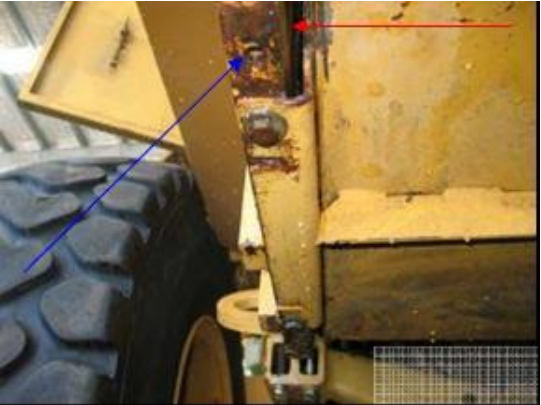
A close-up photograph of a yellow chassis rail. A red arrow points to a small recess between the rail and another component. A blue arrow points to a countersunk bolt hole on the belly plate of the rail. A blue 'X' is marked on the rail surface.

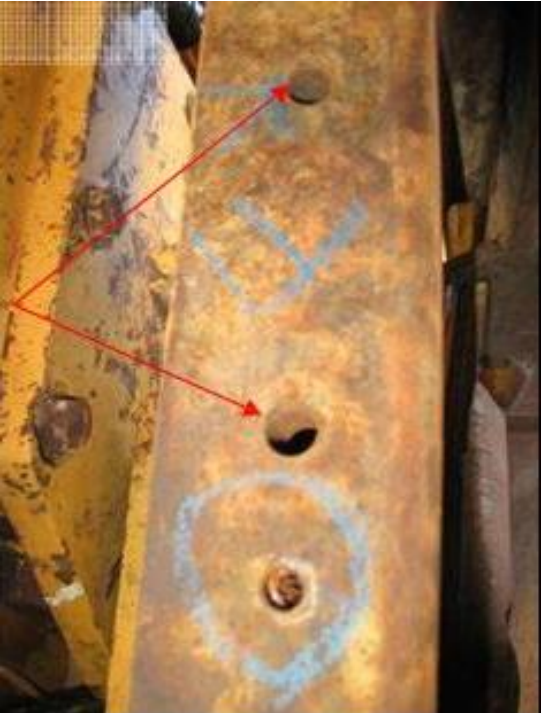
<p>Another example of the belly plate bolt holes (red arrows), allowing this hollow chassis rail to be flushed to verify cleanliness.</p>

A close-up photograph of a rusty, yellow-painted chassis rail. Two red arrows point to bolt holes on the belly plate. A blue 'X' is marked on the rail surface, and a blue circle highlights one of the bolt holes.

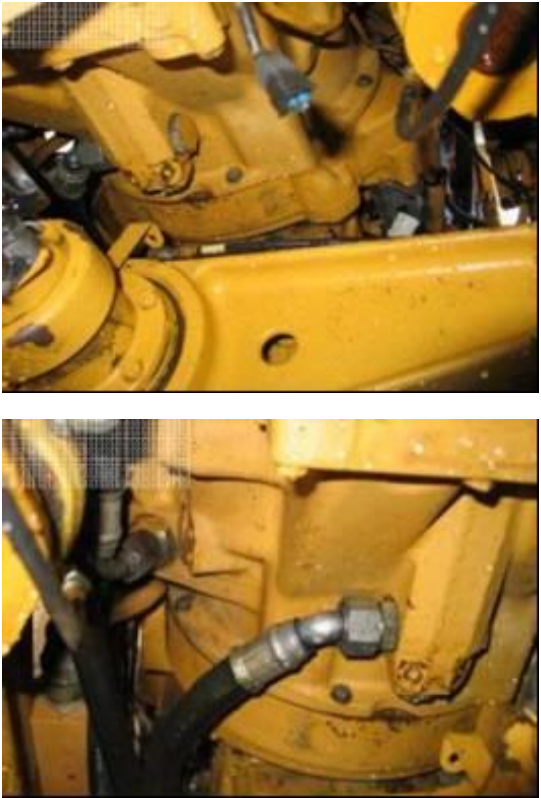
Description	Images
<p>The bell housing as seen from either side of the universal joint. This bell housing has many nooks, ledges, countersunk holes and hydraulic hoses, all of which require careful cleaning and inspection.</p>

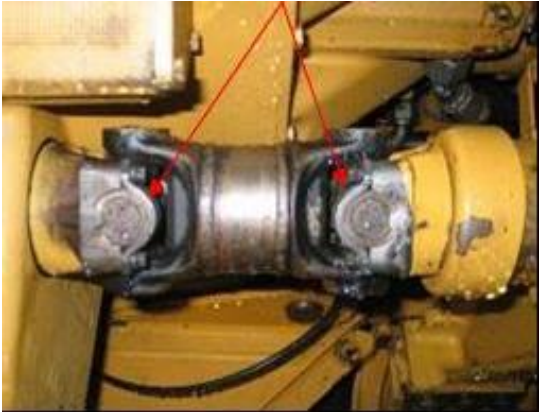
<p>All universal joints must be free of contaminated grease (red arrows).</p>

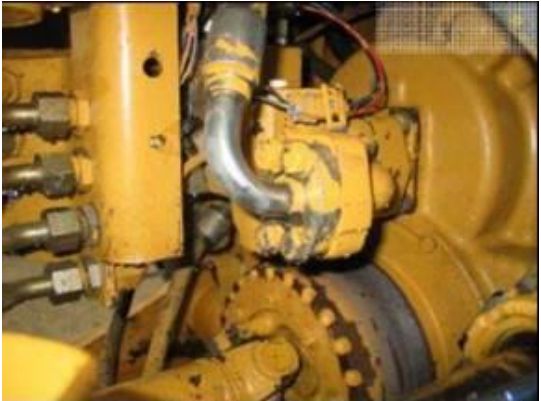
<p>The front of the engine block, situated below the cabin floor. This area has many nooks, ledges, countersunk holes and hydraulic hoses, all of which require careful cleaning and inspection.</p>

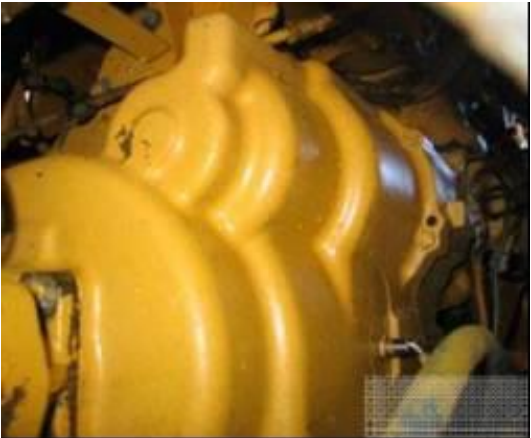
Description	Images
<p>The topside of the engine block, just below the cabin floor. On some models, this area can be one of the hardest areas to clean and inspect. This area also has many nooks, ledges, countersunk holes and hydraulic hoses, all of which require careful cleaning and inspection.</p>

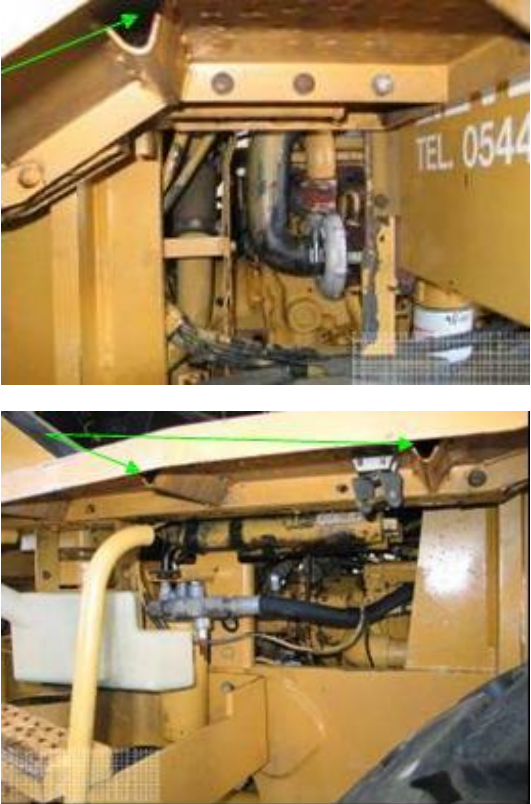
<p>To enable thorough cleaning and inspection, all non-affixed side panels need to be removed. The hollow, open-ended gussets (green arrows) under the rails need checking.</p>

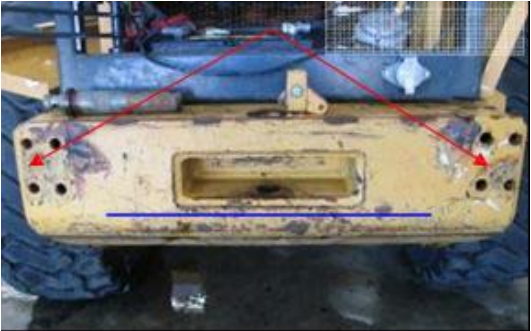
<p>Note that the counterweights have been removed from the rear drawbar (red arrows). The area highlighted by the blue line is hollow and access will be shown next.</p>

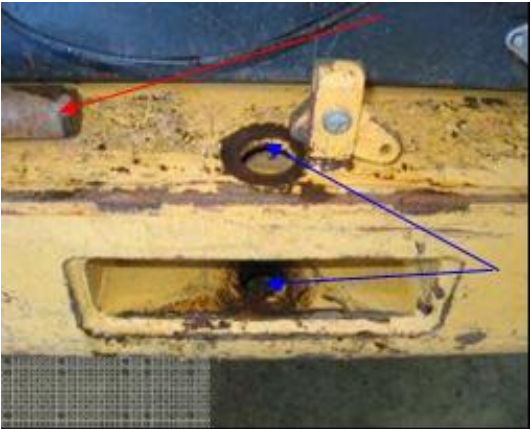
Description	Images
<p>Once the pin is removed from the drawbar (red arrow), on some models this area is hollow and requires flushing to verify cleanliness (blue arrows). Other hollow rear drawbars may have access points elsewhere (drainage holes underside).</p>

A close-up photograph of a yellow metal drawbar. A red arrow points to a pin being removed from a hole. Two blue arrows point to hollow areas on the surface, indicating where flushing is required for cleaning.

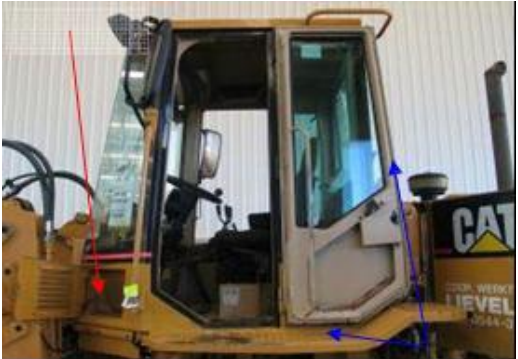
Description	Images
<p>The side view of the wheel loader cabin. Note that all non-affixed panels have been removed allowing cleaning and inspection access (red arrow). All door rubbers have been removed for cleaning (blue arrows).</p>

A side-view photograph of a yellow wheel loader cabin. A red arrow points to a removed panel on the side. Blue arrows point to the removed door rubbers on the door.
<p>The internal door panelling (red arrow) and door rubbers (blue arrows) have been removed for cleaning and inspection.</p>

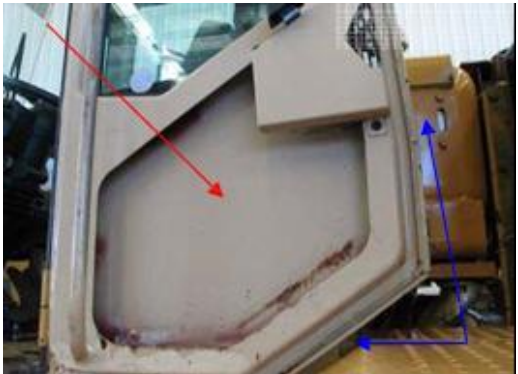
A close-up photograph of the internal door panelling. A red arrow points to the removed panelling. Blue arrows point to the removed door rubbers.

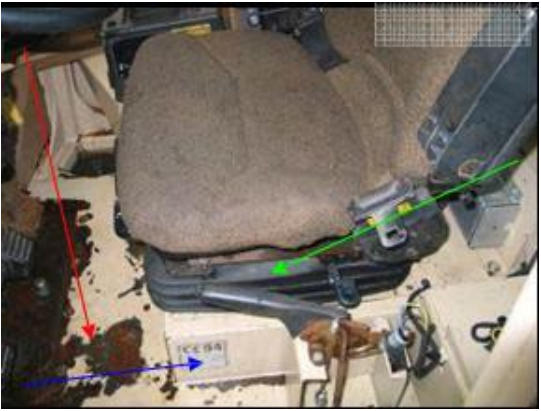
Description	Images
<p>The rubber floor matting has been removed (red arrow). The seat may have to be removed to allow access to the air-conditioning box underneath (blue arrow), or at least to clean under the seat and inside of the rubber shroud (green arrow).</p>

A photograph showing the interior of a wheel loader cab. A large, light-colored seat is in the center. To the left, a red arrow points to the floor area where a rubber mat has been removed. To the right, a green arrow points to the underside of the seat. A blue arrow points to a rectangular box, likely the air conditioning unit, located below the seat. The floor is covered with a light-colored, fibrous material.
<p>Access will be required to verify that the inside surfaces of the joystick control panels are clean (red arrows).</p>

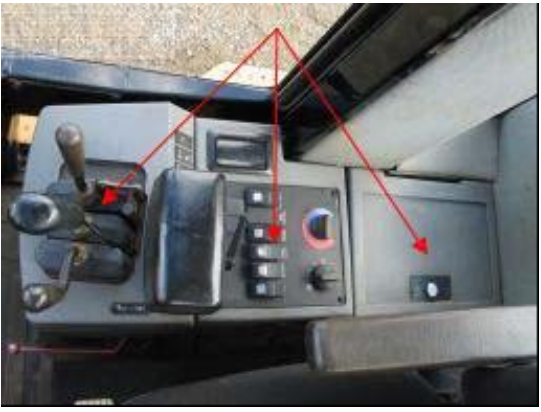
A close-up photograph of the joystick control panels in the cab. Two red arrows point to the internal surfaces of the joystick housings. Another red arrow points to a panel on the right side of the control area. The panels are grey and have various buttons and switches.

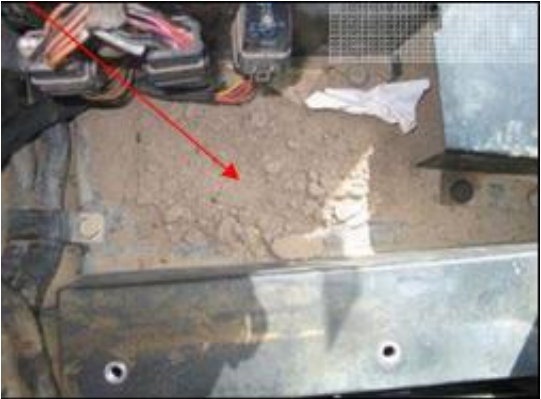
<p>Not all internal surfaces of the joystick controls are contaminated, but this was found after one joystick control panel was removed (red arrow).</p>

A close-up photograph of a removed joystick control panel. A red arrow points to a surface that appears to be contaminated with a light-colored, fibrous material. The panel is resting on a metal surface.

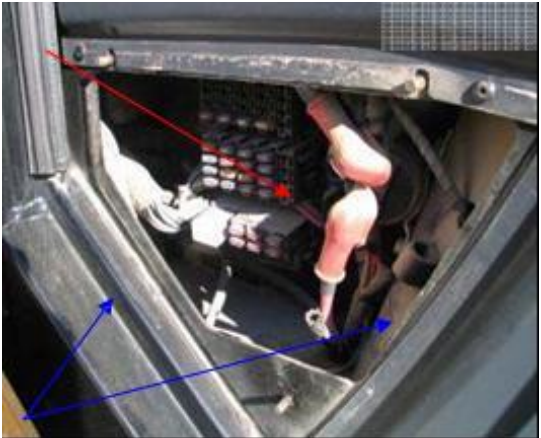
Description	Images
<p>Ensure that the fuse box cover is removed for inspection (red arrow). There is not a lot of biosecurity risk material in this illustration, however all must be free of biosecurity risk material. Also check rubber seals (blue arrows).</p>

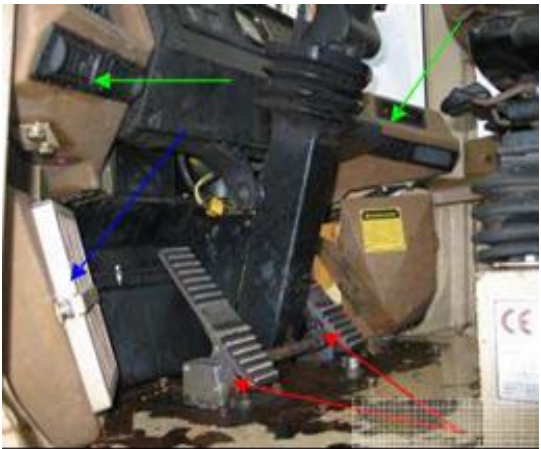
<p>The rubber pedal covers (red arrows) have been removed and cleaned. The internal filter (blue arrow) must be verified, as well as the air-conditioning vents (green arrow).</p>

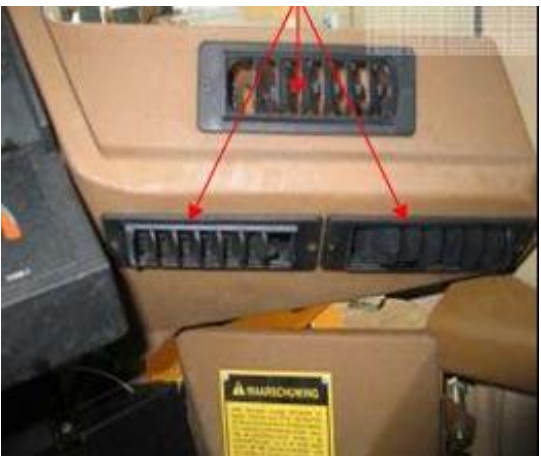
<p>A close up of the air-conditioning vents (red arrows), which must be internally cleaned and accessible for inspection.</p>

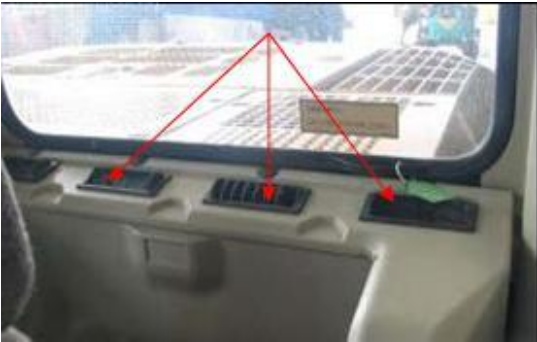
Description	Images
<p>The air-conditioning vents behind the seat (red arrows). These areas must be cleaned and accessible for inspection.</p>

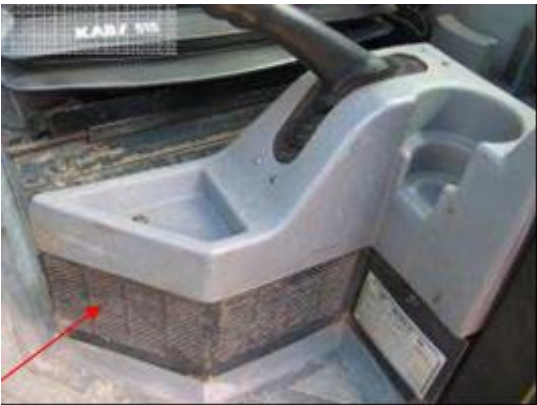
<p>On some models a handbrake set-up such as this may be found. The air-conditioning grill (red arrow) is directly underneath and access for cleaning and inspection will be required.</p>

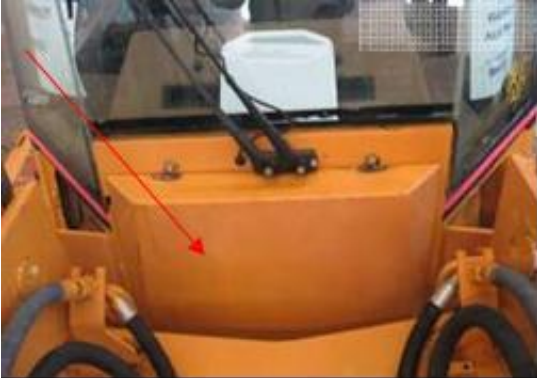
<p>On some models, this non-affixed panel over the windscreen wiper motor must be removed for inspection (red arrow).</p>

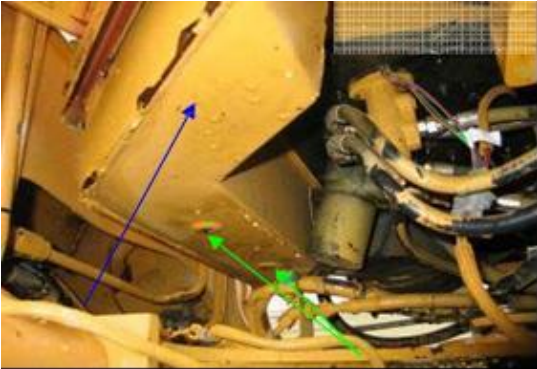
<p>On some models, under the cabin there may be box channels such as the one highlighted in this picture (blue arrow). Note the small drainage holes on the bottom (green arrows). This area must be flushed to verify cleanliness.</p>

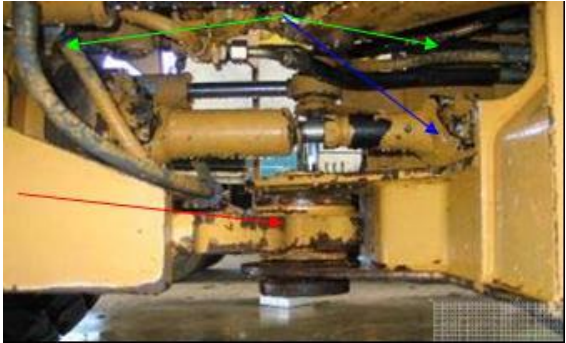
Description	Images
<p>The bottom pivot-point (red arrow) as generally seen on wheel loaders. This area is signified by several pivot points (above), universal joints (blue arrow) and a myriad of hydraulic hoses (green arrows), all requiring thorough cleaning and inspection.</p>

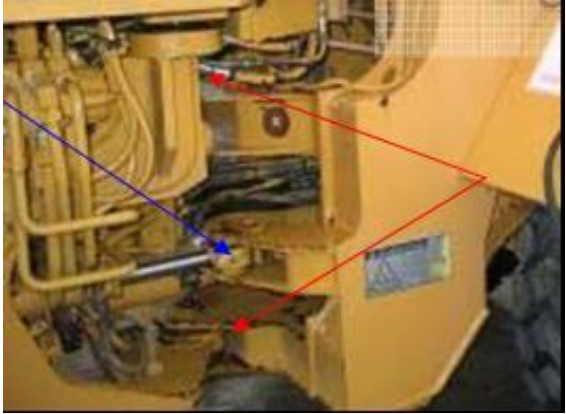
<p>The pivot-points (red arrows) and hydraulic rams (blue arrow). All non-affixed panels and shrouds have been removed, allowing access for cleaning and inspection.</p>

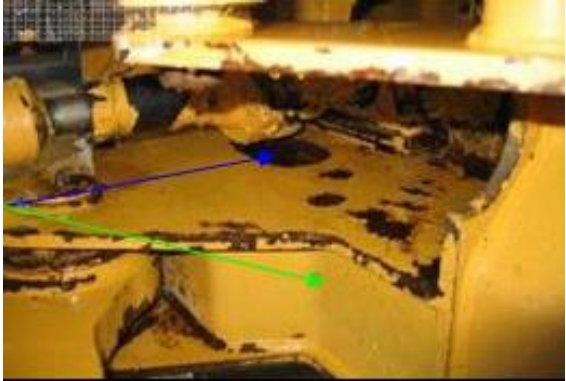
<p>The bottom pivot-point from a slightly elevated angle. Check all hollow framework (green arrow) for entrance holes (blue arrow) or drainage holes underside. This area can harbour a significant amount of biosecurity risk material and must be verified clean.</p>

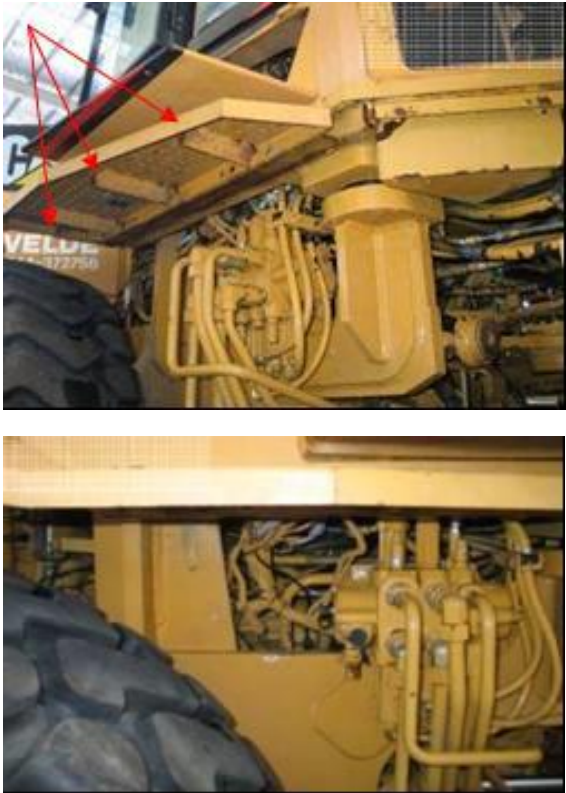
Description	Images
<p>On the underside of the cabin, the protective shrouds and all non-affixed panels have been removed, allowing for cleaning and inspection. Note the open-ended support channels (red arrows) under the side step.</p>

<p>The top photograph shows the underside of the yellow wheel loader cabin. Three red arrows point to open-ended support channels located under the side step. The bottom photograph is a close-up view of the engine compartment, showing various hydraulic lines and components.</p>

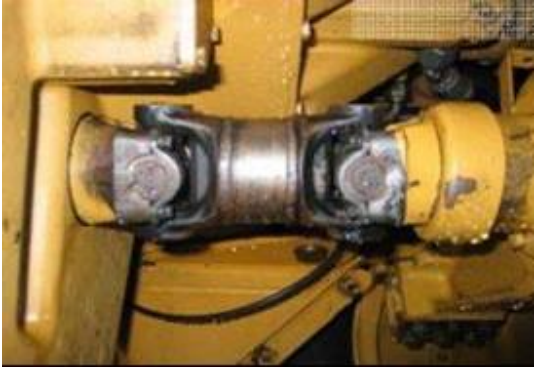
Description	Images
<p>All universal joints must be free of contaminated grease.</p>

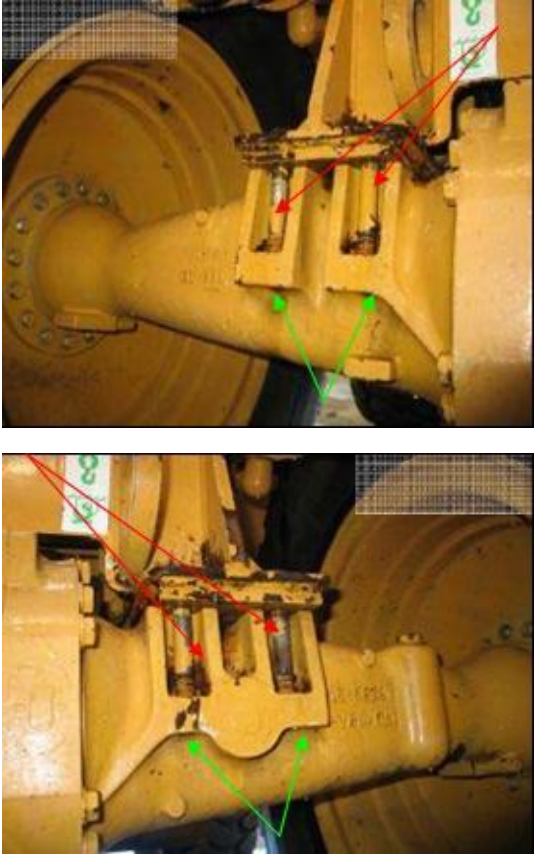
<p>Each axle on either side of the differential has supports (red arrows) for the housing above. Each of these areas requires thorough cleaning and inspection. Check if bolts are countersunk below (green arrows).</p>

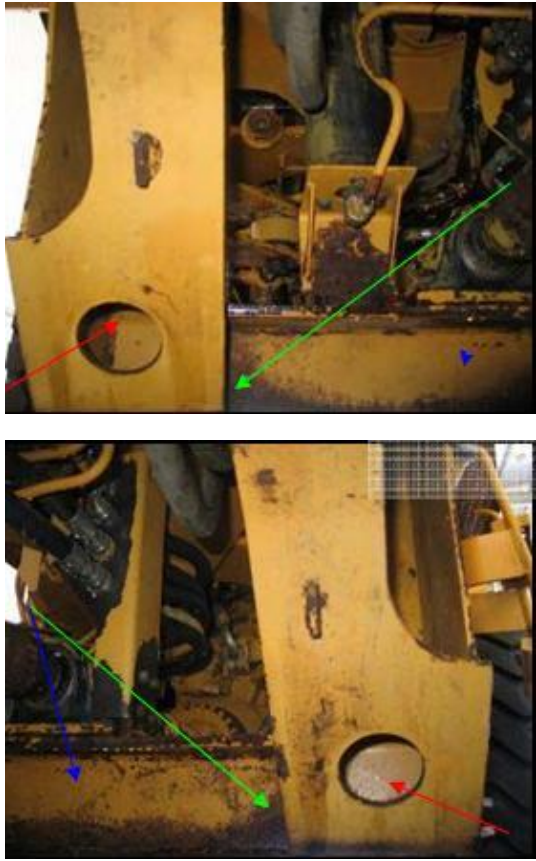
Description	Images
<p>From the front end, looking back towards the articulated pivot-point, open channels (red arrows) like those illustrated above maybe found on either side of the wheel loader. On some models the horizontal structure highlighted below these channels (blue arrows) is hollow and may have drainage points (green arrows).</p>

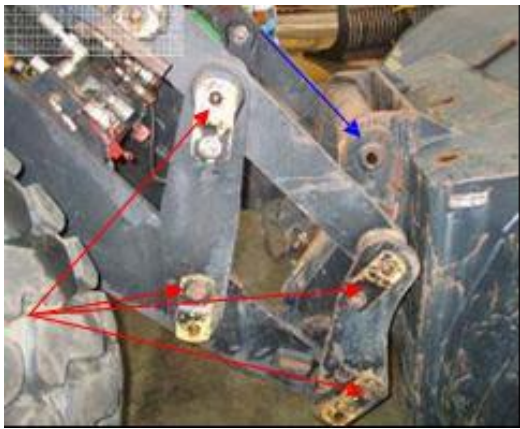
Description	Images
<p>Each pivot-point (red arrows) on the bucket arms is to be free of all contaminated grease. Check for any hollow areas (blue arrow).</p>

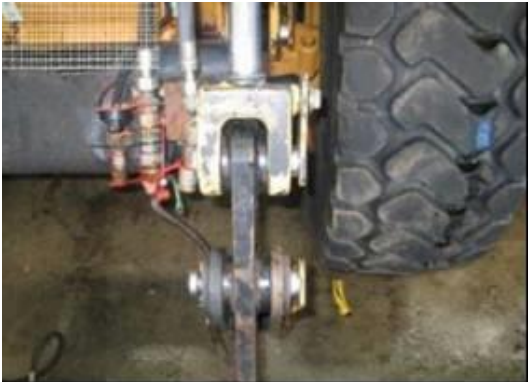
Description	Images
<p>Another view of the bucket arm pivot-points. Ensure all are free of biosecurity risk material.</p>

A close-up photograph of the bucket arm pivot points on a wheel loader. The image shows the metal components, including the bucket arm, the pivot pin, and the hydraulic cylinder. A large, treaded tire is visible in the background.
<p>Check all internal and external surfaces of the bucket for any cracks, splits or evidence of repair. All wear plates are to be loosened for flushing, while cutting teeth are to be removed for inspection.</p>

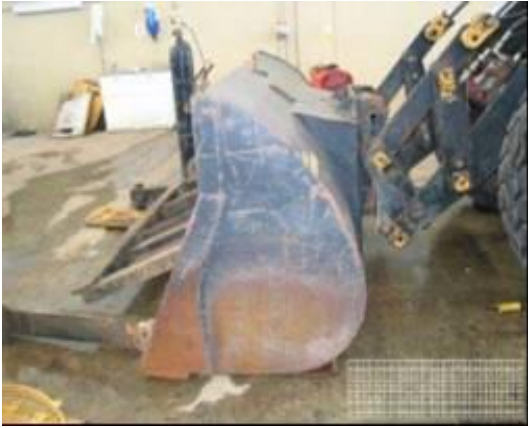
A photograph of a bucket from a wheel loader, showing its internal and external surfaces. The bucket is positioned in a workshop or maintenance area. The bucket is dark-colored and appears to be made of heavy-duty metal.
<p>An example of the variety of cutting teeth on buckets. The cutting teeth (red arrow) are to be removed for inspection, while the cutting blade (green arrow) must be loosened off and flushed to verify cleanliness. Check for small recesses (blue arrow), like the one highlighted.</p>

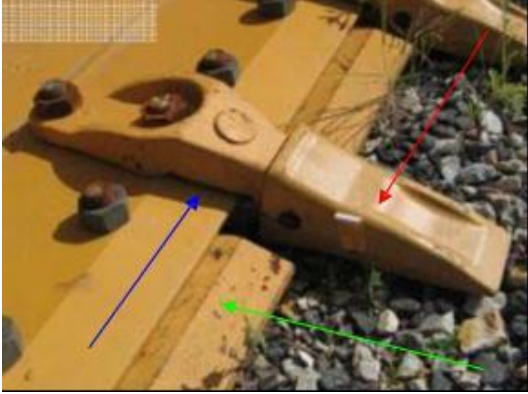
A close-up photograph of the cutting teeth and blade on a bucket. The image shows three different types of cutting teeth: a red arrow points to a sharp, pointed tooth; a green arrow points to a flat, rectangular blade; and a blue arrow points to a small recessed area on the blade. The bucket is resting on a gravel surface.

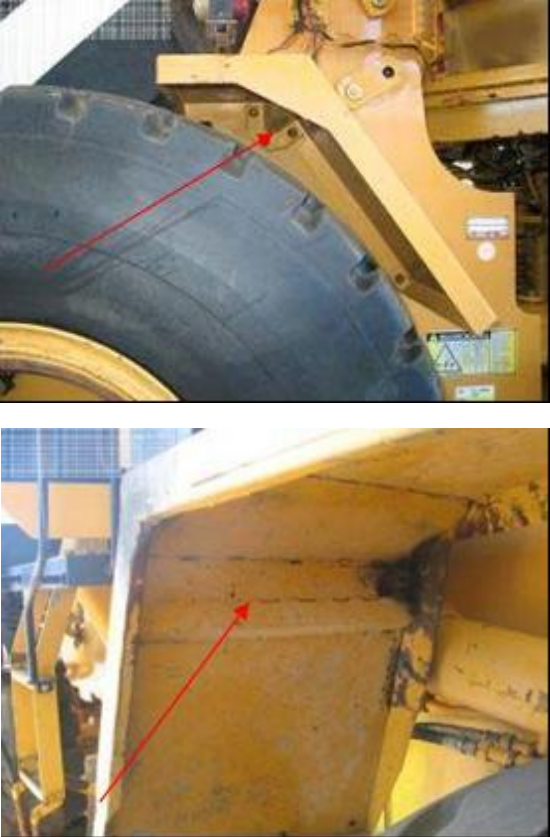
Description	Images
<p>The front wheel arch on the wheel loader. The support structures (red arrow) may be hollow, open ended or only spot-welded. Flush and verify if required.</p>

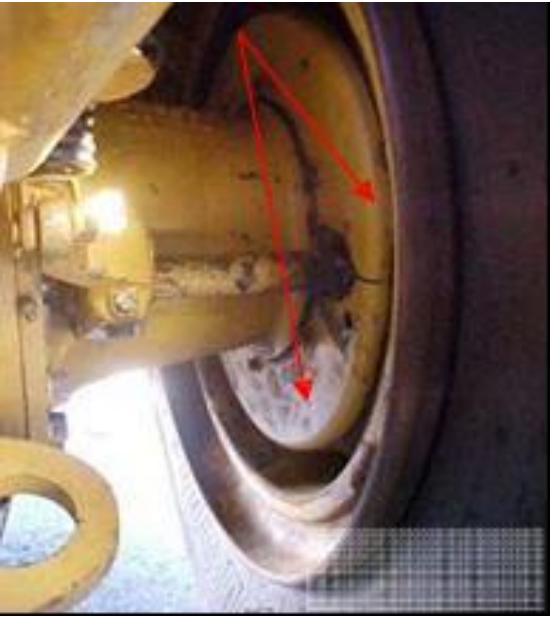
<p>On some models the inside rims are covered by non-affixed plates (red arrows). Remove all non-affixed plates for cleaning and inspection.</p>

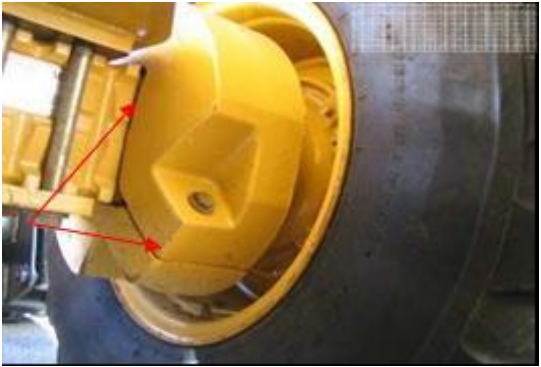
Description	Images
<p>Another example of the inside rim on a wheel loader. Ensure that all small recesses (red arrows) are flushed to verify cleanliness.</p>

A close-up photograph of the inner rim of a yellow wheel loader. Two red arrows point to small, dark recesses or grooves on the rim's surface, indicating areas that need to be flushed for cleanliness.
<p>All cracks and splits in tyres must be verified to ensure that all are free of biosecurity risk material.</p>

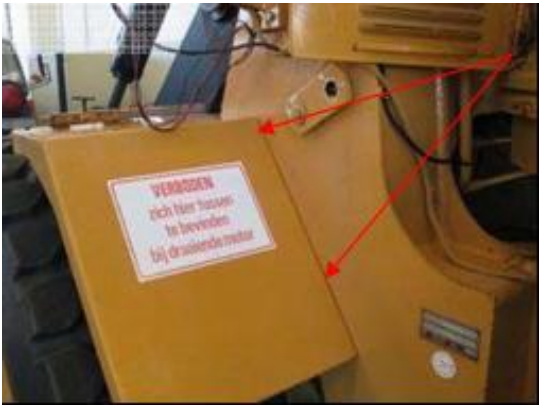
A photograph of a yellow wheel loader's wheel arch. A white warning sign with red text is attached to the arch. Two red arrows point to the seam between the arch and the wheel hub, indicating where to flush for cleanliness. The sign reads: "VERBODEN zich hier tussen te bevinden bij draaiende motor" (Prohibited from being in this area when the motor is running).

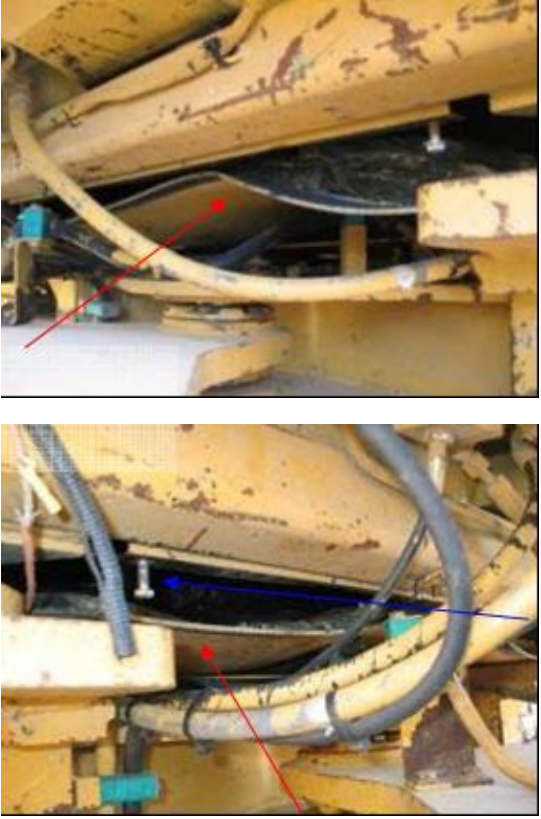
Description	Images
<p>On some models of wheel loaders, under the cabin may be a false floor (red arrows). These are reasonably common and worth illustrating as this area can harbour a significant amount of biosecurity risk material. The false floors can be made from hard rubber or compressed fibreboard and can be unbolted to allow access for cleaning and inspection.</p>

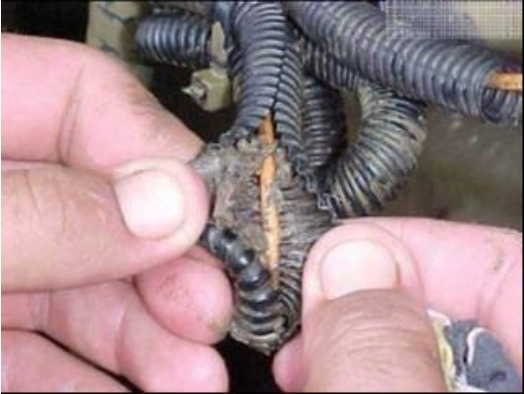
Description	Images
<p>Check all wiring harnesses for internal cleanliness.</p>

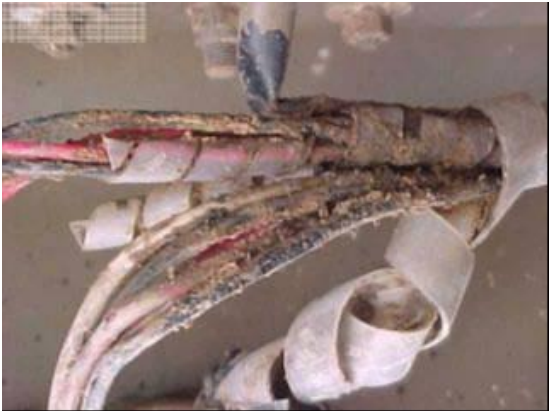
Description	Images
Check all looming around hydraulic hoses for internal cleanliness.

A close-up photograph of a hydraulic hose. A section of the hose has been cut away, revealing the internal structure. The interior is heavily contaminated with dark, fibrous material, likely mold or debris, which is a biosecurity concern. A white tape is wrapped around the cut end of the hose.
Check all footsteps for cleanliness (including underside).

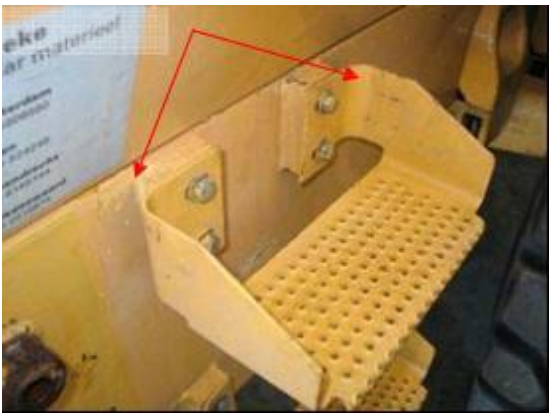
A close-up photograph of a yellow machine footprint. Two red arrows point to the underside of the footprint, highlighting areas that need to be checked for cleanliness. The footprint has a perforated surface.
The ladder to the cabin may have open-ended tubing (red arrows) that requires flushing to verify cleanliness.

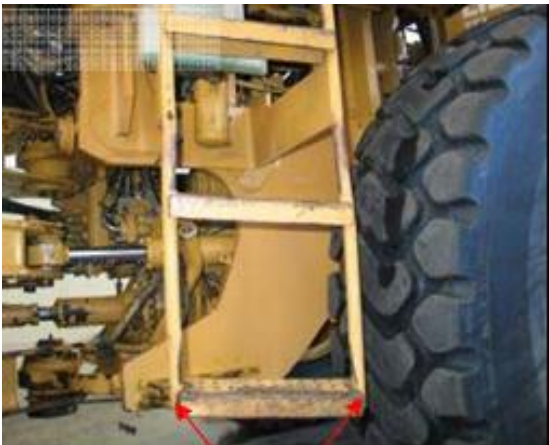
A photograph of a yellow ladder leading up to a machine cabin. Two red arrows point to the bottom of the ladder, where there is open-ended tubing. This tubing is a biosecurity concern because it can collect contaminants and requires flushing to verify cleanliness.

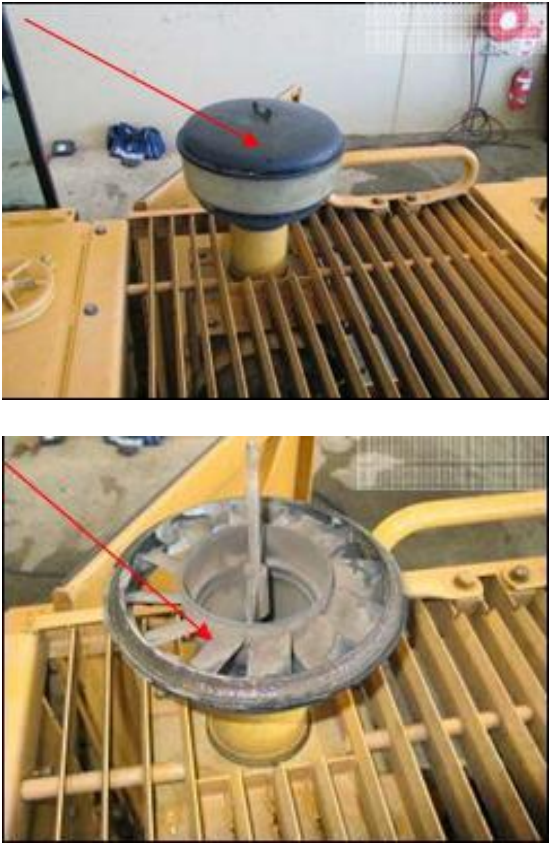
Description	Images
<p>The pre-cleaner or dust collector. The lid must be removed for cleaning and inspection.</p>

<p>The top photograph shows a yellow pre-cleaner or dust collector with a blue lid. A red arrow points to the lid. The bottom photograph shows the same unit with the lid removed, revealing the internal components. A red arrow points to the inner structure.</p>
<p>Flush any open-ended piping to verify cleanliness (red arrow).</p>

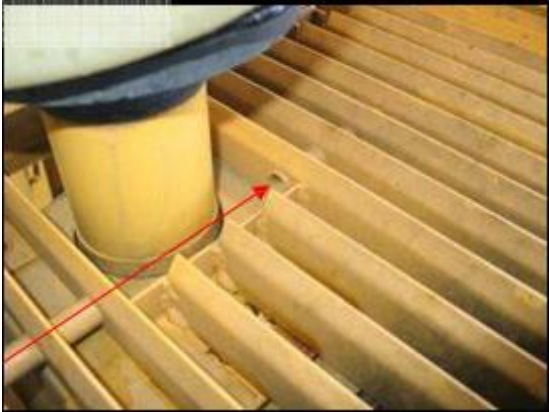
<p>The photograph shows a close-up of the pre-cleaner or dust collector. A red arrow points to an open-ended piping.</p>
